**COLORADO DIVISION OF RECLAMATION, MINING AND SAFETY  
COAL PROGRAM INSPECTION REPORT**

<b>Permit Number:</b> C-2009-087 <b>Mine Name:</b> Peabody Sage Creek Mine <b>Operator:</b> Peabody Sage Creek Mining, LLC <b>Operator Address:</b> Mr B. Scott Cowman P.O. Box 250 36600 Routt County Road 27 Hayden, CO 81639	<b>County:</b> Routt <b>Operation Type:</b> Underground <b>Permit Status:</b> Active <b>Ownership:</b> Federal
	<b>Operator Representative Present:</b>  Scott Cowman
<b>Operator Representative Signature:</b> (Field Issuance Only)

<b>Inspection Start Date:</b> April 8, 2013 <b>Inspection Start Time:</b> 12:45 <b>Inspection End Date:</b> April 8, 2013 <b>Inspection End Time:</b> 16:00	<b>Inspection Type:</b> Coal Partial Inspection <b>Inspection Reason:</b> Normal I&E Program <b>Weather:</b> Cloudy
<b>Joint Inspection Agency:</b>  None	<b>Joint Inspection Contacts:</b>
<b>Post Inspection Agency:</b>  None	<b>Post Inspection Contacts:</b>
<b>Inspector(s):</b>  Jason D. Musick	<b>Inspector's Signature:</b>

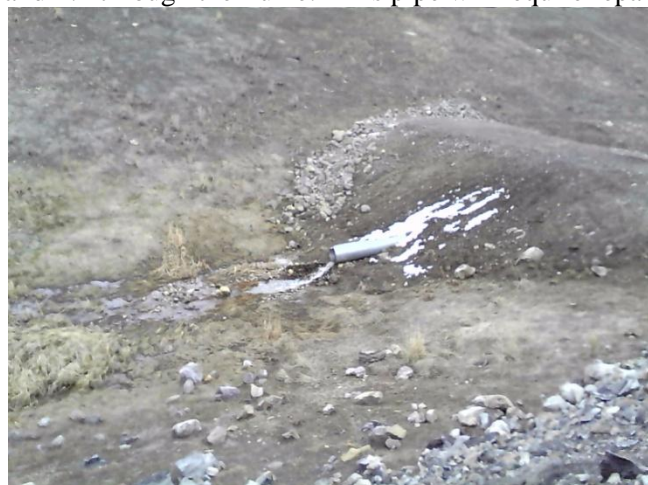
Lower Sump Outlet

- The primary spillway of the Lower Sump has been damaged due to ice. The riser pipe has become detached from the straight pipe. No off site impacts were observed as the discharge of the Lower Sump discharges to Pond 002. Discharge through the Lower Sump was ~ 1/4 full through the pipe. Discharge through Pond 002 was clear and ~.2 through the flume. This pipe will require repair by April 30th, 2013.

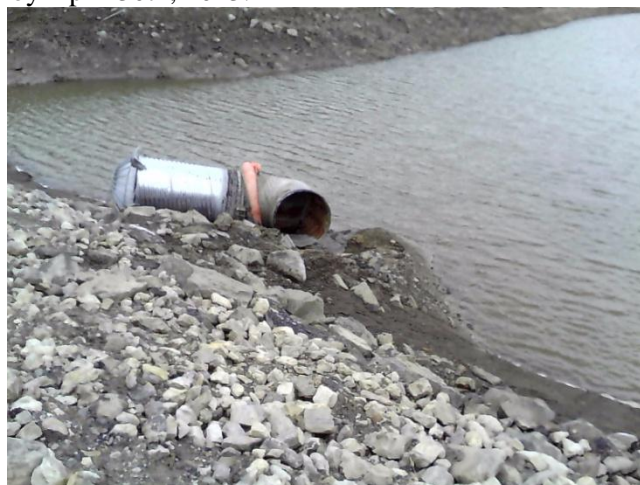
Lower Sump Damaged Riser Pipe

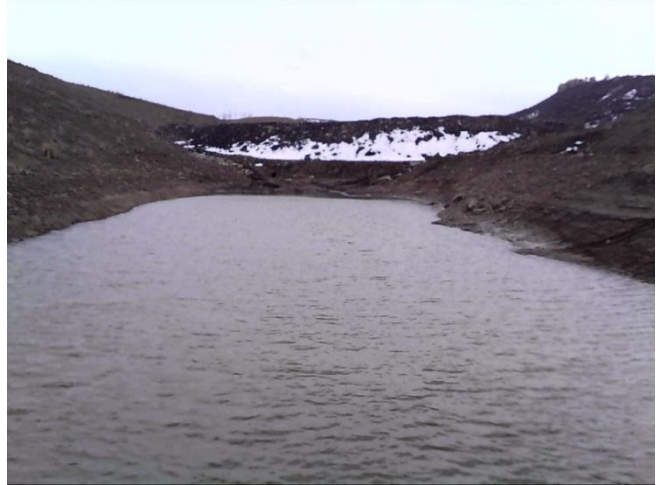
- The crest of the embankment of Lower Sump displayed surface cracking due to settling. The Lower Sump construction/reconstruction was completed in the Fall of 2012. The embankment should be monitored for any structural issues throughout the spring and summer.

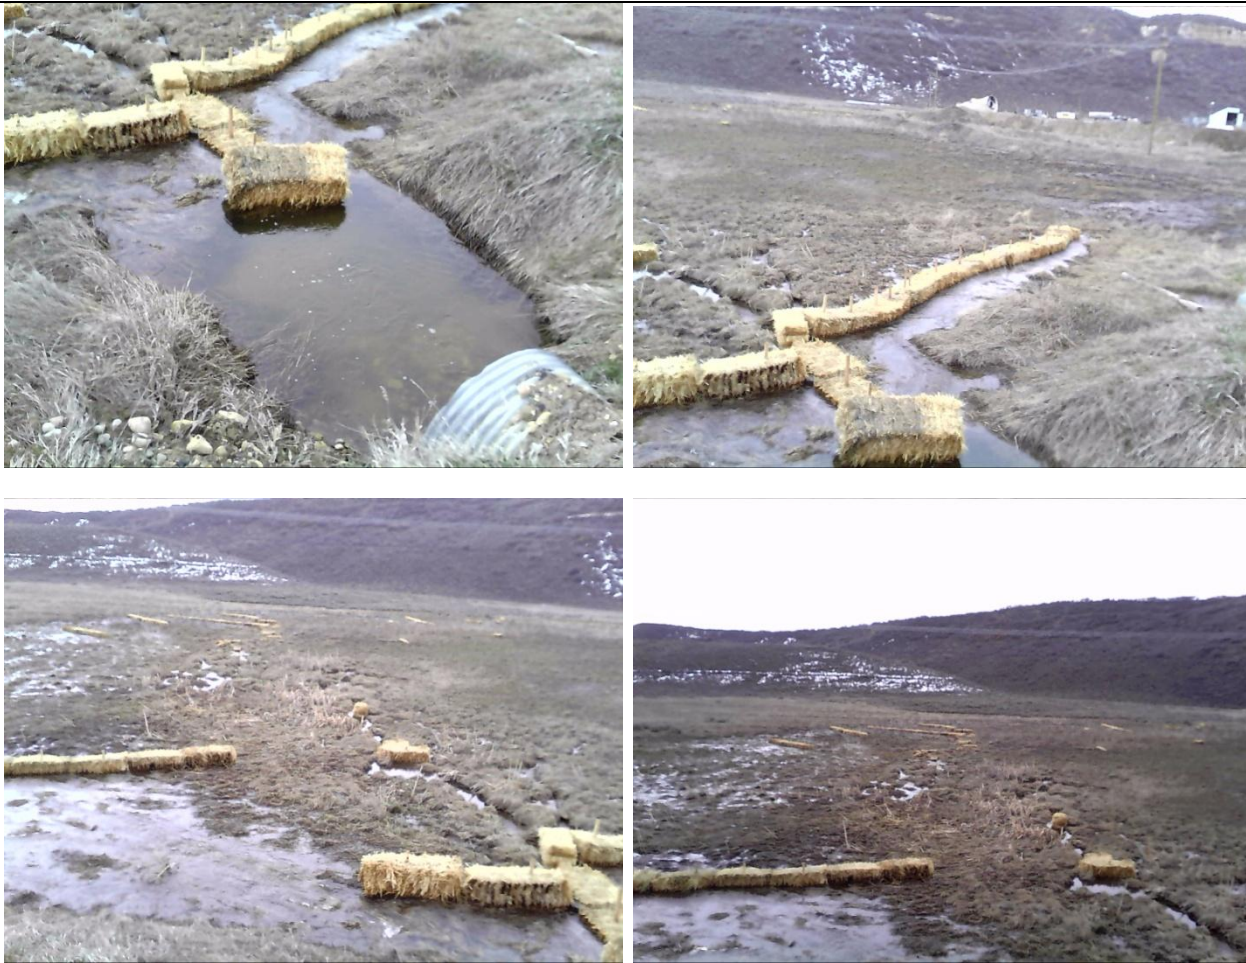
Installed Straw Bales

The Peabody Sage Creek site is currently in negotiations with CDPHE concerning a NOV of its discharge permit with regard to selenium. In order to help address the issue Peabody Sage Creek has installed straw bales at the outlet of culvert 9A which is the continuation of Little Grassy Creek. The purpose of the straw bales is to help distribute the water from centralized channel to a naturally established wetlands area. No disturbance was observed. However, This activity may require permitting with the Division.
