COLORADO DIVISION OF RECLAMATION, MINING AND SAFETY COAL PROGRAM INSPECTION REPORT

Permit Number: C-1981-014 Mine Name: Southfield Mine Operator: Energy Fuels Coal, Inc. Operator Address: Mr George Patterson P.O. Box 459 Florence, CO 81226	County: Fremont Operation Type: Underground Permit Status: Permanent Cessation Ownership: Private
	Operator Representative Present: George Patterson
Operator Representative Signature: (Field Issuance Only)

Inspection Start Date: September 17, 2012 Inspection Start Time: 12:00 Inspection End Date: September 28, 2012 Inspection End Time: 10:00	Inspection Type: Coal Complete Inspection Inspection Reason: Normal I&E Program Weather: Cloudy
Joint Inspection Agency: None	Joint Inspection Contacts:
Post Inspection Agency: None	Post Inspection Contacts:
Inspector(s): Janet H. Binns Dan Hernandez Leigh D. Simmons	Inspector's Signature:

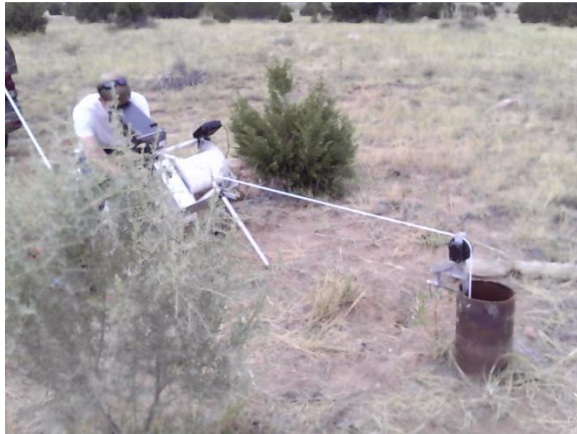
On August 28, 2012, EFCI provided documentation to the Division that the cable had been removed from MW-NW. The Division used a borehole camera to confirm the removal of the cable and document the status of the monitoring well.

Photo 1: investigation of MW-NW with bore hole camera.

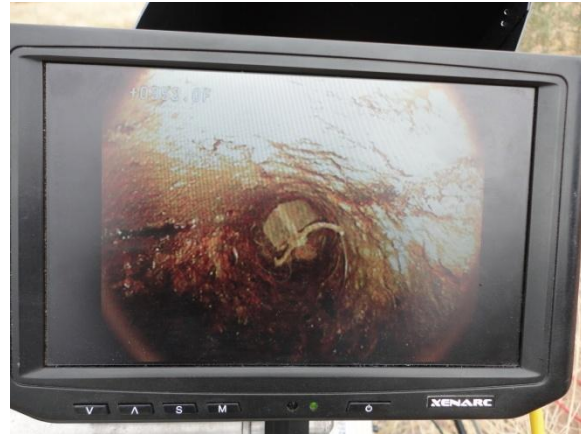
The camera showed intact casing throughout the monitoring well. The cable had previously been encountered at 334 ft. below the top of the well casing. The cable had been successfully removed. At 352.5 ft. below the casing, EFCI's water probe was encountered. The probe consisted of a piece of wooden 2x4 (approximately 8 to 10 inches long according to George) with a rope threaded through it then connected to a 1/16 inch steel cable. a small piece of steel cable could be seen below the wooden 2x4. The 2x4 is setting at the 352.5 foot level. It was unclear

what the “probe” is sitting on. It appears that there may be rocks or other obstructions below the probe. The camera was limited by the wooden 2x4 from seeing below the wooden 2x4. George stated that the probe became stuck on March 22, 2012 when he was monitoring the MW-NW well. The well appeared dry at the level of the probe. No standing water was observed at the base of the probe at the level of the obstruction. The Division successfully recorded a DVD video of the condition of the well and the obstruction of the probe using the borehole camera. Please note that EFCI’s letter dated August 28, 2012, reports the probe and obstruction depth at 356 ft. below the top of the casing. This is a variance of 3.5 ft or 1% error between the Division’s measurement and EFCI’s.

EFCI has removed the cable from monitoring well MW-NW, but a wooden block and other obstruction remain in the well.

Photo 2: wooden probe @ 352.0 ft. in MW-NW

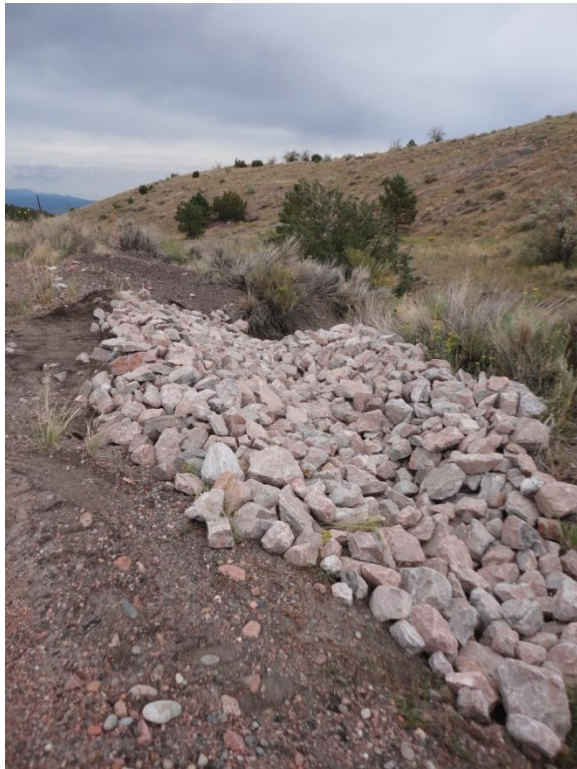
EFCI has reinforced the road cut immediately north of the access road turn off to the Monarch fan road. Runoff from the Southfield access road enters the drainage north of Pond 5 at this location.

Photo 3: rock armoring at Access rd. drainage

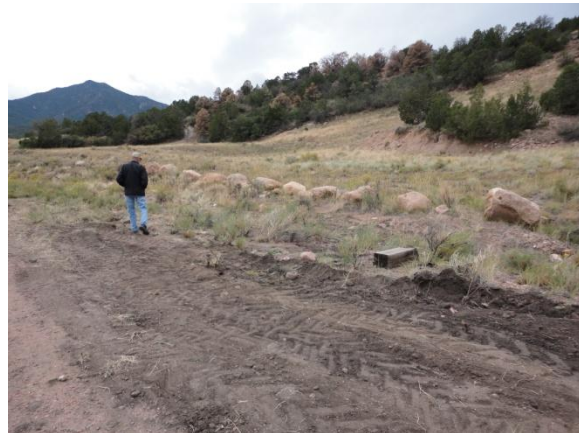
EFCI has removed the portable fuel tank and the 5 gal. gas jugs from the site. Minor oil leaks (drips) from the grader and the backhoe were confined to small area immediately under the machinery. EFCI commits to cleaning up hydrocarbon affected material and disposing properly prior to final bond release. All areas with equipment drain to Pond 5.

Photo 4: fuel tank removed.

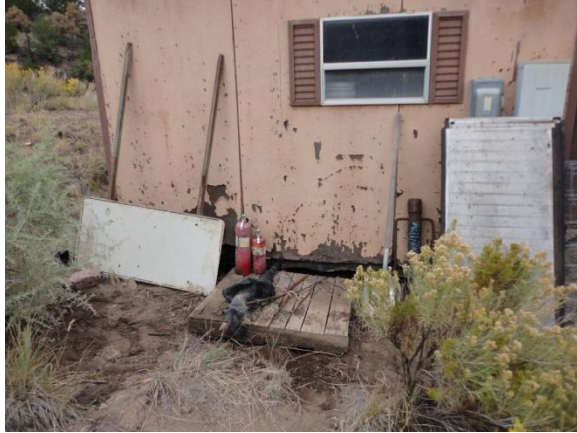
Photo 5: gas cans and barrels removed

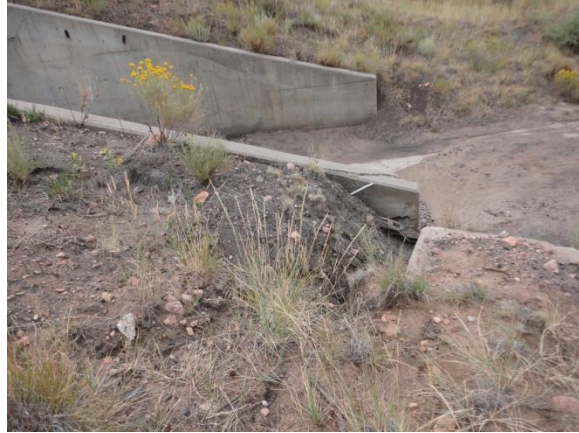
Photo 6: NE corner of truck tunnel needs erosion control measure.

Erosion control measures are needed at the top of the slope on the northeast side of the truck tunnel. Runoff is concentrating and running down this slope. Dispersion of the flow path and rill mitigation is recommended at this location (photo)

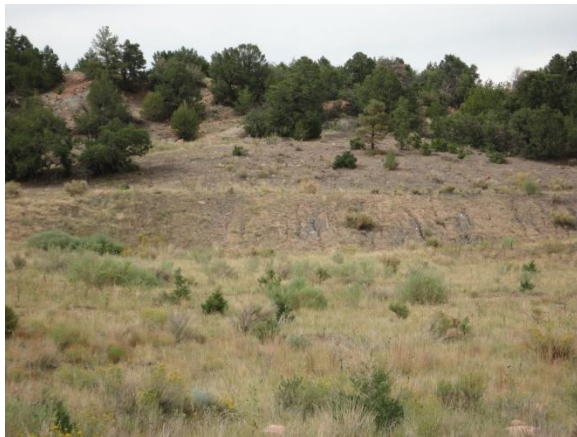
Photo 7: Slope north of portal area gravel pad, needs rill mitigation

Some rilling was noted on the slope north of the gravel pad area at the portal reclamation area. Rill repair is warranted in this location. (photo)

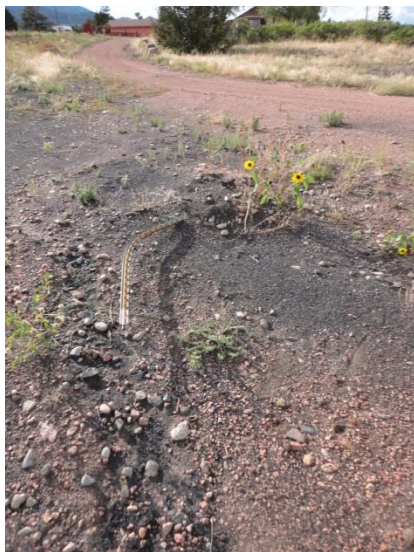
Photo 9: boundary marker needs replacement Intersection substn. Rd. & ranch driveway

Disturbance area boundary markers are needed at the reclaimed rock dust storage area. Disturbance area marker along the access road to the substation have been knocked down and need to be reinstalled. The damaged marker at the turnoff from the substation road to the Thompson ranch is broken as to present a vehicle tire hazard and needs to be removed and replaced.

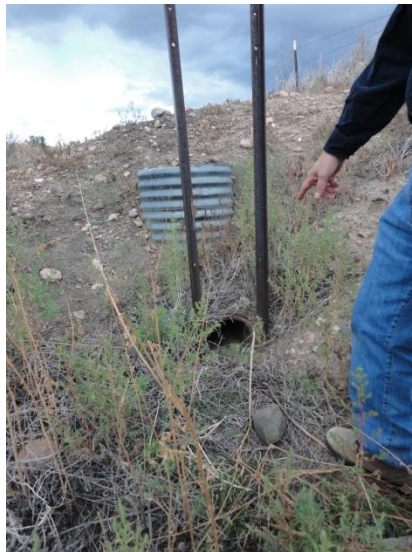
Photo 10: gated valve missing from pond L1 riser @ loadout

Both ponds at the load out were dry. No trash has been deposited in either pond. The primary spillway at Load out Pond 1 (east pond) needs material dug away from the top of the discharge inlet. Material from the pond embankment is sloughing off and into the primary riser. EFCI needs to assure that dirt and soil material does not spill into the discharge structure and needs to remove material that has sloughed into the pipe. The primary riser is also missing the decant gated valve. EFCI needs to repair the primary riser to the approved design. (Map 26)

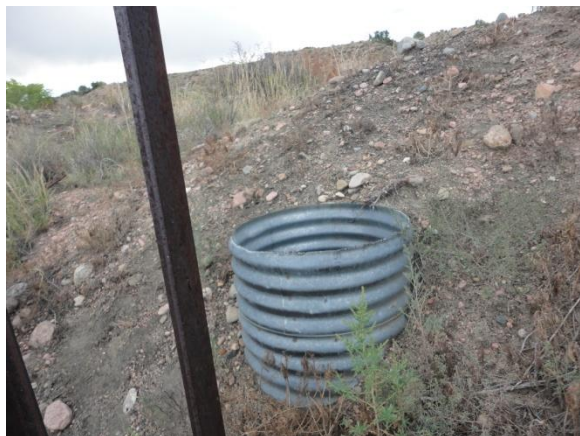
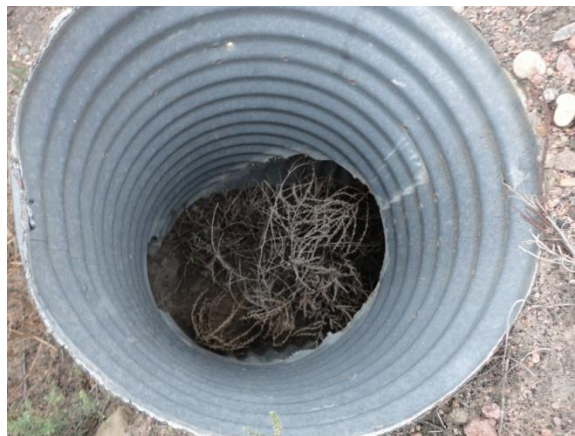
Photo 11: slope sloughing into pond L1 riser

Photo 12: material sloughing into Pond L1 riser

effective. No erosional features were noted. Maintenance is needed on the primary spill way of Pond L1.

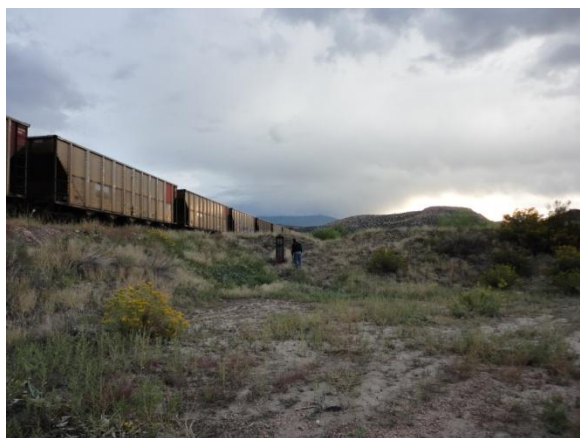
Photo 13: Pond L2 at load out.
