COLORADO DIVISION OF RECLAMATION, MINING AND SAFETY
MINERALS PROGRAM INSPECTION REPORT
PHONE: (303) 866-3567

MINE NAME: Pribble Pit	MINE/PROSPECTING ID#: M-2008-020	MINERAL: Sandstone (silica, st quartzite)	COUNTY: Dolores
INSPECTION TYPE: Monitoring	INSPECTOR(S): Kate A. Pickford	INSP. DATE: April 4, 2013	INSP. TIME: 13:00
OPERATOR: Dolores County	OPERATOR REPRESENTATIVE: Lonnie Pribble	TYPE OF OPERATION: 110c - Construction Limited Impact

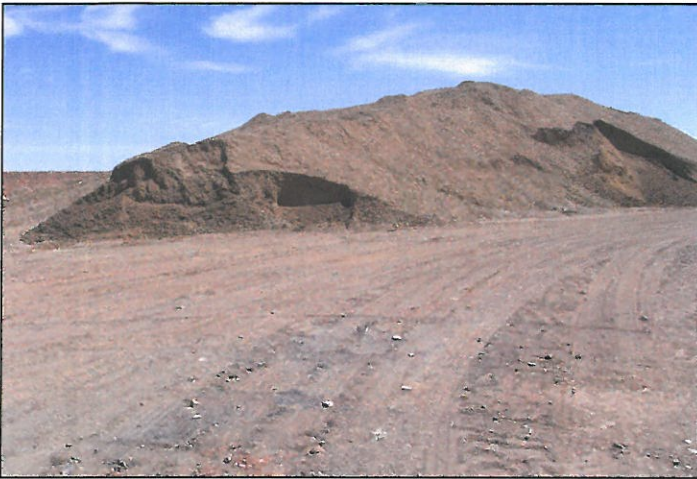
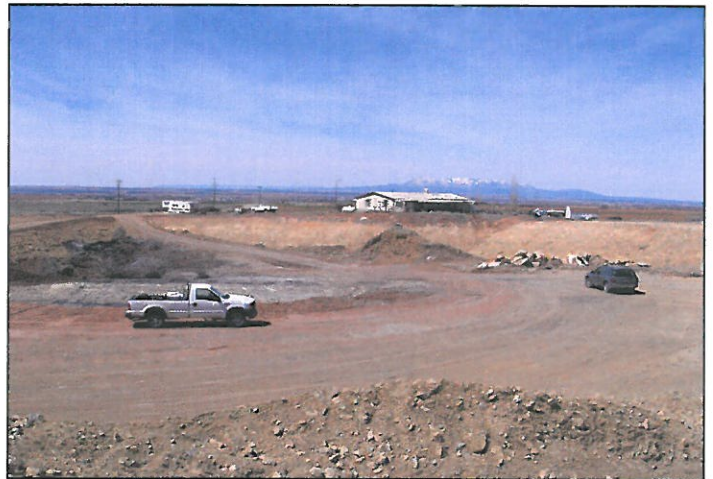
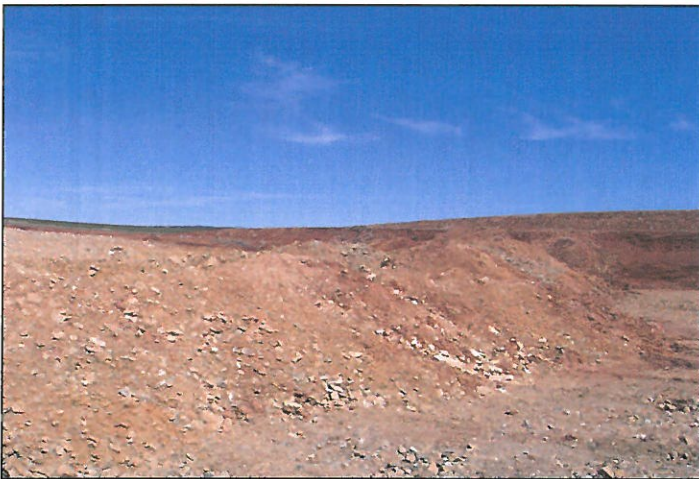
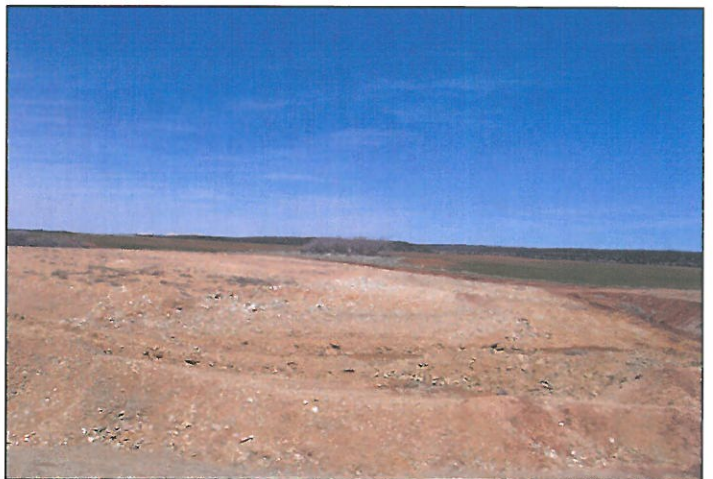
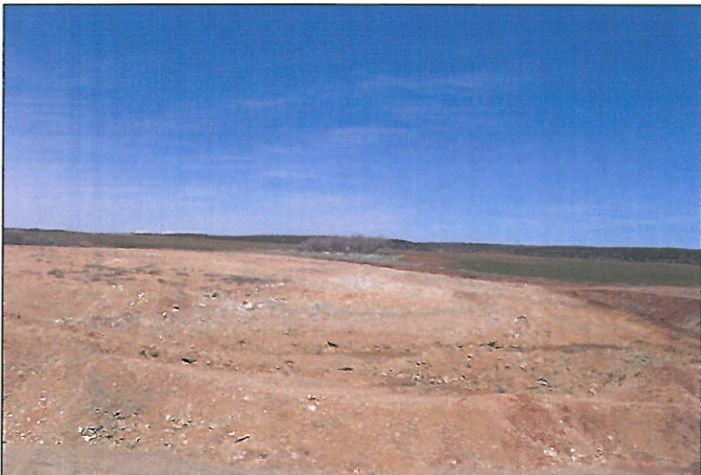
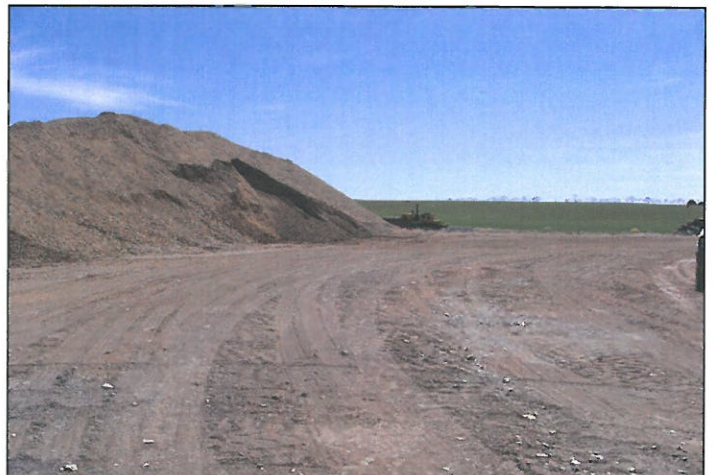
PHOTOGRAPHS

The site is fully disturbed due to mining related activities. Stockpiles of topsoil, overburden and crushed gravel are distributed throughout the permit area. There is vegetative material on the pit floor that Mr. Pribble indicates is periodically burned and will not be buried.

No problems were observed during this inspection.
