## COLORADO DIVISION OF RECLAMATION, MINING AND SAFETY COAL PROGRAM INSPECTION REPORT

<b>Permit Number:</b> C-1981-028 <b>Mine Name:</b> Keenesburg Strip Mine <b>Operator:</b> Coors Energy Company <b>Operator Address:</b> Mr. Benjamin Moline P.O. Box 4030 Suite 400 Golden, CO 80401	<b>County:</b> Weld <b>Operation Type:</b> Surface <b>Permit Status:</b> Active <b>Ownership:</b> Private
	<b>Operator Representative Present:</b>  Danny Kipp
<b>Operator Representative Signature:</b> (Field Issuance Only)

<b>Inspection Start Date:</b> April 18, 2013 <b>Inspection Start Time:</b> 09:30 <b>Inspection End Date:</b> April 18, 2013 <b>Inspection End Time:</b> 10:00	<b>Inspection Type:</b> Coal Partial Inspection <b>Inspection Reason:</b> Normal I&E Program <b>Weather:</b> Cloudy
<b>Joint Inspection Agency:</b>  None	<b>Joint Inspection Contacts:</b>
<b>Post Inspection Agency:</b>  None	<b>Post Inspection Contacts:</b>
<b>Inspector(s):</b>  Brock F. Bowles	<b>Inspector's Signature:</b>

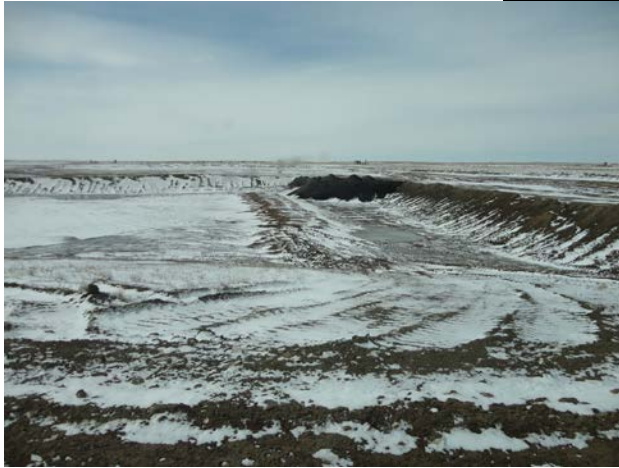
Ash was stacked in B-Pit ready for backfilling. On a daily basis, the ash is backfilled and covered with coverfill material. The current lift in B-Pit is being backfilled from west to east (photo 1).

Photo 1 – Backfilling in b-Pit

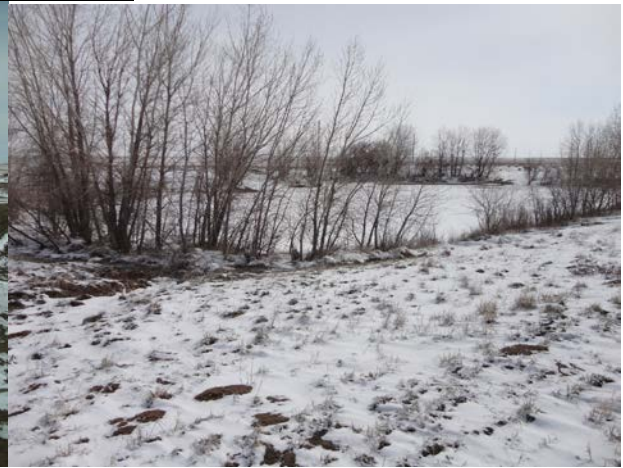
Sediment pond 2 did not contain standing water but had a few inches of snow (photo 2). The rocks in the West Perimeter ditch reported in the last inspection report as blocking the ditch were moved. The rocks were arranged along the sides of the ditch and are now being used as armor.

Photo 2 – Sediment Pond 2
