# COLORADO DIVISION OF RECLAMATION, MINING AND SAFETY COAL PROGRAM INSPECTION REPORT

| <b>Permit Number:</b> C-1980-006<br><b>Mine Name:</b> Marr Mine<br><b>Operator:</b> Kerr Coal Company<br><b>Operator Address:</b><br>Mr. George Patterson<br>C/O Energy Fuels Coal, Inc.<br>P.O. Box 459<br>Florence, CO 81226 | <b>County:</b> Jackson<br><b>Operation Type:</b> Surface<br><b>Permit Status:</b> Permanent Cessation<br><b>Ownership:</b> Federal |

| <b>Inspection Start Date:</b> April 18, 2013<br><b>Inspection Start Time:</b> 11:30<br><b>Inspection End Date:</b><br><b>Inspection End Time:</b> | <b>Inspection Type:</b> Coal Partial Inspection<br><b>Inspection Reason:</b> Normal I&E Program<br><b>Weather:</b> Snowing |

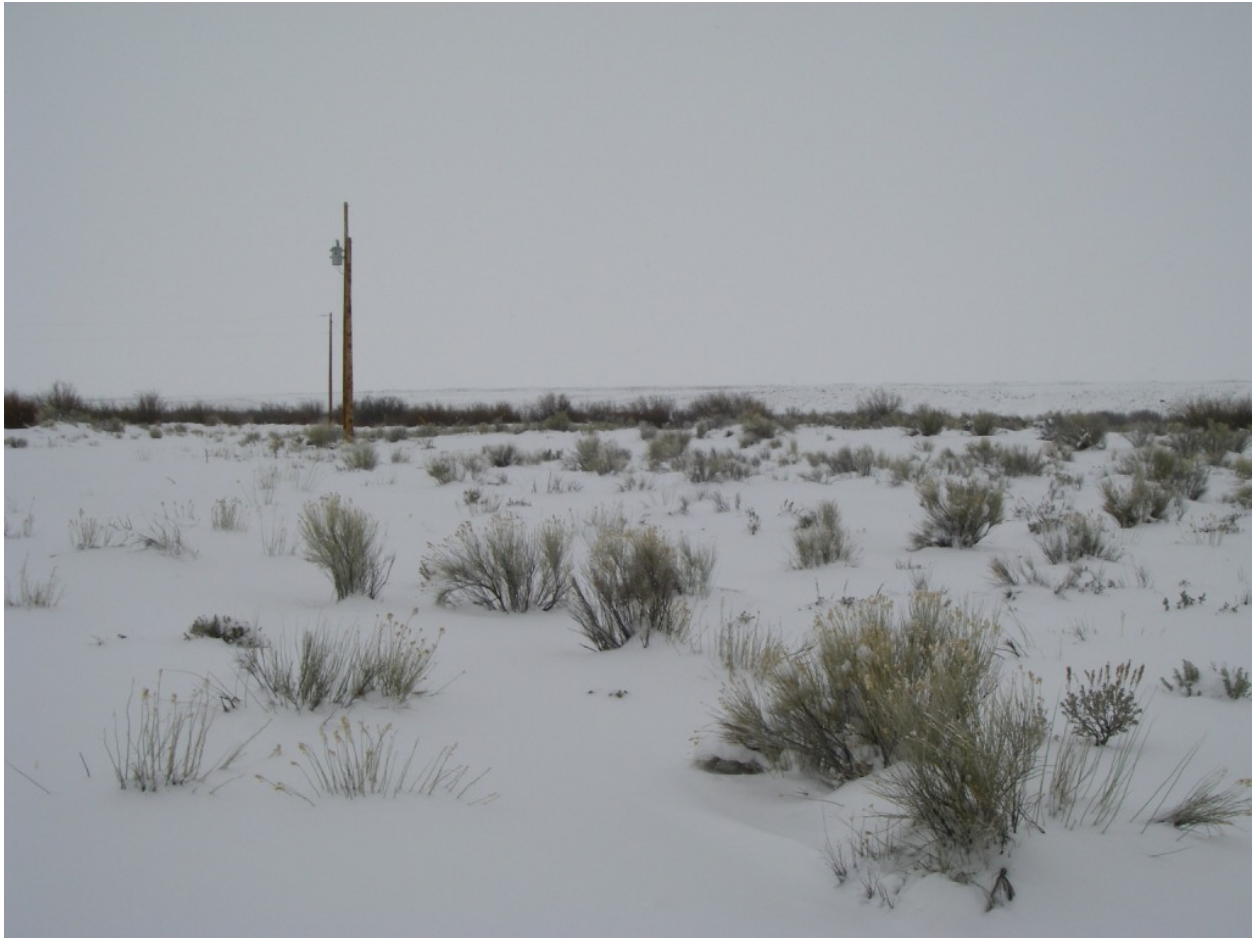
At the loadout, no erosion, large weed patches, or other problems were seen.

**Reclamation at Loadout, looking south**
