# COLORADO DIVISION OF RECLAMATION, MINING AND SAFETY COAL PROGRAM INSPECTION REPORT

<b>Permit Number:</b> C-1981-014 <b>Mine Name:</b> Southfield Mine <b>Operator:</b> Energy Fuels Coal, Inc. <b>Operator Address:</b> Mr George Patterson P.O. Box 459 Florence, CO 81226	<b>County:</b> Fremont <b>Operation Type:</b> Underground <b>Permit Status:</b> Permanent Cessation <b>Ownership:</b> Private
<b>Operator Representative Present:</b>  None	
<b>Operator Representative Signature: (Field Issuance Only)</b>

<b>Inspection Start Date:</b> April 15, 2013 <b>Inspection Start Time:</b> 11:30 <b>Inspection End Date:</b> April 15, 2013 <b>Inspection End Time:</b> 17:00	<b>Inspection Type:</b> Coal Partial Inspection <b>Inspection Reason:</b> Normal I&E Program <b>Weather:</b> Clear
<b>Joint Inspection Agency:</b>  None	<b>Joint Inspection Contacts:</b>  
<b>Post Inspection Agency:</b>  None	<b>Post Inspection Contacts:</b>  
<b>Inspector(s):</b>  Janet H. Binns	<b>Inspector's Signature:</b>

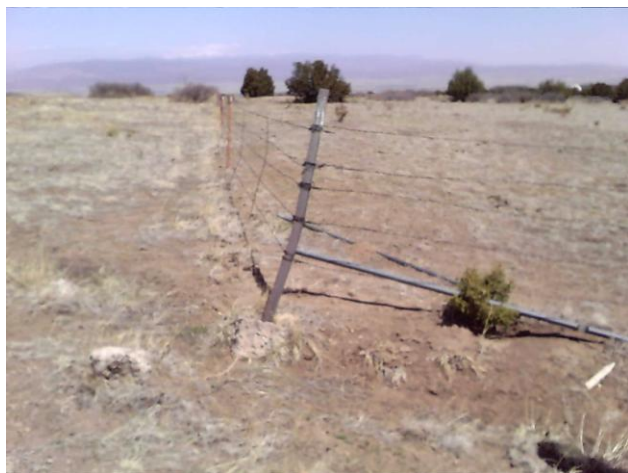
The landowner has identified 3 fence corner posts that have pulled out of the ground. He believes these may be a result of subsidence impacts. We visited two of the affected fence corners during the inspection. The first location is north of the Corley Mountain Ranch road in T20S, R70W Section 24. (Photo 1)

Photo 1: fence corner in Section 24

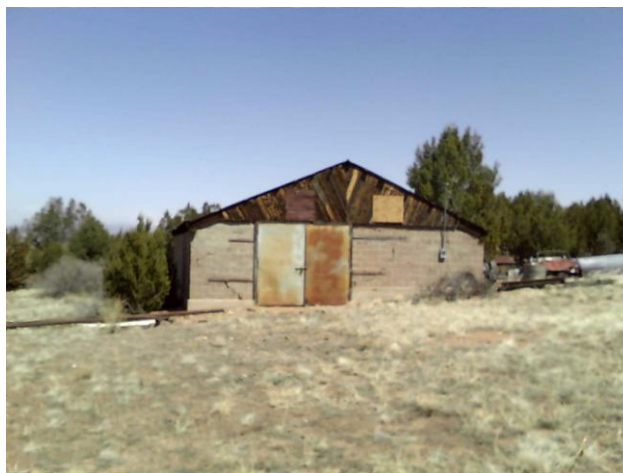
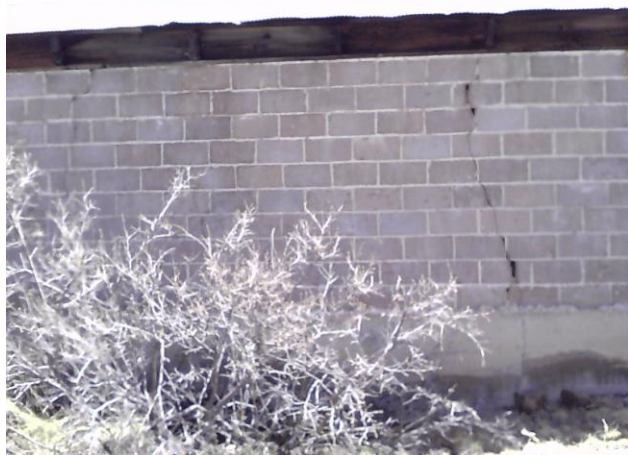
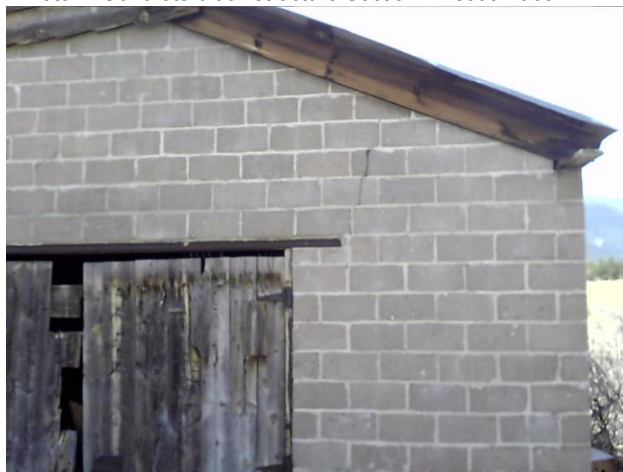
The cinderblock storage building is located along the Corley Mountain Ranch road in T20S, R70W Section 24. The landowner estimated that this structure was constructed in the 1930's. There are cracks in the masonry on the south and west sides of the building. Repairs have been implemented on the cracks previously. (Photos 2-4)

Photo 2: Concrete block structure Section 24 south face

Photo 3: West side concrete storage building

Photo 4: North side concrete storage building

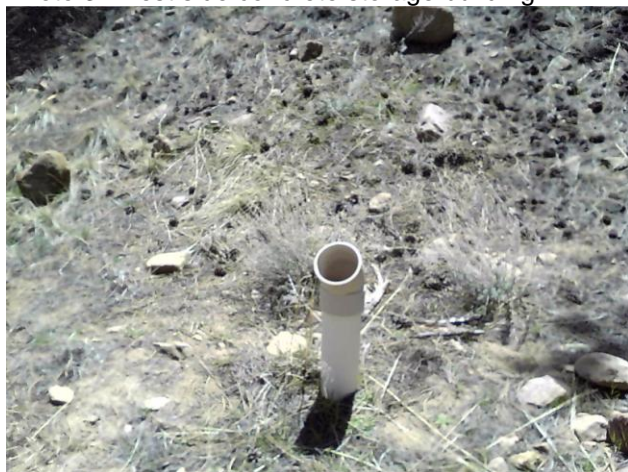
Photo 5: 4" PVC south of Corley Ranch house

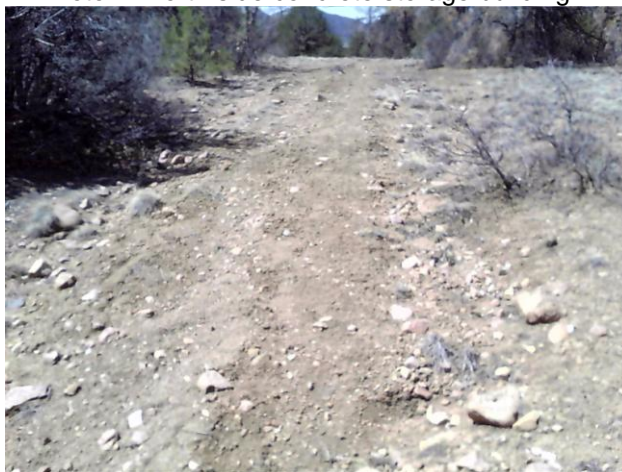
drainage. Continuing eastward along the waterline path, there are some stretches of the line that have poor vegetation re-establishment. It is unclear if animals are using this as a travel path, but little vegetation has established over the old line (Photos 6 & 7). Along portions of the waterline path there are remnants of broken PVC. These broken pieces are weathered and have sharp exposed edges. The landowner uses some of his property for livestock. Other portions of 4" PVC are still present protruding from the ground (Photo 8). A portion of 4" PVC is becoming exposed at the head of a gully located west of Well 119459. The 2" PVC also noted at this location was a waterline utilized by the landowner. (Photo 9) Three portions of 4" PVC protrude from the ground west of well 119459. (Photo 10)

Photo 6: bare path along waterline route

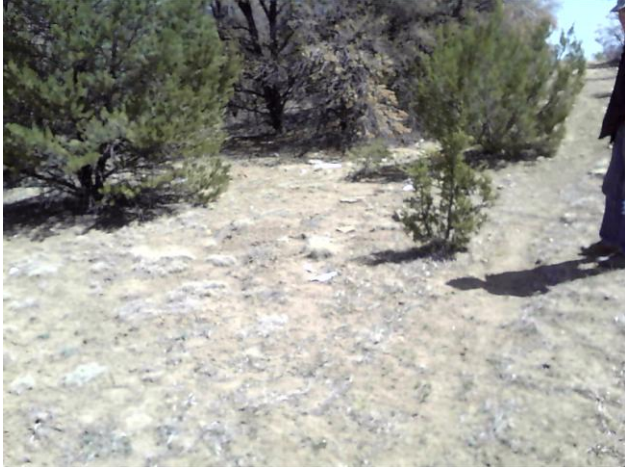
Photo 7: broken PVC pieces along waterline route

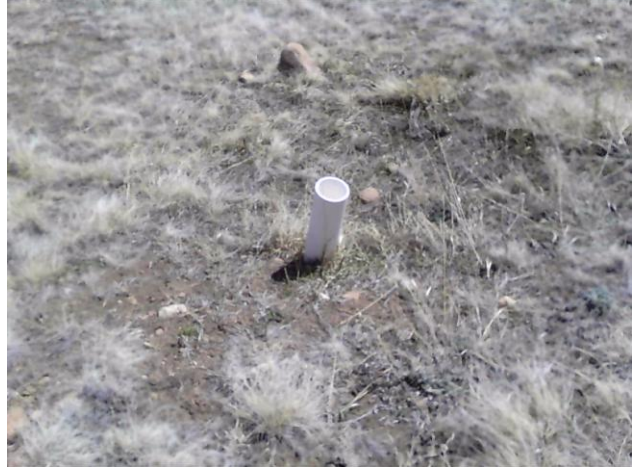
Photo 8: protruding PVC pipe

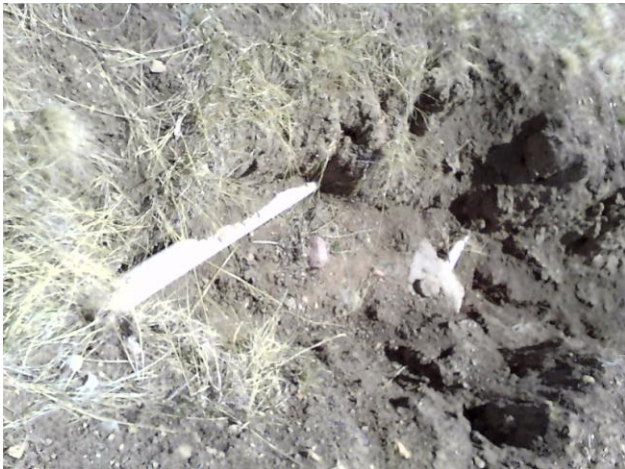
Photo 9: Exposed PVC pipe in gully

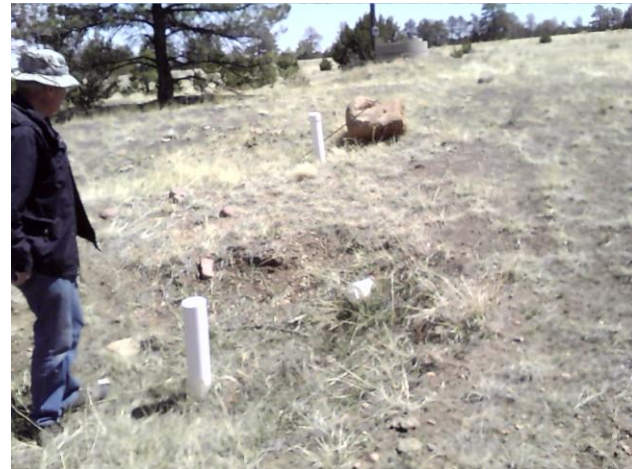
Photo 10: Protruding PVC near well 119459

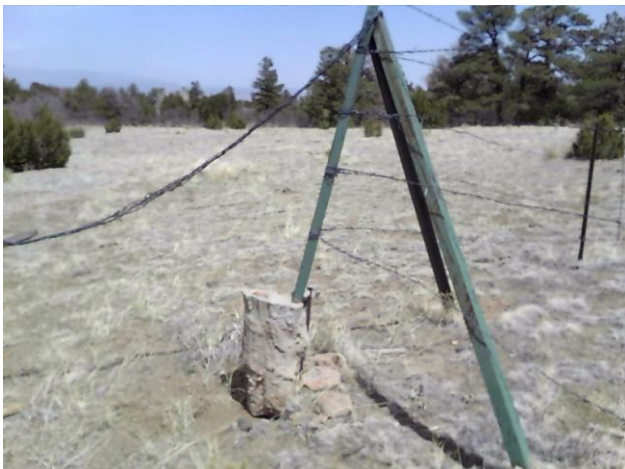
The second affected fence corner is at the NW corner of Dr. Corley's property and The Vento Group's property, between R70W T20S Sec 24 and R69W, T20S Sec 19 (Photo 11). The landowner reported that the third affected fence corner is in Section 31, and not easily accessible. Dr. Corley sent the coordinates of the 3rd fence corner to the Division.

Photo 11: Fence corner at Dr. Corley & Vento Group corner

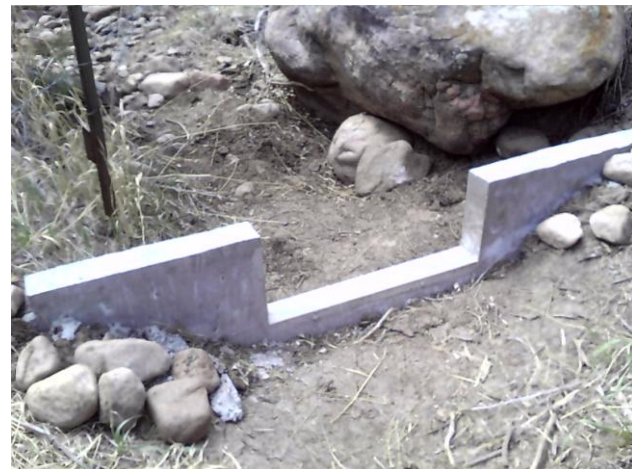
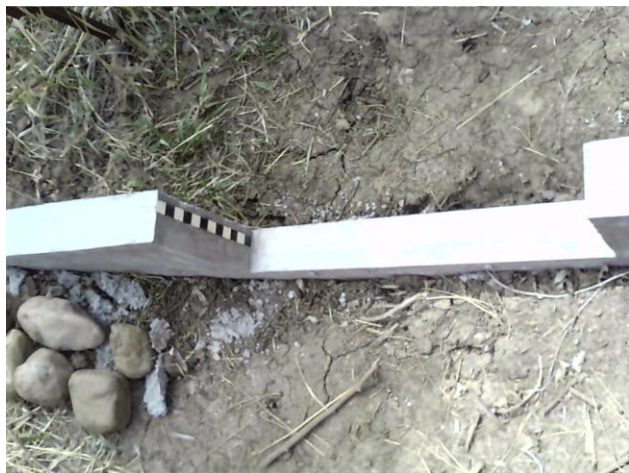
The landowner has installed a weir on Newlin Creek to allow him to measure the flow in Newlin Creek when it flows. The Division collected GPS coordinates at the location of the landowner's weir. (Photos 12 & 13)

Photo 12: Landowner's Newlin Creek Weir

Photo 13: Landowner's Newlin Creek Weir

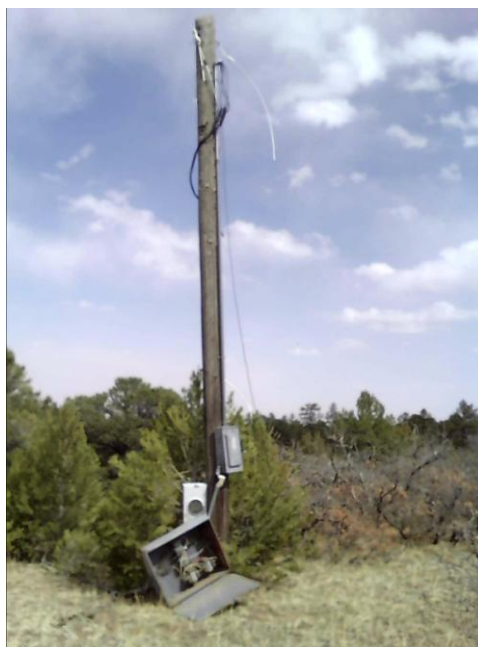
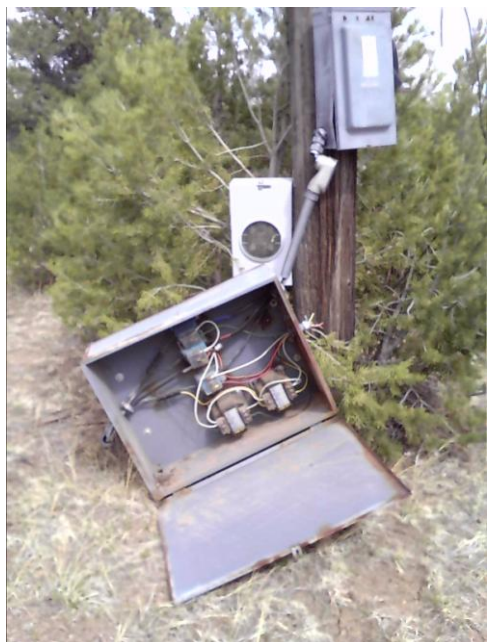
Photo 14: Powerpole & electrical boxes  
West of Monarch Fan road

Photo 15: Powerpole & electrical boxes

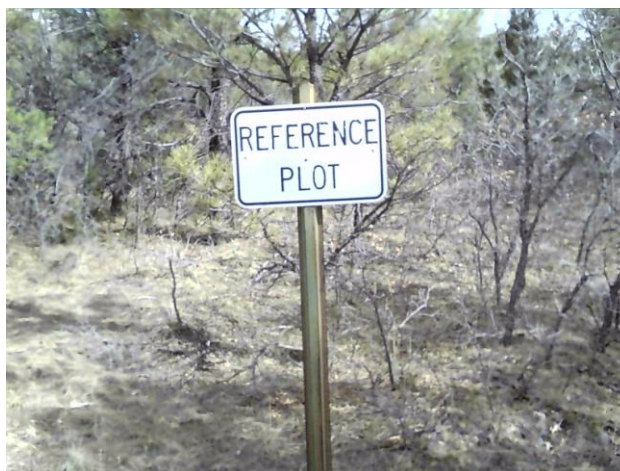
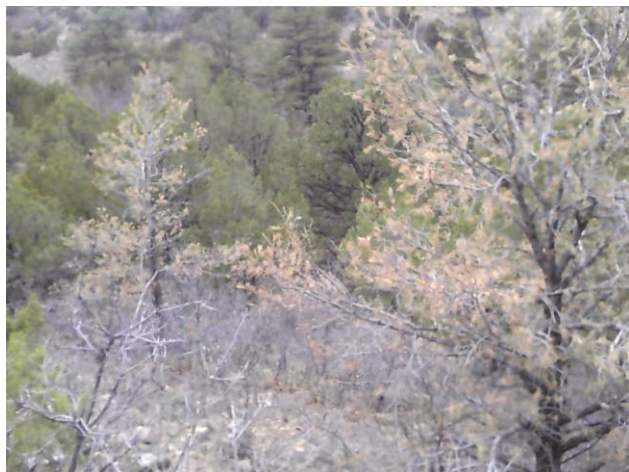
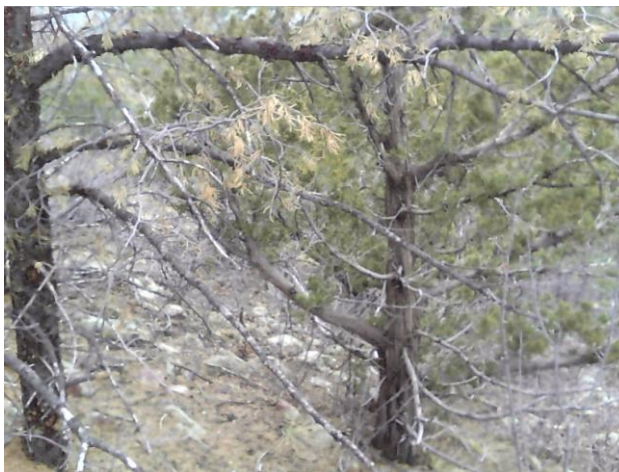
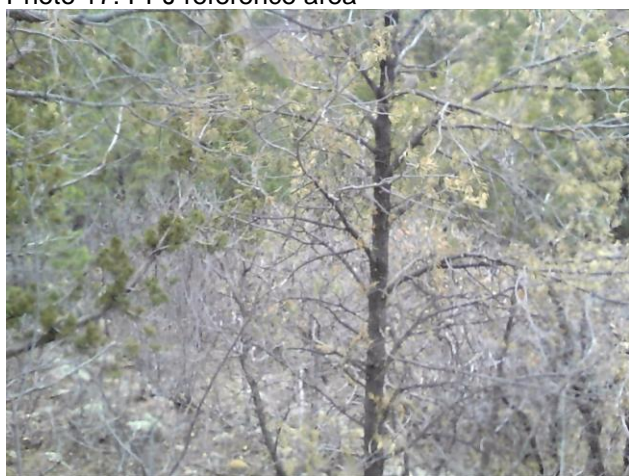
The inspector tried to walk the perimeter of the currently approved PPJ reference area and record the condition of the reference area. Efforts to enter a base map, Map16, into the GPS prior to the inspection was unsuccessful due to program errors. So the Division used a paper copy of Map 16 along with the GPS. The current Plot B (PPJ reference area) is nestled between previously disturbed areas, the reclaimed explosives storage area on the south and the historic Peacock mine on the north. Plot B is very steep, has a natural drainage bisecting it, and is on a steep rocky northwest facing slope. The inspector began plotting this area at the identification sign stating "Plot B". This sign is on the west side of the plot. The inspector continued approximately 60 feet to the north east before turning east and scaling the hill. The vegetation consists of tangled oak brush, with juniper and pinyon pine interspersed with scattered grasses in the understory. Due to the dense oakbrush and steep slope, the inspector was unable to match the perimeter boundary of the mapped reference area (Map 16). Photos taken within the PPJ reference area show numerous standing dead pine and juniper trees. Oak brush had not yet leafed out at the time of the inspection. (Photos 16-19)

Photo 16: PPJ reference area

Photo 17: PPJ reference area

Photo 18: PPJ reference area

Photo 19: PPJ reference area

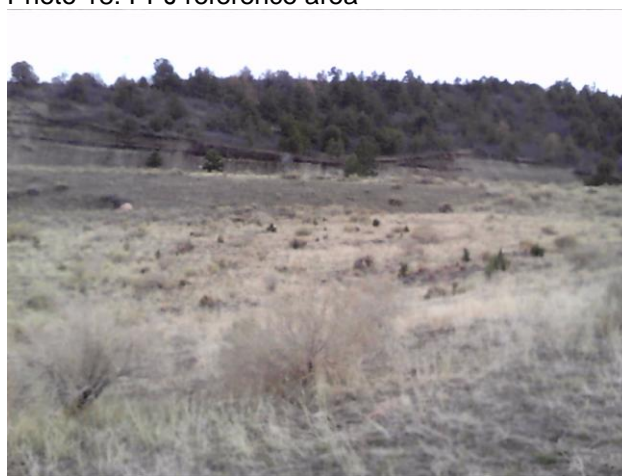
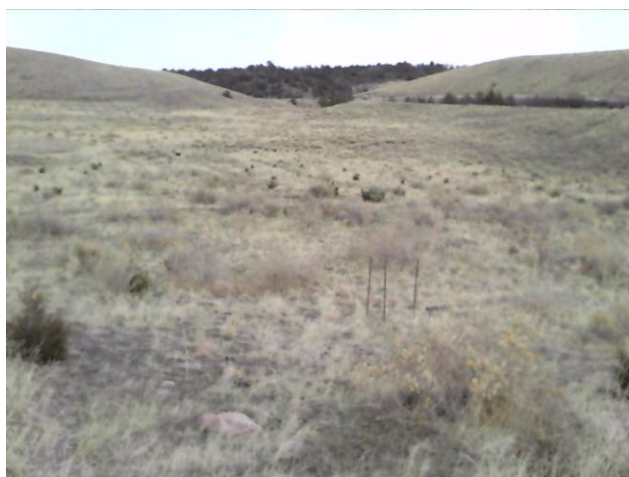
Photos 20-22 show shrub survival on the southern extent of the reclaimed portal facilities area. The grass is still low, so the healthy tree and shrub individual show up well in the photos.

Photo 20: shrubs visible in Portal area reclamation

Photo 21: shrubs visible in Portal area reclamation

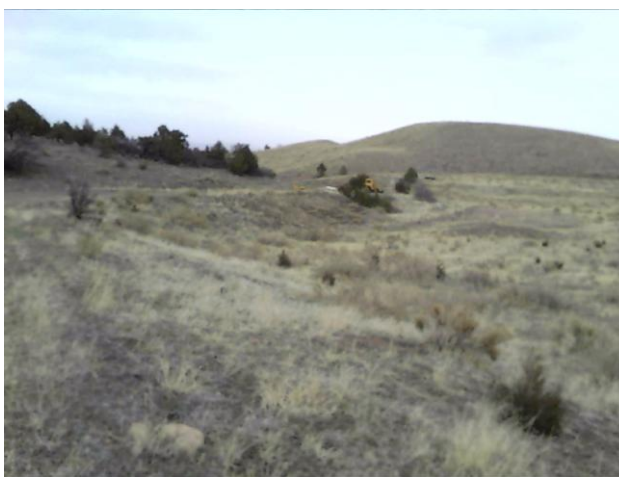
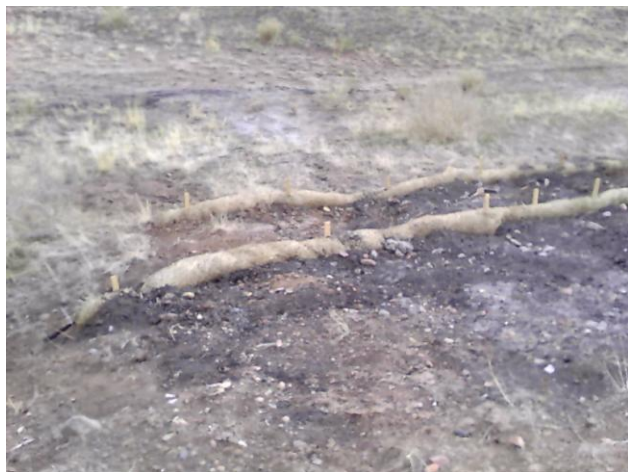
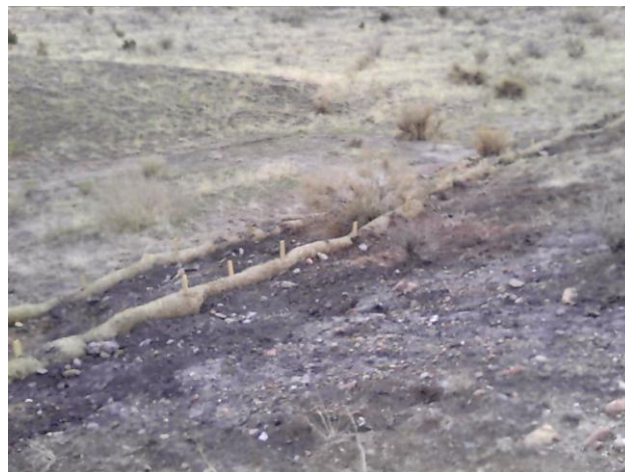
EFCI has installed and anchored coir wattles along the slope north of the facilities area permanent parking area. (Photo 22-24). Wattles have been anchored towards the lower portion of the slope. This slope had been receiving run on from the road ditch above. Maintenance of the ditch and wattle placement should assist in reducing the flow down this slope.

Photo 22: wattles placed on slope

Photo 23: wattles placed on slope

Photo 24: wattles placed on slope
