COLORADO DIVISION OF RECLAMATION, MINING AND SAFETY COAL PROGRAM INSPECTION REPORT

Permit Number: C-1980-006 Mine Name: Marr Mine Operator: Kerr Coal Company Operator Address: Mr. George Patterson C/O Energy Fuels Coal, Inc. P.O. Box 459 Florence, CO 81226	County: Jackson Operation Type: Surface Permit Status: Permanent Cessation Ownership: Federal
Operator Representative Present:	
Operator Representative Signature: (Field Issuance Only)

Inspection Start Date: April 18, 2013 Inspection Start Time: 11:30 Inspection End Date: Inspection End Time:	Inspection Type: Coal Partial Inspection Inspection Reason: Normal I&E Program Weather: Snowing
Joint Inspection Agency: None	Joint Inspection Contacts:
Post Inspection Agency: None	Post Inspection Contacts:
Inspector(s): Robert D. Zuber, P.E.	Inspector's Signature:

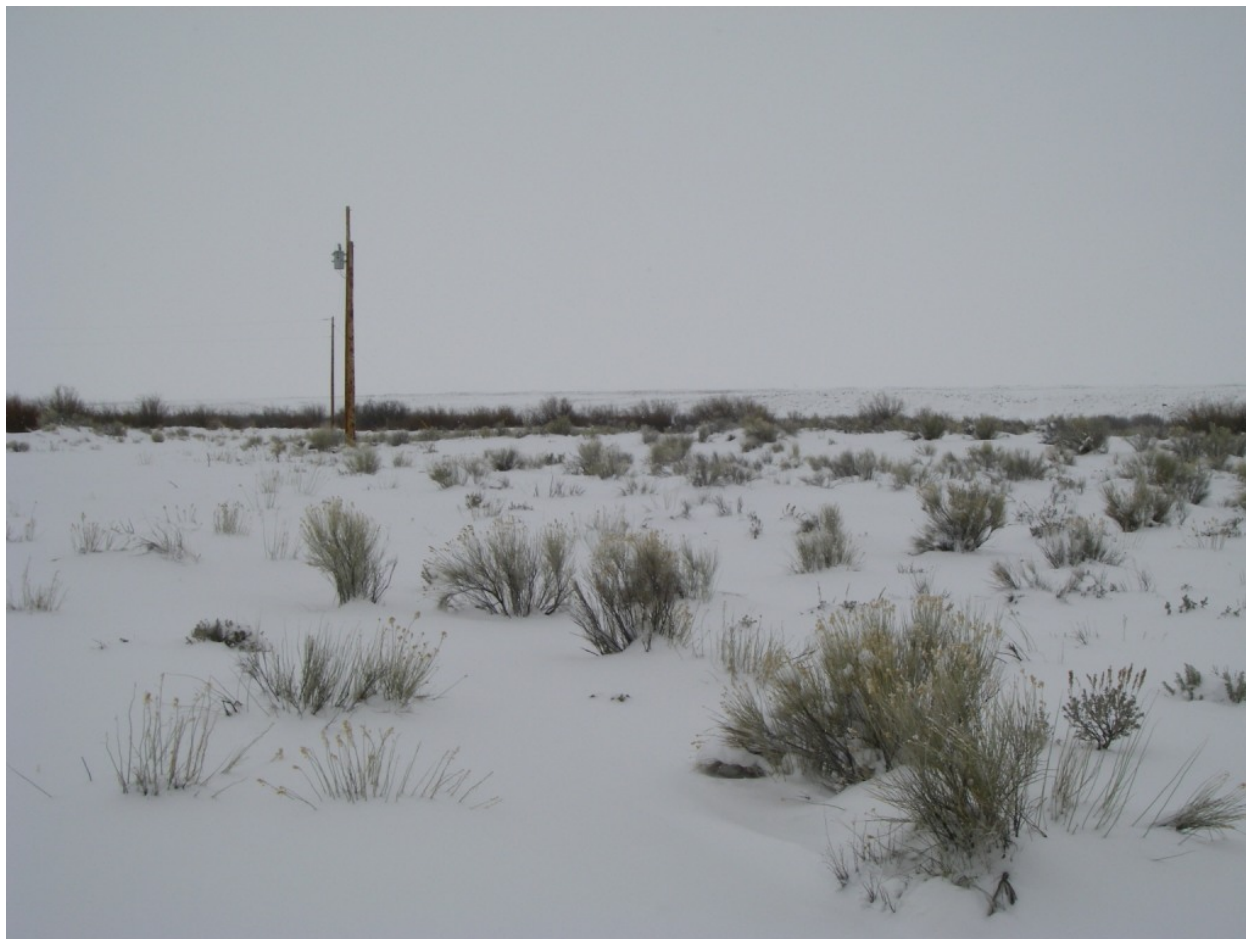
At the loadout, no erosion, large weed patches, or other problems were seen.

Reclamation at Loadout, looking south

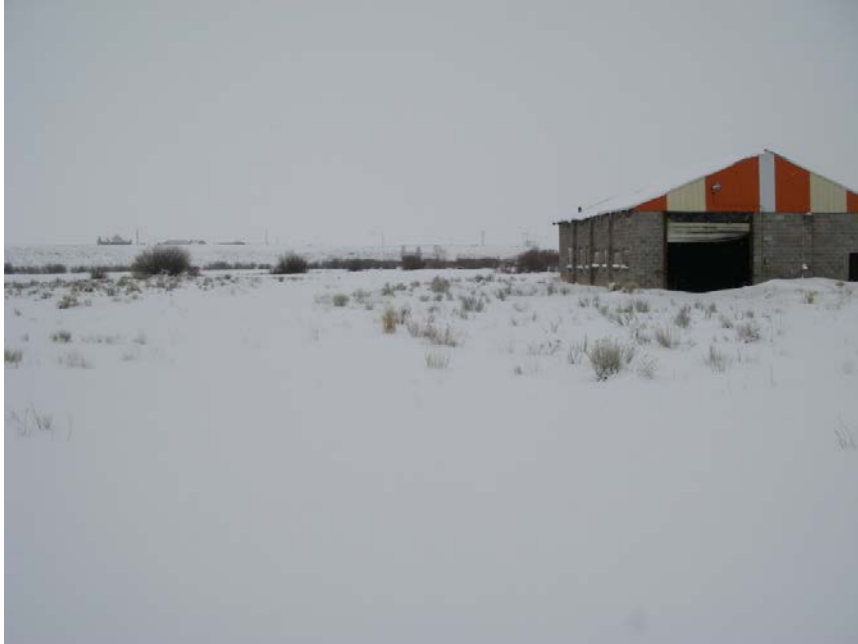
Area at Loadout where reclaimed pond was accessed, looking west

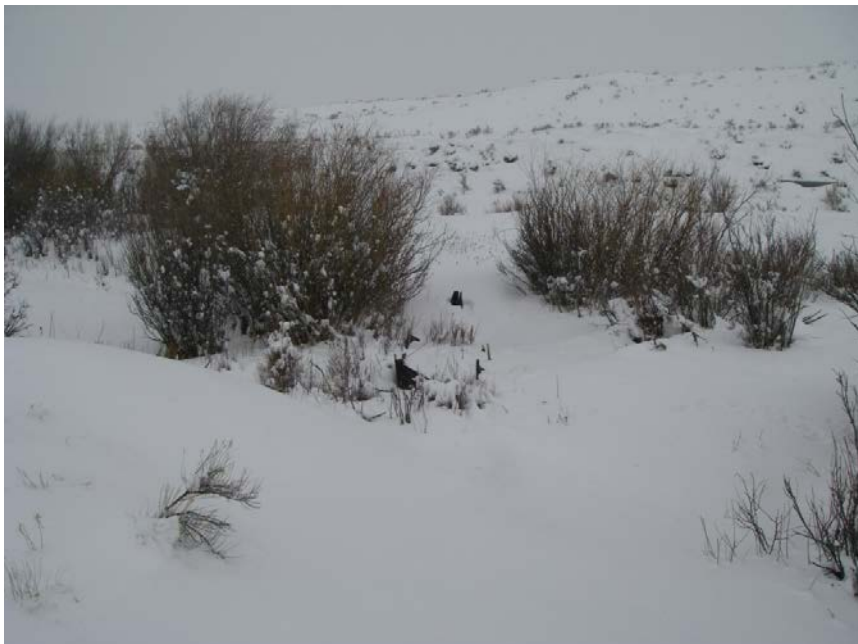
The Best Management Practices for sediment control from the reclaimed pond area at the loadout were covered with snow, and thus it could not be determined if they are functioning.

BMPs below reclaimed pond area
