**COLORADO DIVISION OF RECLAMATION, MINING AND SAFETY  
COAL PROGRAM INSPECTION REPORT**

<b>Permit Number:</b> C-1981-019 <b>Mine Name:</b> Colowyo Coal Mine <b>Operator:</b> Colowyo Coal Company L.P. <b>Operator Address:</b> Mr. Tony Tennyson 5731 State Highway 13 Meeker, CO 81641	<b>County:</b> Moffat, Rio Blanco <b>Operation Type:</b> Surface <b>Permit Status:</b> Active <b>Ownership:</b> Federal
	<b>Operator Representative Present:</b>  Kurt Blunt, Tony Tennyson
<b>Operator Representative Signature: (Field Issuance Only)</b>

<b>Inspection Start Date:</b> April 16, 2013 <b>Inspection Start Time:</b> 08:30 <b>Inspection End Date:</b> April 17, 2013 <b>Inspection End Time:</b> 14:45	<b>Inspection Type:</b> Coal Partial Inspection <b>Inspection Reason:</b> Normal I&E Program <b>Weather:</b> Snowing
<b>Joint Inspection Agency:</b>  None	<b>Joint Inspection Contacts:</b>
<b>Post Inspection Agency:</b>  None	<b>Post Inspection Contacts:</b>
<b>Inspector(s):</b>  Robert D. Zuber, P.E.	<b>Inspector's Signature:</b>

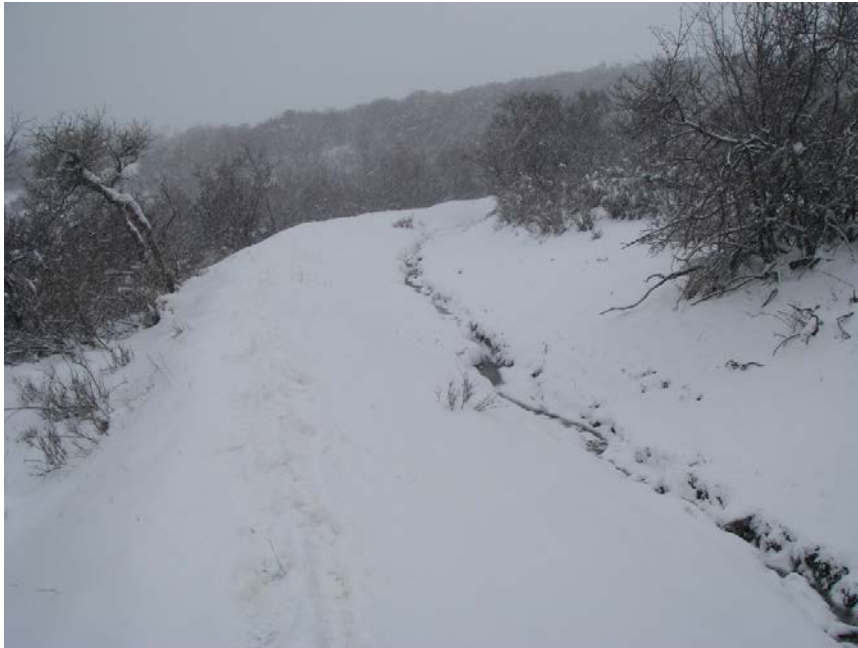
**Section 16 Pond Ditch**

The Section 16 Pond Ditch was inspected from the pond to a point approximately one mile to the west of the pond (distance along the ditch). No problems were identified with the ditch or its berm.

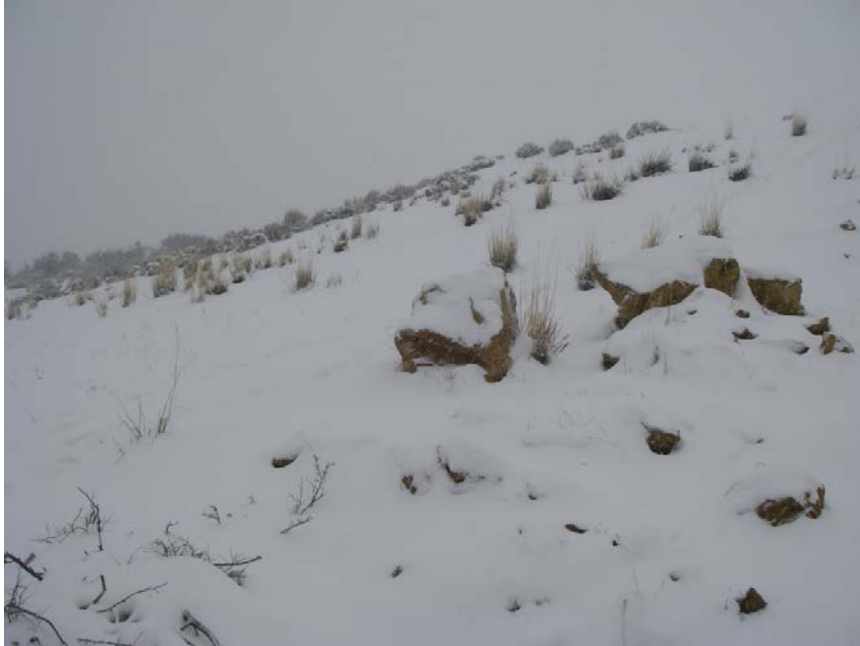
**Section 16 Pond embankment**

Relatively large flows were being discharged from Prospect Pond and Streeter Pond. The Section 16 Pond, Stoker Siding Pond, and the Gossard Pond had small discharges. For all discharging ponds, no sign of pollutants was observed. No problems were found with embankments or other structures except for the flume at the Section 16 Pond, which needs to be leveled.
