**COLORADO DIVISION OF RECLAMATION, MINING AND SAFETY
COAL PROGRAM INSPECTION REPORT**

Permit Number: C-1981-010 Mine Name: Trapper Mine Operator: Trapper Mining, Inc. Operator Address: Mr Forrest V Luke P.O. Box 187 Craig, CO 81626	County: Moffat Operation Type: Surface Permit Status: Active Ownership: Federal
	Operator Representative Present: Graham Roberts
Operator Representative Signature: (Field Issuance Only)

Inspection Start Date: April 18, 2013 Inspection Start Time: 07:40 Inspection End Date: April 18, 2013 Inspection End Time: 12:00	Inspection Type: Coal Partial Inspection Inspection Reason: Normal I&E Program Weather: Cloudy
Joint Inspection Agency: None	Joint Inspection Contacts:
Post Inspection Agency: None	Post Inspection Contacts:
Inspector(s): Jared L. Ebert	Inspector's Signature:

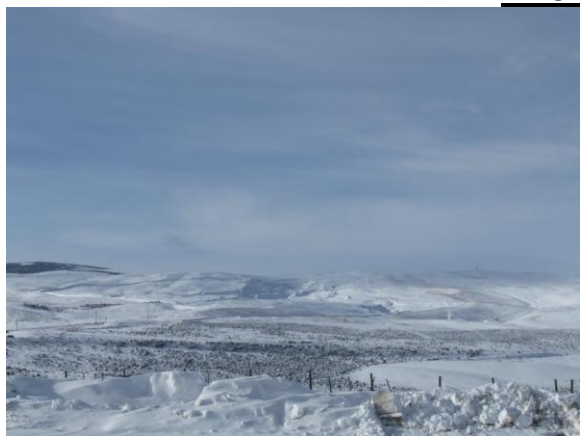
D pit, view from the office parking area.

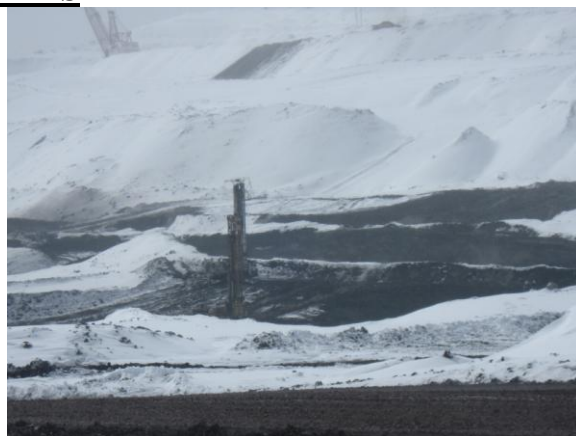
A drilling operation for a new blast pattern was occurring in the K-Strike Pit.

Drill pattern in K-Strike area.

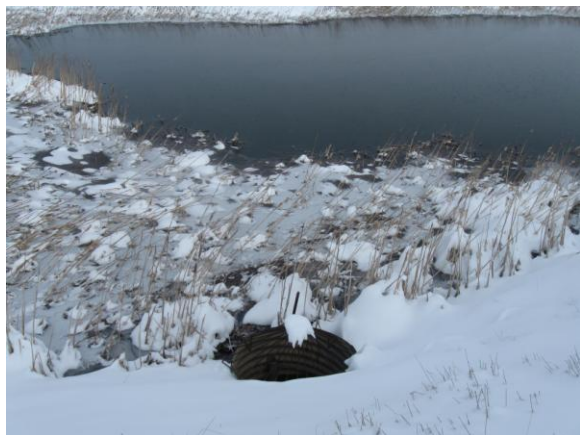
Impoundment H was holding water and was ice covered. The spillway was clear of debris and functional and the pond was discharging from a culvert that runs under the haul road.

Impoundment H, primary spillway culvert.

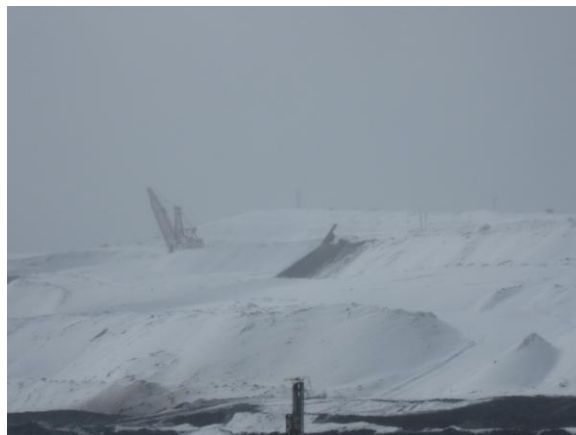
TMI is actively backfilling behind the mining operations.

Actively backfilling behind current pit area.

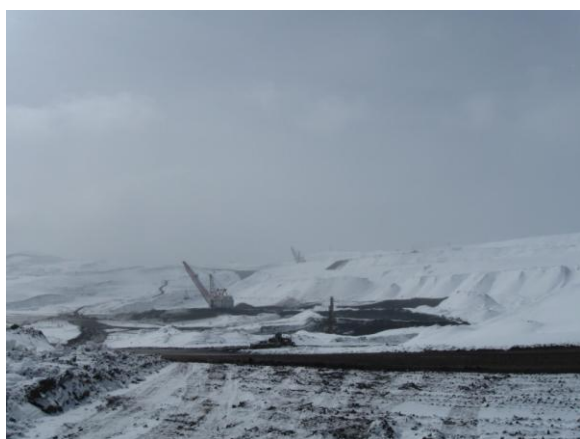
Active mining area.

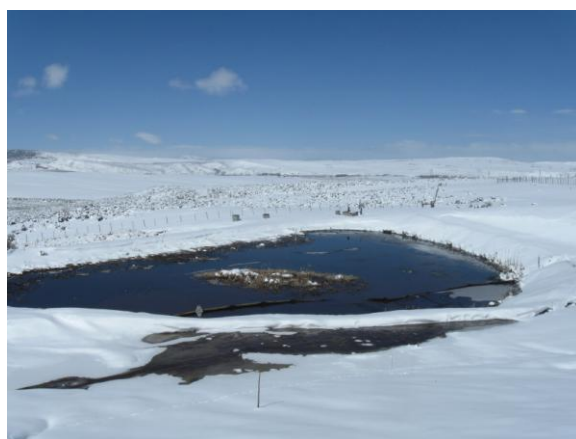
The industrial waste pond was holding water; the surface boom was in place and was functional.

Industrial waste pond.
