**COLORADO DIVISION OF RECLAMATION, MINING AND SAFETY  
COAL PROGRAM INSPECTION REPORT**

<b>Permit Number:</b> C-1994-082 <b>Mine Name:</b> Yoast Mine <b>Operator:</b> Seneca Coal Company, LLC <b>Operator Address:</b> Mr Roy Karo 37796 Routt County Road 53 P.O. Box 670 Hayden, CO 81639	<b>County:</b> Routt <b>Operation Type:</b> Surface <b>Permit Status:</b> Permanent Cessation <b>Ownership:</b> Federal
	<b>Operator Representative Present:</b>  Roy Karo
<b>Operator Representative Signature: (Field Issuance Only)</b>

<b>Inspection Start Date:</b> April 17, 2013 <b>Inspection Start Time:</b> 14:13 <b>Inspection End Date:</b> April 18, 2013 <b>Inspection End Time:</b> 17:00		<b>Inspection Type:</b> Coal Partial Inspection <b>Inspection Reason:</b> Normal I&E Program <b>Weather:</b> Snowing	
<b>Joint Inspection Agency:</b>  None		<b>Joint Inspection Contacts:</b>	
<b>Post Inspection Agency:</b>  None		<b>Post Inspection Contacts:</b>	
<b>Inspector(s):</b>  Jared L. Ebert	<b>Inspector's Signature:</b>

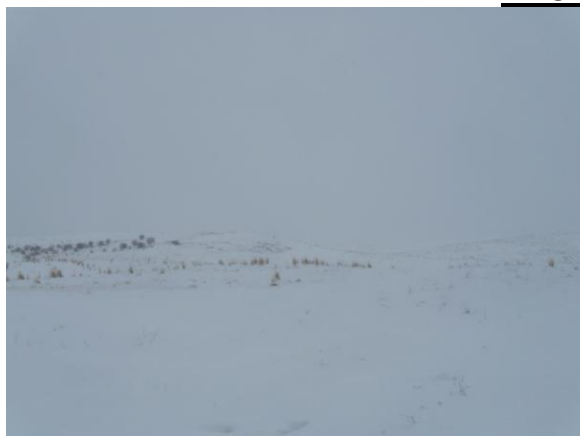
Pond 013 was holding water and discharging. The embankment was snow covered but appeared stable. The primary spillway was clear and functional and the emergency spillway was snow covered.

YPM-4, 3-2, 17 and 14 drainages and drainage areas were visible. These areas were snow covered.

Pond 013 slide area and the YPM-4 drainage.

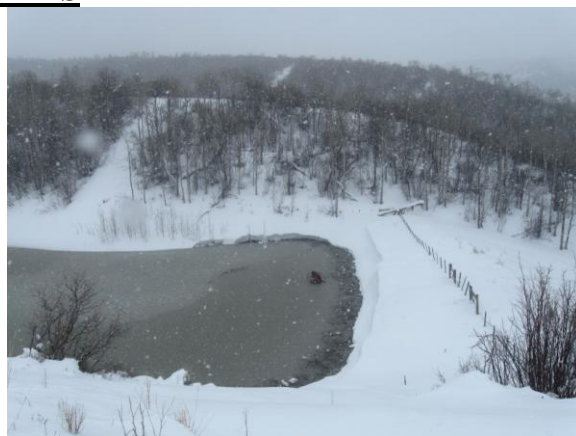
Pond 014 was holding water and discharging from the primary spillway, however no water was discharging at the flume. The area was snow covered and some water was pooling in a low area near the flume. The primary spillway was clear and functional and the emergency spillway was snow covered. The embankment was snow covered but appeared stable.

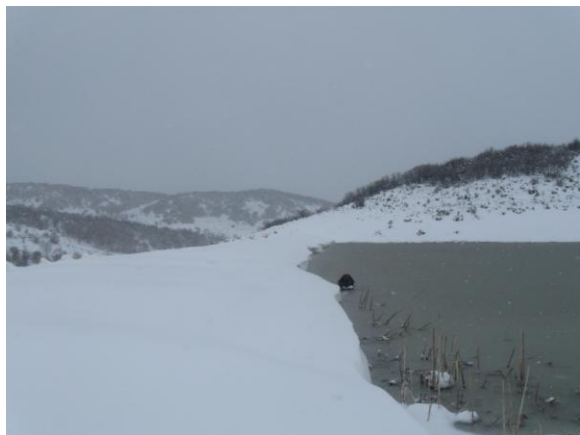
Pond 013 embankment.

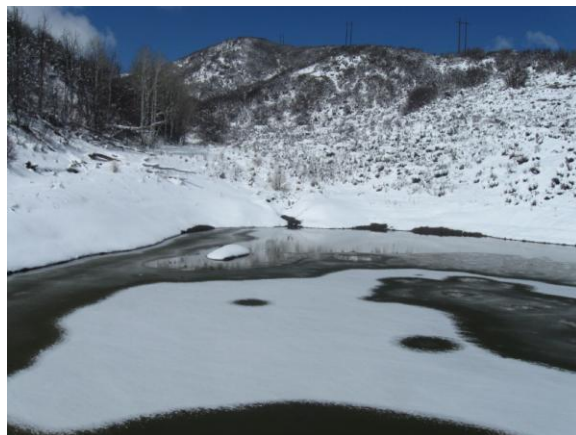
Pond 011 was holding water but was not discharging. The primary spillway was clear and functional and the emergency spillway was snow covered. The embankment was snow covered and appeared stable.

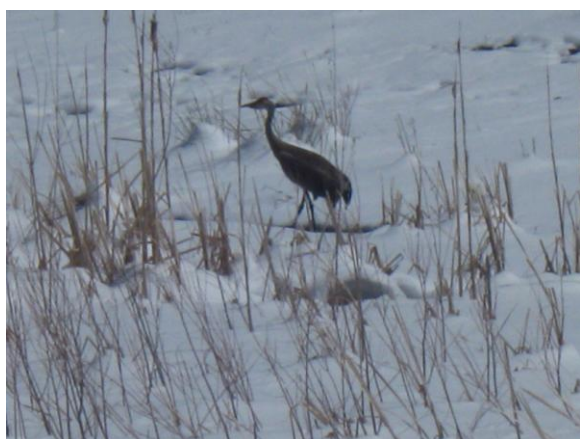
A Sand Hill Crane was observed on the edge of Pond 010.

Sandhill Crane.

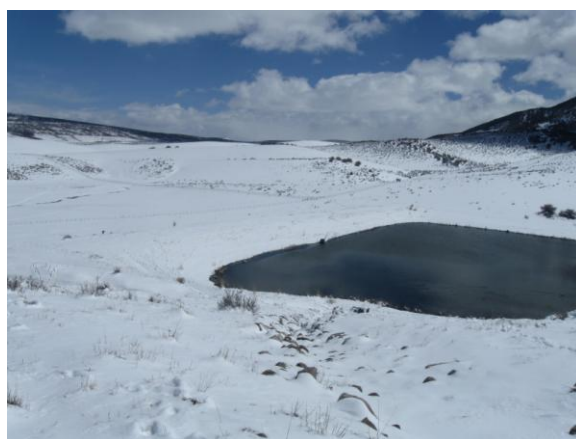
Pond 010 was inspected on Thursday April 18. The access road was recently plowed to move equipment into the area. The pond was holding water and discharging. The primary spillway was clear and functional and the emergency spillway was snow covered. The pond embankment was snow covered but appeared stable.
