**COLORADO DIVISION OF RECLAMATION, MINING AND SAFETY  
COAL PROGRAM INSPECTION REPORT**

| <b>Permit Number:</b> C-2010-089<br><b>Mine Name:</b> New Horizon North Mine<br><b>Operator:</b> Western Fuels-Colorado, LLC<br><b>Operator Address:</b><br>Mr. David G Anderson<br>12050 N. Pecos St., Suite 100<br>Westminster, CO 80234 | <b>County:</b> Montrose<br><b>Operation Type:</b> Surface<br><b>Permit Status:</b> Active<br><b>Ownership:</b> Private |

| <b>Inspection Start Date:</b> April 19, 2013<br><b>Inspection Start Time:</b> 11:52<br><b>Inspection End Date:</b> April 19, 2013<br><b>Inspection End Time:</b> 11:53 | <b>Inspection Type:</b> Aerial Inspection<br><b>Inspection Reason:</b> Normal I&E Program<br><b>Weather:</b> Clear |

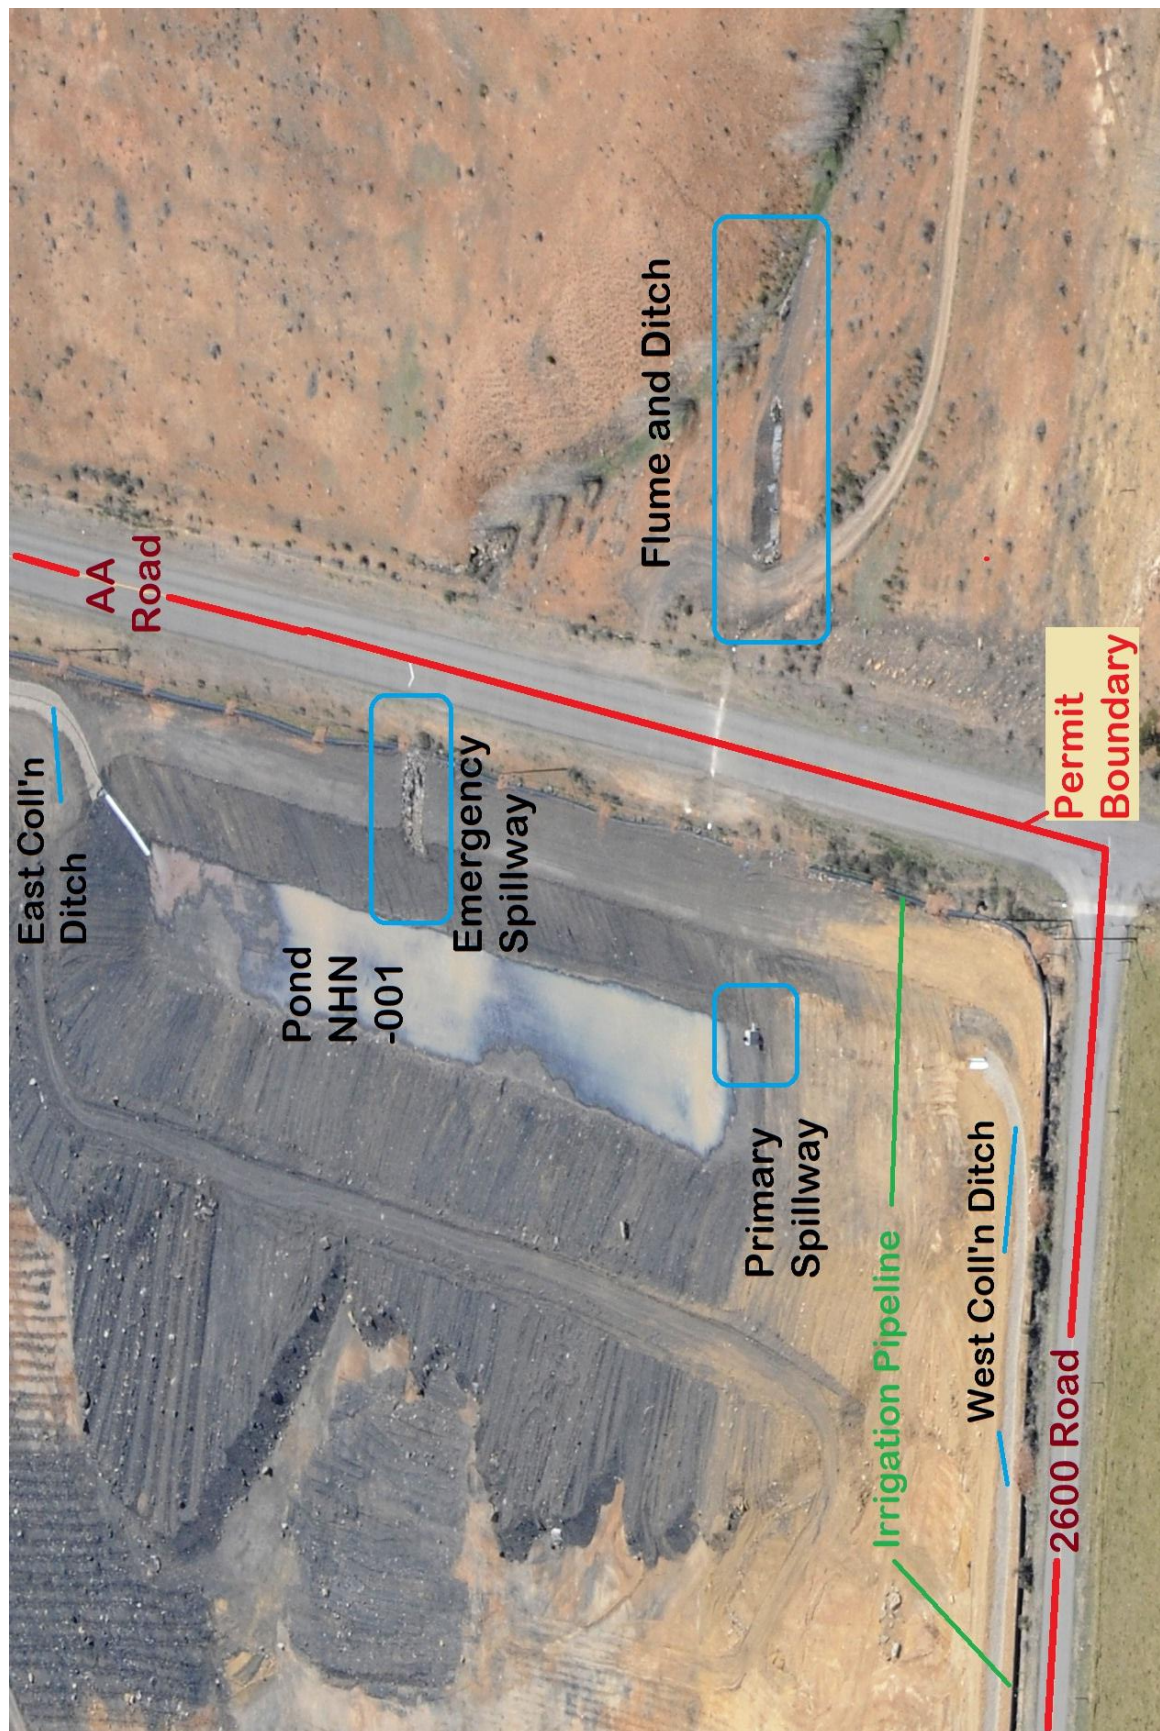
- The bottom of Pond NHN-001 was partially covered with water.
- Pond NHN-001 features are shown in Photo 1.

Photo 1 – Pond NHN-001 location and features, looking East
