**COLORADO DIVISION OF RECLAMATION, MINING AND SAFETY
COAL PROGRAM INSPECTION REPORT**

| Permit Number: C-1982-057 Mine Name: Seneca II-W Mine Operator: Seneca Coal Company, LLC Operator Address: Mr Roy Karo 37796 Routt County Road 53 P.O. Box 670 Hayden, CO 81639 | County: Routt Operation Type: Surface Permit Status: Permanent Cessation Ownership: Federal |

| Inspection Start Date: April 18, 2013 Inspection Start Time: 14:30 Inspection End Date: April 19, 2013 Inspection End Time: 09:45 | Inspection Type: Coal Partial Inspection Inspection Reason: Normal I&E Program Weather: Cloudy |

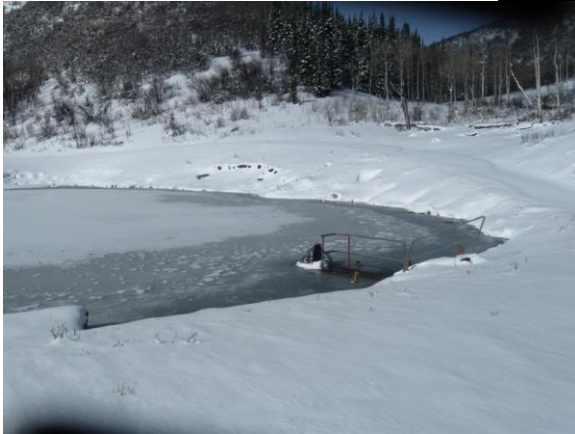
Pond 015 was holding water and discharging. The primary spillway was partially iced over but was still draining. The emergency spillway was snow covered. The embankment was snow covered but appeared stable.

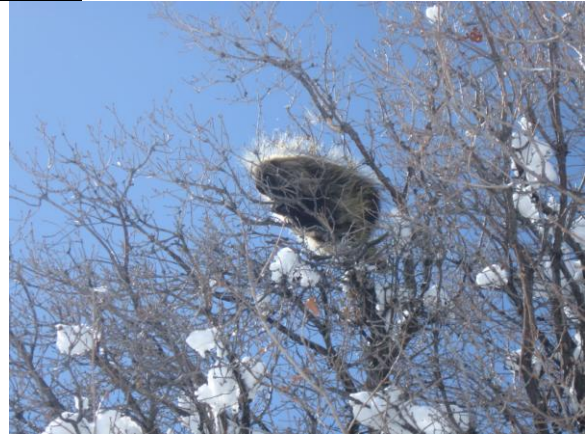
Two porcupines were observed in the gamble oak trees next to Pond 005.

Porcupine next to Pond 005

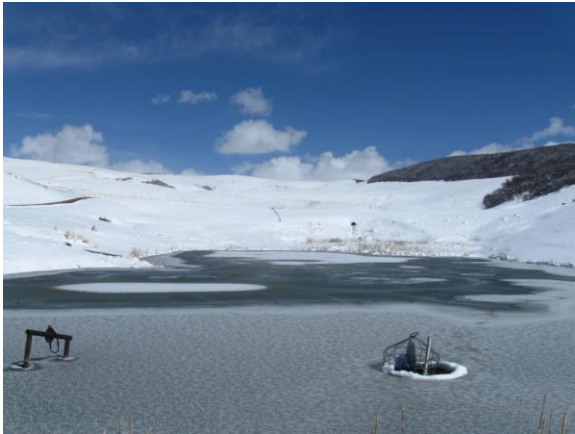
Pond 006 was holding water and discharging. The primary spillway was clear and functional and the emergency spillway was snow covered. The embankment was snow covered but appeared stable.

The 006 drainage and drainage basin was visible from Pond 006. The area was snow covered but appeared stable.
