COLORADO DIVISION OF RECLAMATION, MINING AND SAFETY COAL PROGRAM INSPECTION REPORT

Permit Number: C-1981-038 Mine Name: Bowie No. 1 Mine Operator: Bowie Resources, LLC Operator Address: Mr Basil Bear P.O. Box 1488 Paonia, CO 81428	County: Delta Operation Type: Underground Permit Status: Active Ownership: Federal
	Operator Representative Present: None Present - Aerial Inspection
Operator Representative Signature: (Field Issuance Only)

Inspection Start Date: April 19, 2013 Inspection Start Time: 12:31 Inspection End Date: April 19, 2013 Inspection End Time: 12:32	Inspection Type: Aerial Inspection Inspection Reason: Normal I&E Program Weather: Clear
Joint Inspection Agency: None	Joint Inspection Contacts:
Post Inspection Agency: None	Post Inspection Contacts:
Inspector(s): Susan L. Burgmaier Harry B. Ranney	Inspector's Signature: <i>Susan Burgmaier</i> Signature Date: 04/23/2013

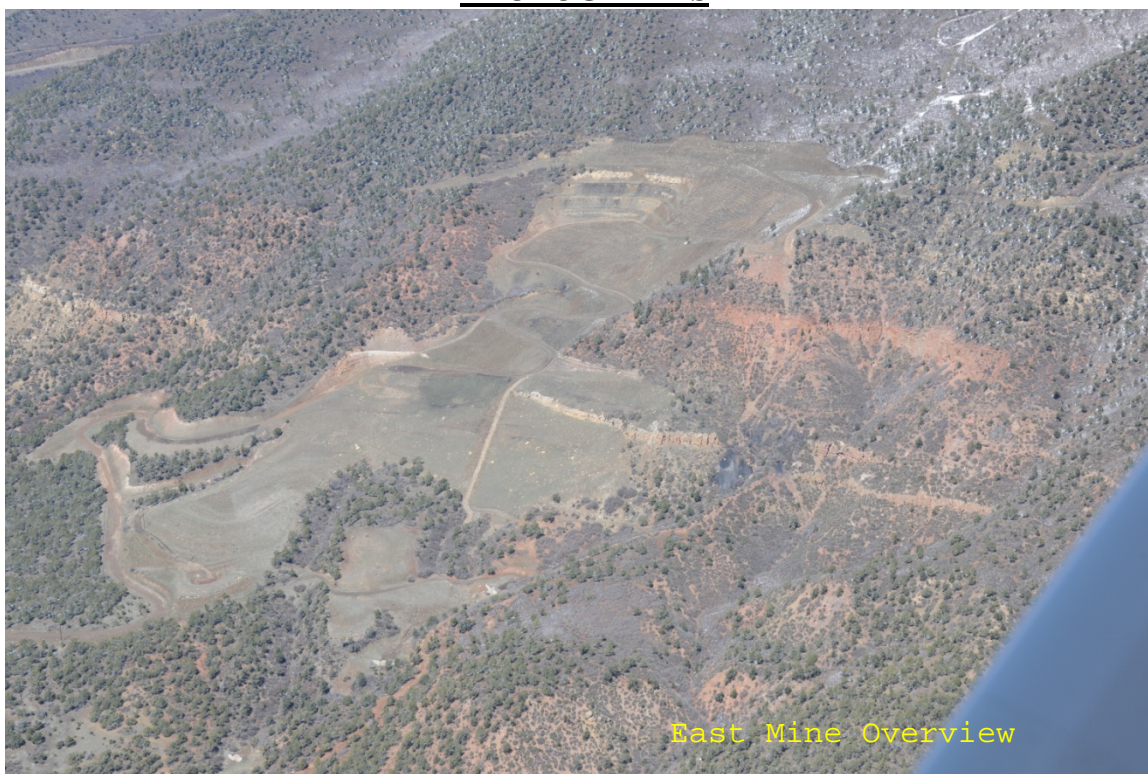
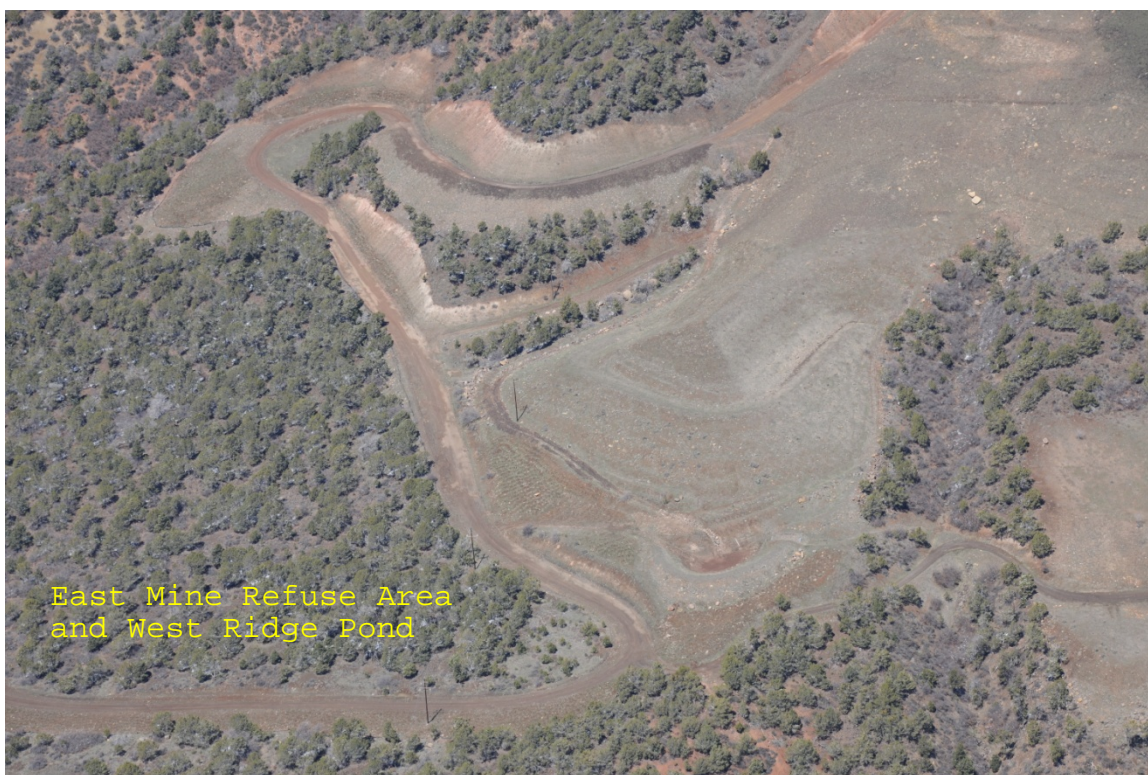
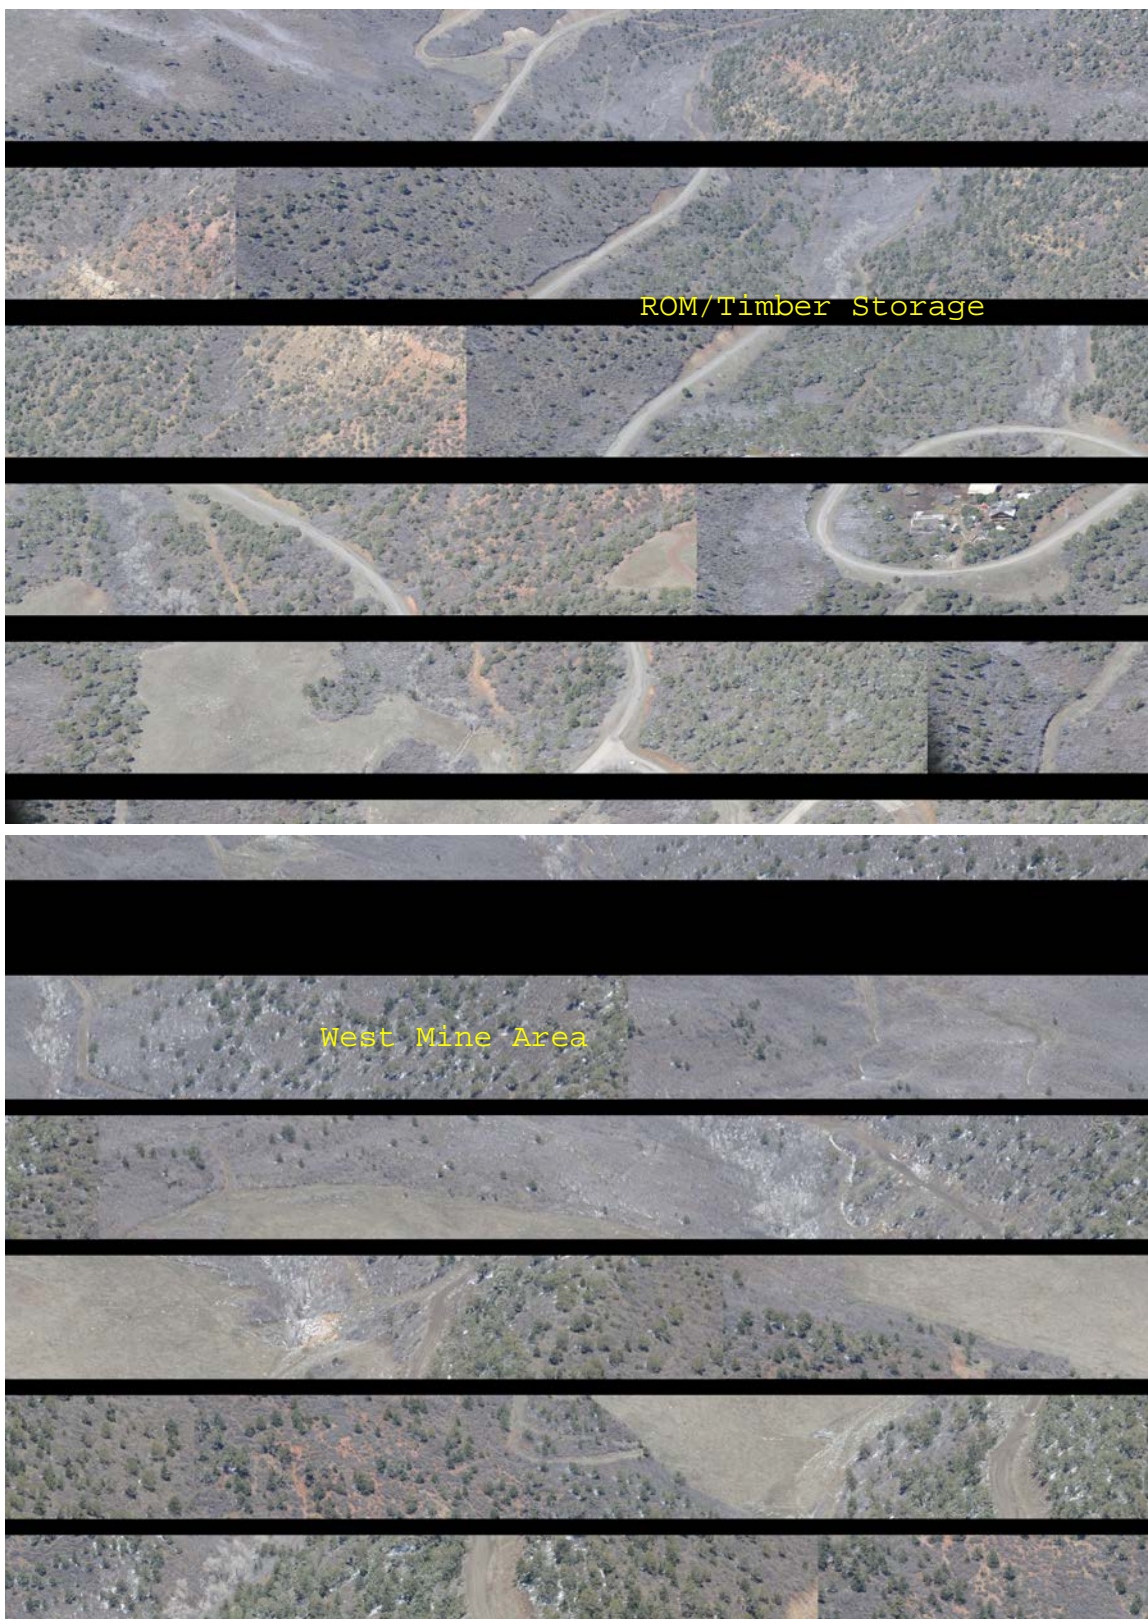
PHOTOGRAPHS

Backfilled and regraded areas appeared to be stable; no signs of slope movement or excessive erosion were apparent.

Pond 1 at the West Mine, the ROM pond, and Ponds 1 and 2 at the East Mine held small amounts of water. Pond 2 at the West Mine, the West Ridge pond and Pond 3 at the East Mine were dry. Pond 4 at the East Mine and the loadout area ponds were not photographed.
