COLORADO DIVISION OF RECLAMATION, MINING AND SAFETY COAL PROGRAM INSPECTION REPORT

Permit Number: C-1981-044	County: Moffat
Mine Name: Williams Fork Mines	Operation Type: Underground
Operator: Moffat County Mining, LLC	Permit Status: Active
Operator Address:	Ownership: Federal
Mr Jason Davis	
29515 Routt County Road #27	Operator Representative Present
Oak Creek, CO 80467	
	Brian Watterson

Inspection Start Date: April 17, 2013 Inspection Start Time: 13:00 Inspection End Date: April 17, 2013 Inspection End Time: 14:00		Inspection Type: Coal Partial Inspection Inspection Reason: Normal I&E Program Weather: Snowing			
Joint Inspection Agency: Joint Inspection Agency:		Joint	Joint Inspection Contacts:		
None		None	None		
Post Inspection Agency: Post		Post	Post Inspection Contacts:		
None		None	None		
Inspector(s):	Inspector	r's Sig	nature:	Signature Date:	
Zach T. Trujillo	30	1		4/24/13

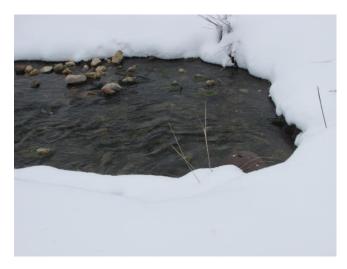
The Mine No. 5 dewatering pump was operating at the time of the inspection. Ponds 5-P5, 5-P6 and 5-P7 all held water and was discharging from Pond 5-P7 (NPDES 003). Discharge was clear. All embankments of Ponds 5-P5, 5-P6 and 5-P7 were snow covered and were stable. Maintenance to the northern embankment of Pond 5-P7 is still needed from the rodent holes noted in the previous inspection. Snow fall and temperatures has postponed

Discharge from mine dewatering ponds. (NPDES 003) Pond HR-P1a.
