COLORADO DIVISION OF RECLAMATION, MINING AND SAFETY COAL PROGRAM INSPECTION REPORT

Permit Number: C-1981-008 Mine Name: New Horizon Mine Operator: Western Fuels - Colorado, LLC Operator Address: Mr. Ross L Gubka P.O. Box 628 Nucla, CO 81424	County: Montrose Operation Type: Surface Permit Status: Active Ownership: Private
	Operator Representative Present: None (Aerial Inspection)
Operator Representative Signature: (Field Issuance Only) This report was issued electronically from the Division's Durango Field Office.

Inspection Start Date: April 19, 2013 Inspection Start Time: 11:50 Inspection End Date: April 19, 2013 Inspection End Time: 11:52	Inspection Type: Aerial Inspection Inspection Reason: Normal I&E Program Weather: Clear
Joint Inspection Agency: None	Joint Inspection Contacts:
Post Inspection Agency: None	Post Inspection Contacts:
Inspector(s): Marcia L. Talvitie, P.E.	Inspector's Signature:

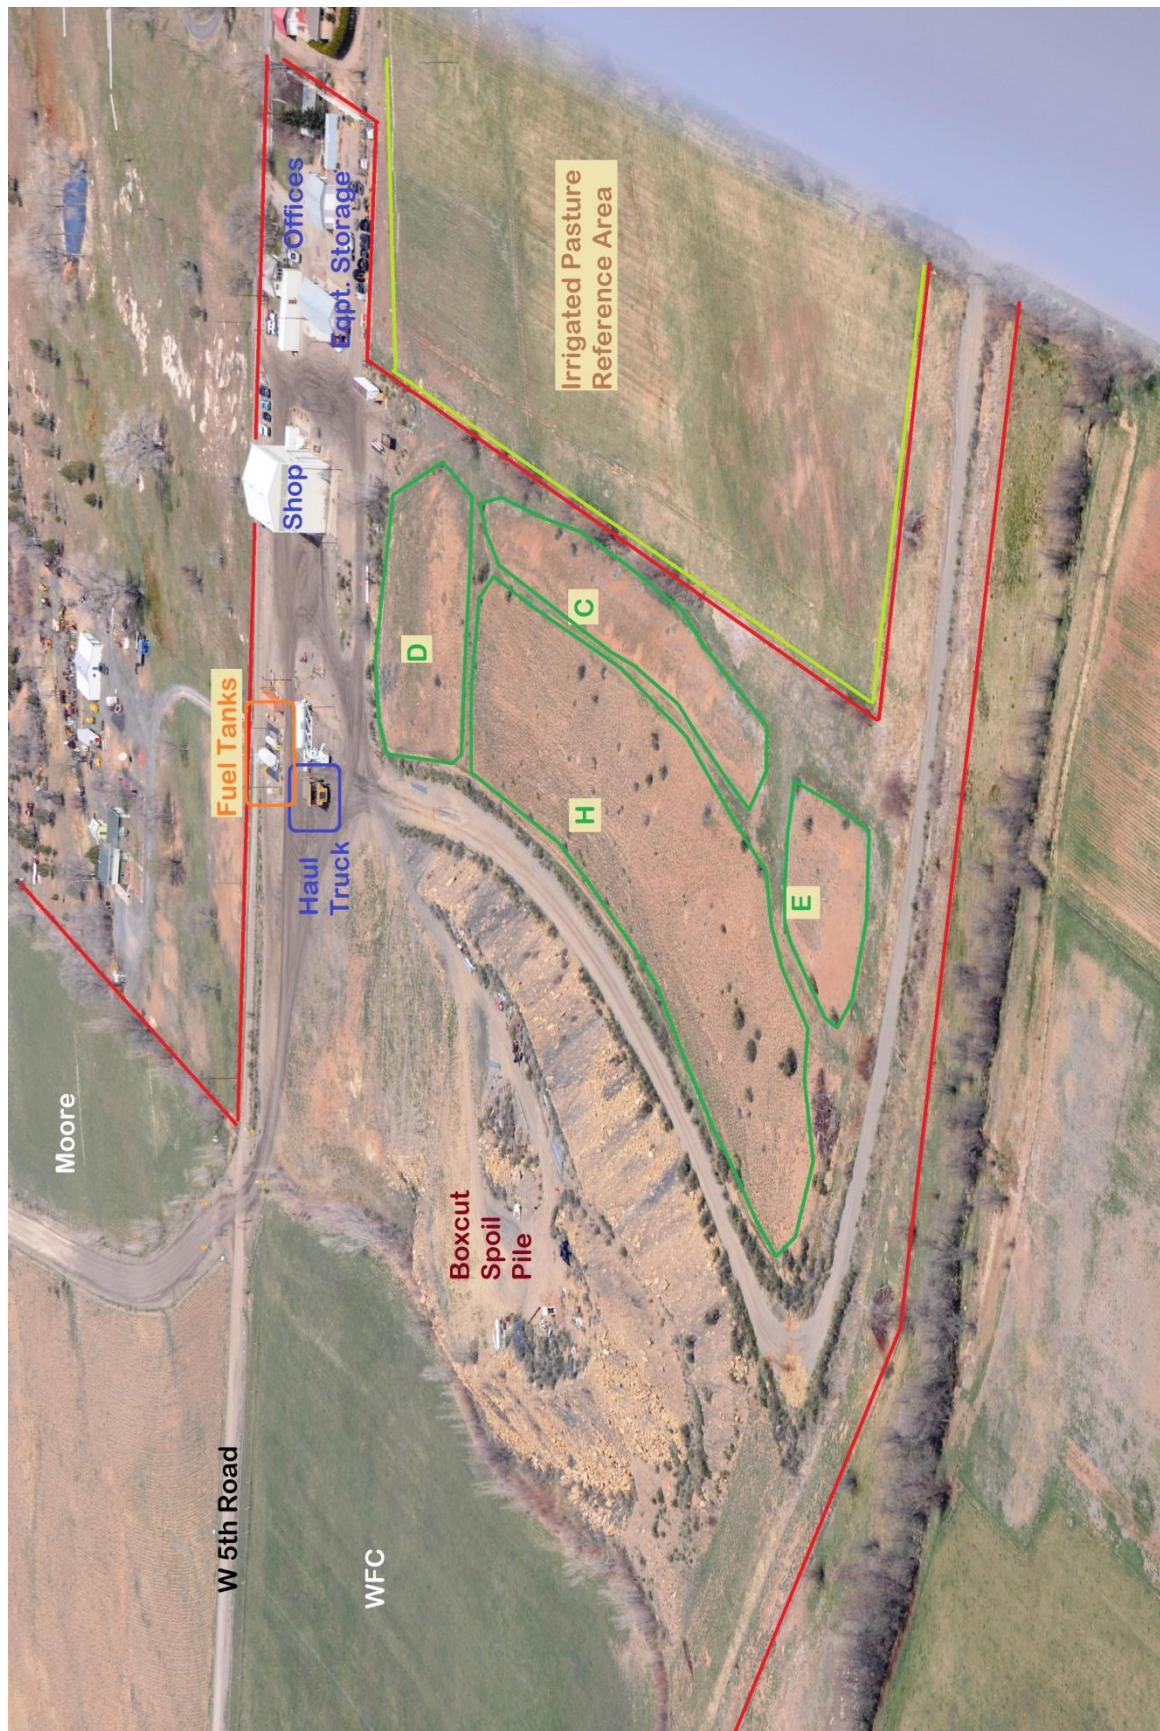
Photo 1 – Facilities Area

- The mine's support facilities consist of offices, material and equipment storage, a heavy equipment shop, and fuel storage. All appears to be in order at the site.

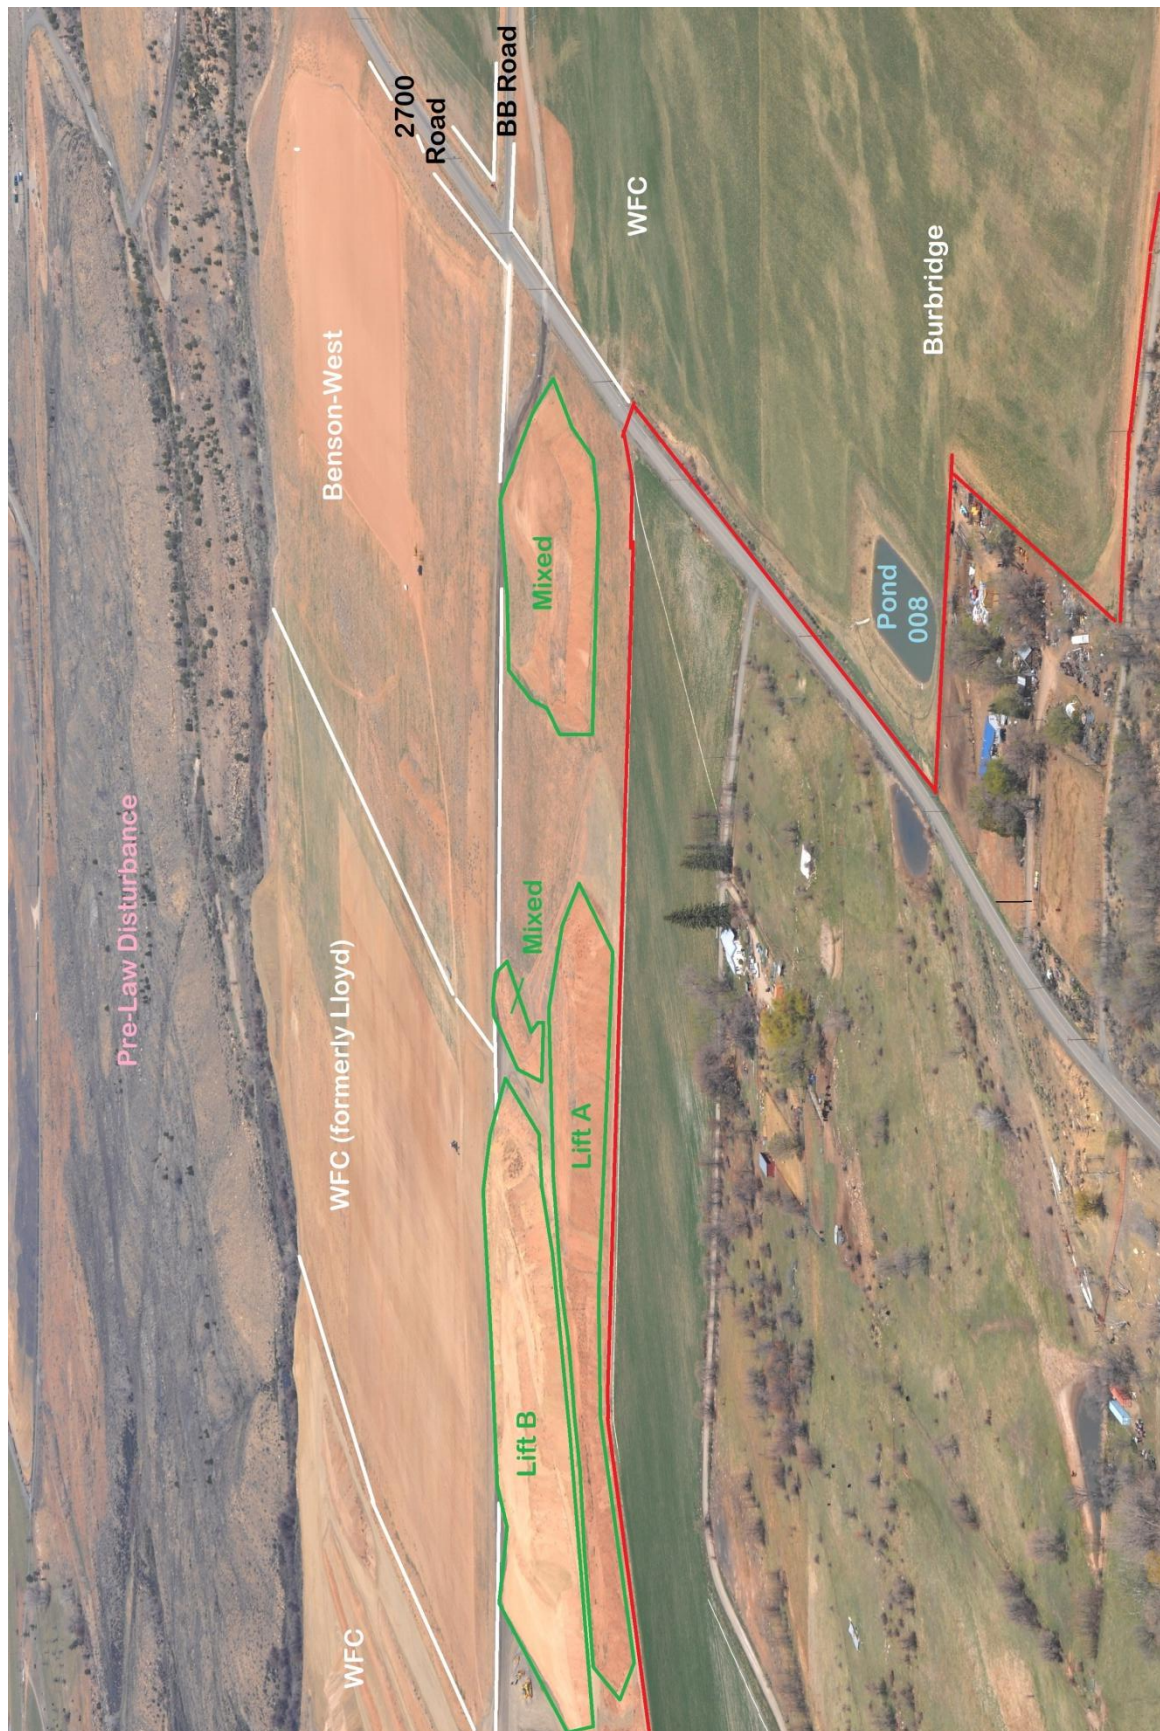
Photo 5 – Lands immediately west of 2700 Road, with topsoil stockpiles

- Topsoil stockpiles are scattered throughout the permit area, and are identified in green in the attached photographs.

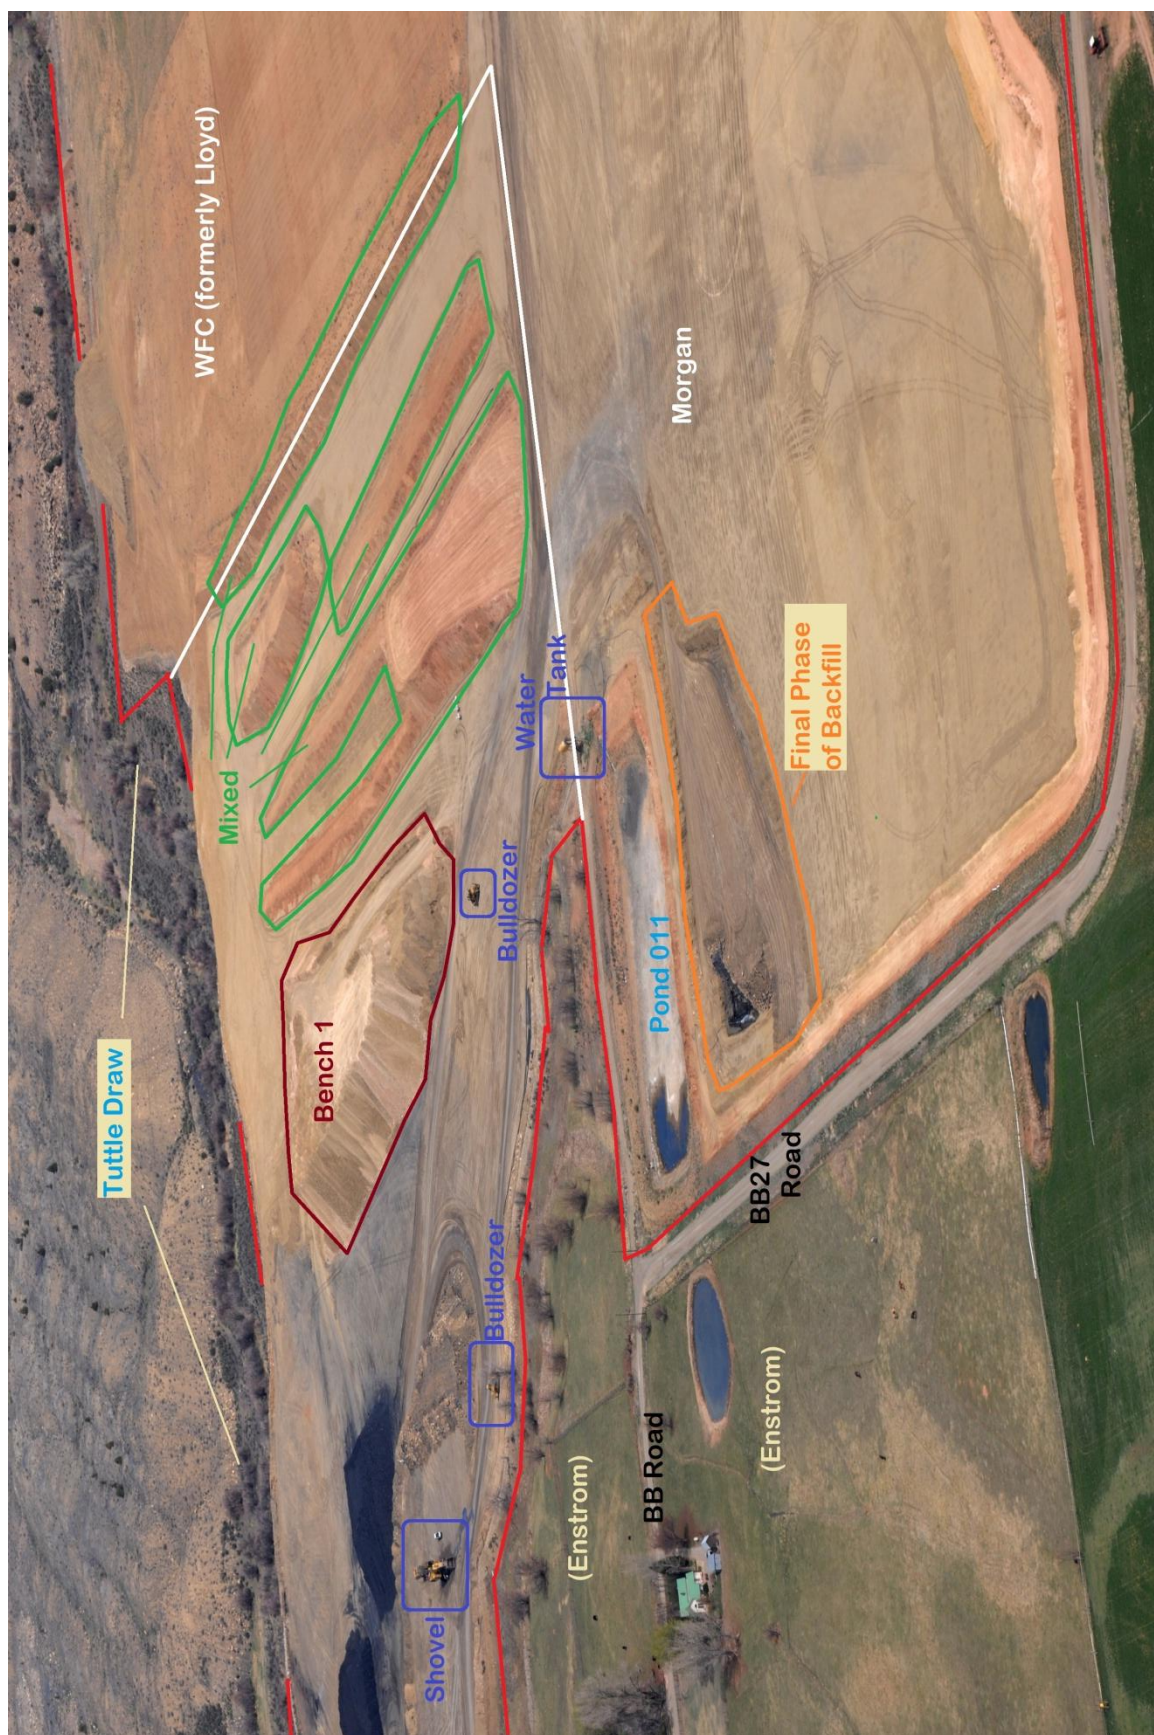
Photo 8 – West end of Morgan; stockpiles on WFC

- Backfilling of the final pit is nearly complete on the Morgan property, and there is still material remaining in the Bench 1 “OB1” stockpile.
- A bulldozer was grading Bench 2 spoil east of (behind) the active pit on WFC’s property.
- The boxcut spoil pile is located immediately southwest of the mine’s surface facilities. It does not appear that any additional material has recently been taken from this pile for use in backfill operations.

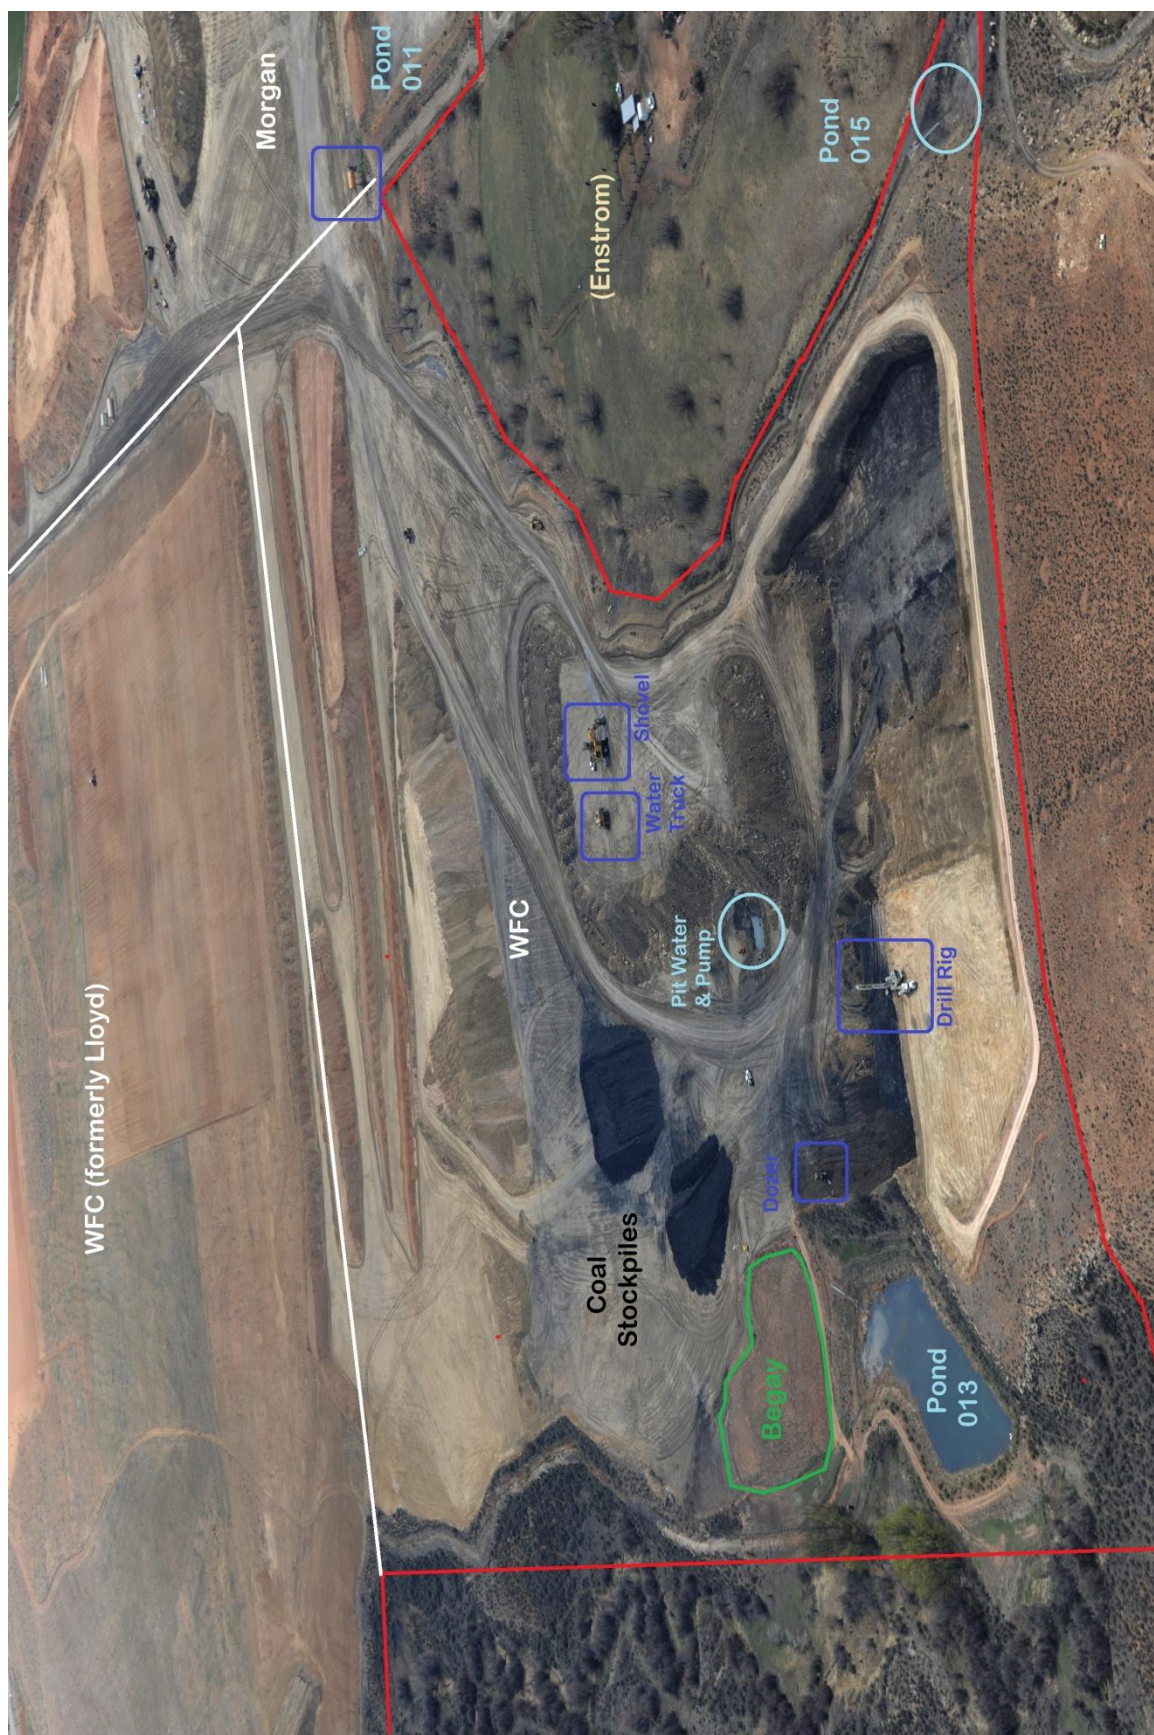
Photo 10 – Active operations on WFC property, looking East

- The drill rig, which is operated by a contractor to the mine, appeared to be drilling a single row of holes along the face of the highwall on the WFC property.

- The mine's shovel was parked and not in use at the time of the inspection, as were the three haul trucks, a motor grader, and two bulldozers.
- Active operations are nearing the far western end of the permit area, and mining at New Horizon is nearly complete. (In the attached photos, the permit boundary is shown in red.)
- Two small coal stockpiles had been built on the WFC property, east of the pit.
