**COLORADO DIVISION OF RECLAMATION, MINING AND SAFETY  
COAL PROGRAM INSPECTION REPORT**

<b>Permit Number:</b> C-1981-018 <b>Mine Name:</b> Deserado Mine <b>Operator:</b> Blue Mountain Energy, Inc <b>Operator Address:</b> Mr Scott Wanstedt 3607 County Road 65 Rangely, CO 81648	<b>County:</b> Rio Blanco <b>Operation Type:</b> Underground <b>Permit Status:</b> Active <b>Ownership:</b> Federal
	<b>Operator Representative Present:</b>  Scott Wanstedt
<b>Operator Representative Signature: (Field Issuance Only)</b>

<b>Inspection Start Date:</b> April 18, 2013 <b>Inspection Start Time:</b> 08:00 <b>Inspection End Date:</b> April 18, 2013 <b>Inspection End Time:</b> 11:00		<b>Inspection Type:</b> Coal Partial Inspection <b>Inspection Reason:</b> Normal I&E Program <b>Weather:</b> Cloudy	
<b>Joint Inspection Agency:</b>  None		<b>Joint Inspection Contacts:</b>  None	
<b>Post Inspection Agency:</b>  None		<b>Post Inspection Contacts:</b>  None	
<b>Inspector(s):</b>  Zach T. Trujillo	<b>Inspector's Signature:</b>

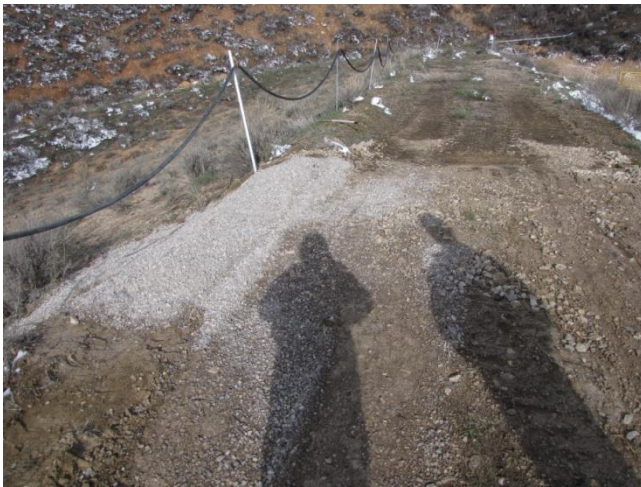
Pond DP-1 held water at the time of the inspection with no discharge. Embankment was stable and vegetated. The sink hole mentioned in the previous inspection has been backfilled and compacted. No additional holes were observed in the pond embankment.

Backfilled sink hole in Pond DP-1 embankment.

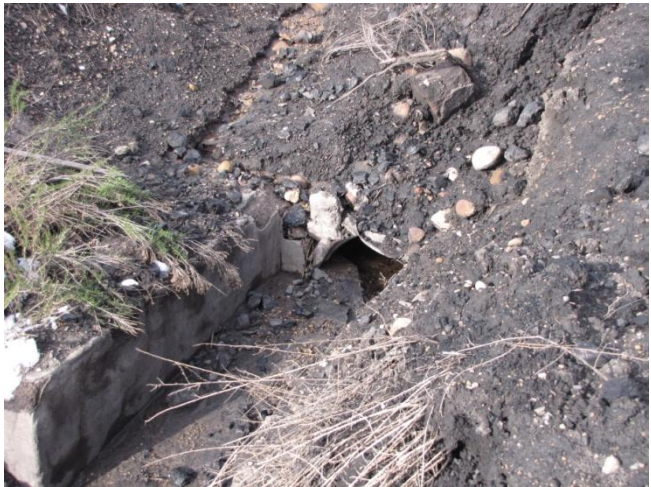
All culverts inspected were clear or had been recently cleaned except for one. The culvert that runs below the road intersection to Moon Lake Substation still needs to be cleaned. The culvert was approximately 75% full of sediment.

Culvert below intersection to substation.

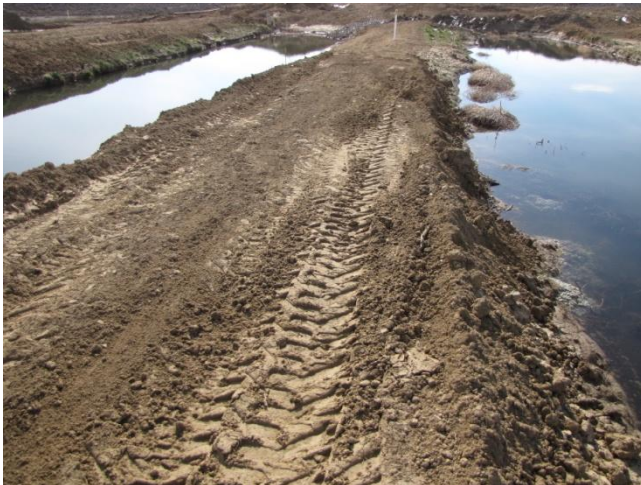
The B-Seam mine dewatering pond system held water up to the 6th cell. Water was now being pumped directly into the second cell to allow the first cell to dry for cleaning. The breach between the 3rd and 4th cell has been repaired and water now flows through its intended channels. Water has yet to reach the wetlands section of the pond system and to the date of this inspection, no water has been discharged from the B-Seam mine dewatering pond system.

B-Seam dewatering pond embankment repair.

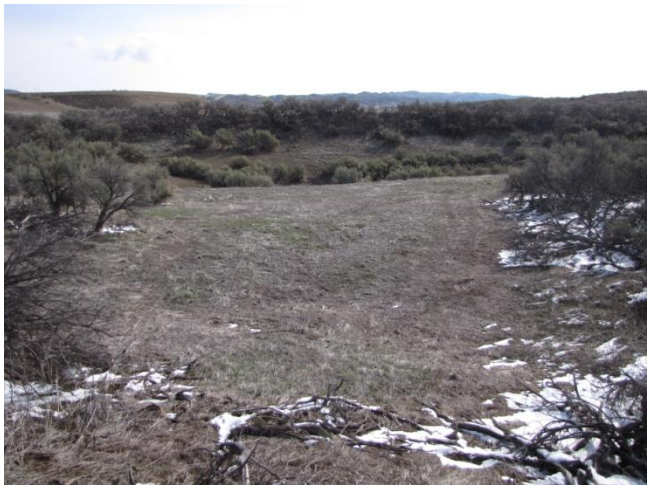
The Red Wash Reservoir #2 was inspected. Currently Deserado Mine is in the process of applying for a coal lease that would expand below the Red Wash Reservoir #2. The reason behind inspecting the reservoir was to get an idea of its location, size and its potential to be impacted by subsidence. Future comments on the Red Wash Reservoir #2 may occur with the Division's adequacy letter related to BME's PR-8.

Red Wash Reservoir #2.

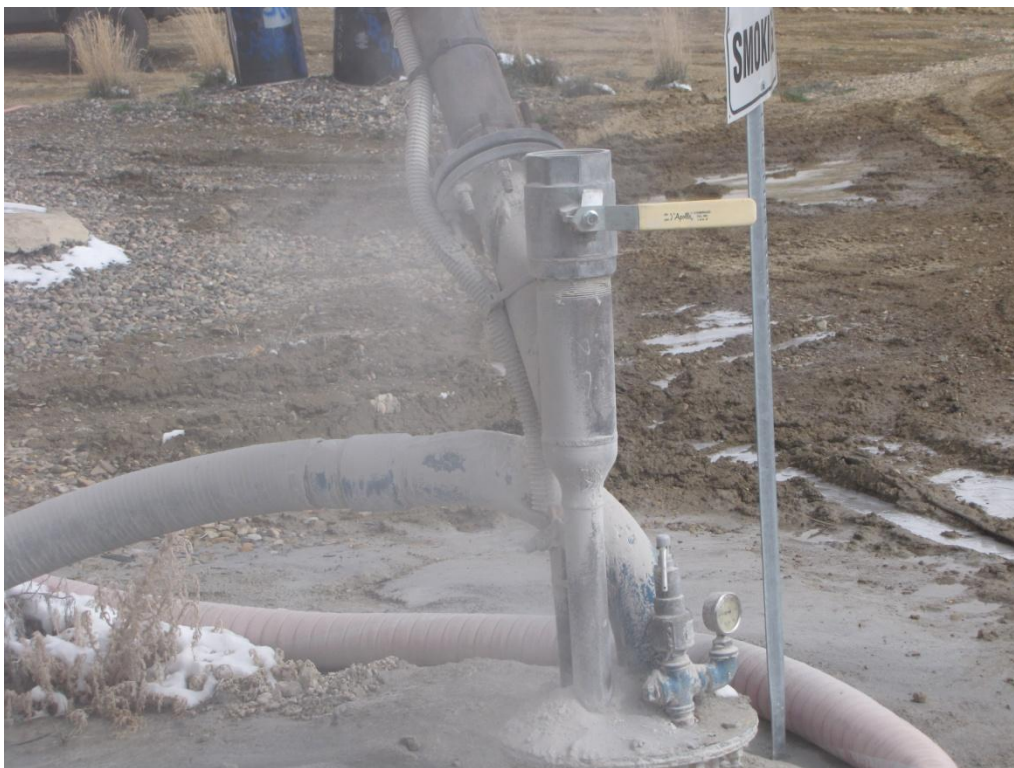
The rock dust tank near the Nitrogen Plant was leaking and in need of repair. Rock dust was being sprayed out from the neck joint. It appears a hole was created due to vibration and rubbing. Rock dust was collecting near the injection point. No signs of rock dust leaving the direct area of the rock dust tank SAE were observed.

Rock dust tank leak.
