COLORADO DIVISION OF RECLAMATION, MINING AND SAFETY COAL PROGRAM INSPECTION REPORT

Permit Number: C-1981-035 Mine Name: King Coal Mine Operator: GCC Energy, LLC Operator Address: Mr. Tom Bird 6473 County Road 120 Hesperus, CO 81326	County: La Plata Operation Type: Underground Permit Status: Active Ownership: Federal
	Operator Representative Present: Tom Bird
Operator Representative Signature: (Field Issuance Only) This report was issued electronically from the Division's Durango Field Office.

Inspection Start Date: April 22, 2013 Inspection Start Time: 08:25 Inspection End Date: April 22, 2013 Inspection End Time: 10:15		Inspection Type: Coal Partial Inspection Inspection Reason: Normal I&E Program Weather: Clear	
Joint Inspection Agency: None		Joint Inspection Contacts:	
Post Inspection Agency: None		Post Inspection Contacts:	
Inspector(s): Marcia L. Talvitie, P.E.	Inspector's Signature:

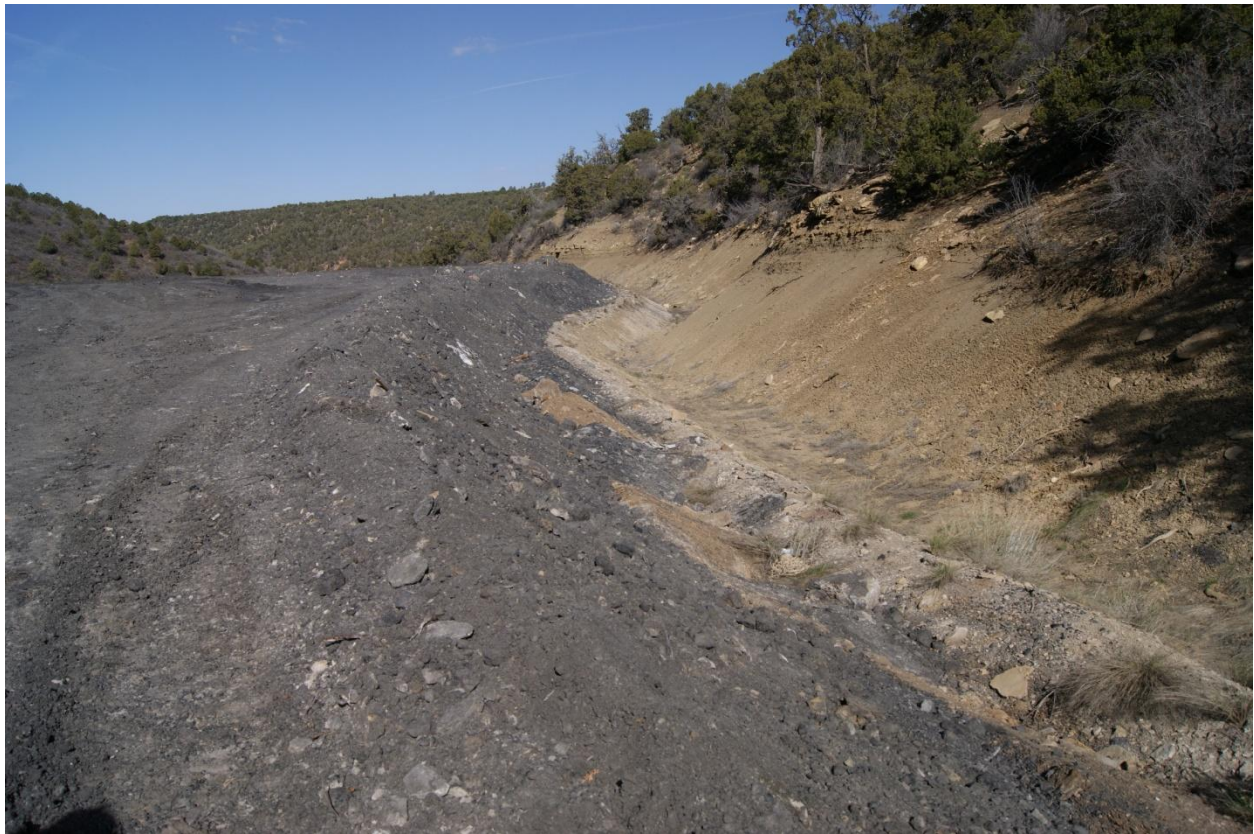
- The refuse brought to the pile in 2012 from the yard below has increased the height of the pile. Clear water continues to be diverted away from the refuse by the ditch on the north side of the pile, and this ditch will need to be relocated further up the slope in order to allow the placement of refuse to the north side of the valley (Photo 1). GCC has not yet determined how far up the slope the next phase of the clear water diversion ditch will be constructed.

Photo 1 – Clear water diversion ditch – north side of Refuse Pile, looking west

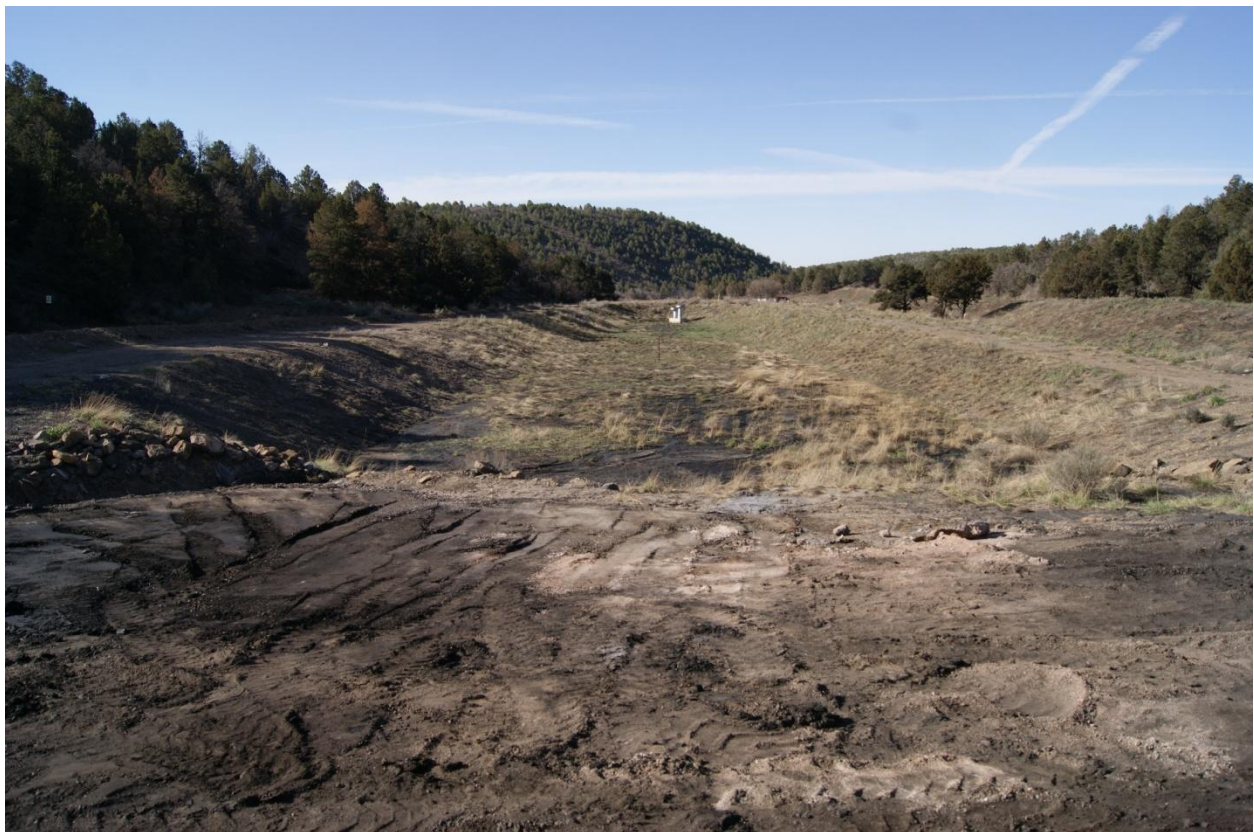
- The King II sediment pond was dry (Photo 2). Minor re-grading work (seasonal maintenance) was under way at the area between the northern end of the pond and the haul road, where snow had been piled during the winter.
- During the March 2013 inspection, I noted that the grated inlet adjacent to the screen tower had been blocked with coal fines. That inlet was clear on this inspection, and well protected with riprap and straw wattles (Photo 3).

Photo 2 – King II Sediment Pond, looking south; regraded area in foreground

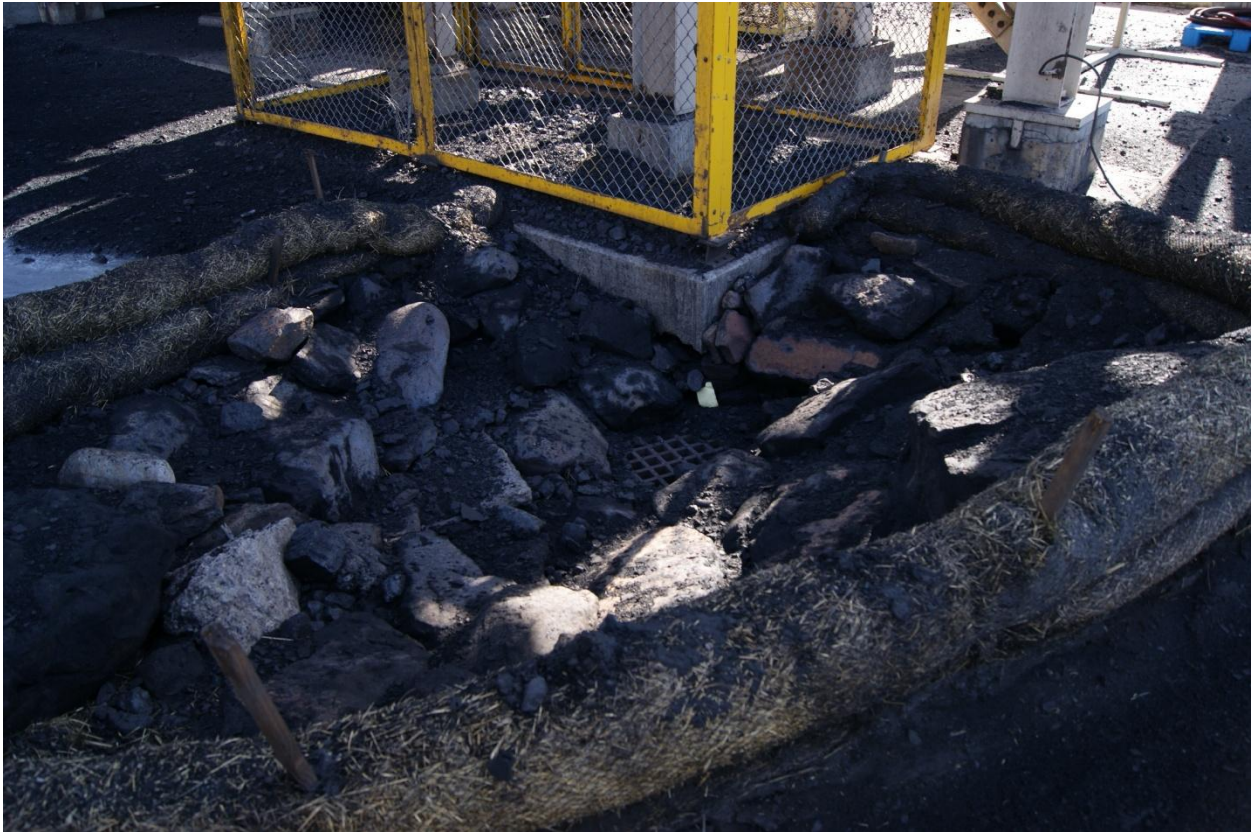
Photo 3 – Grated drop inlet at foot of screening tower

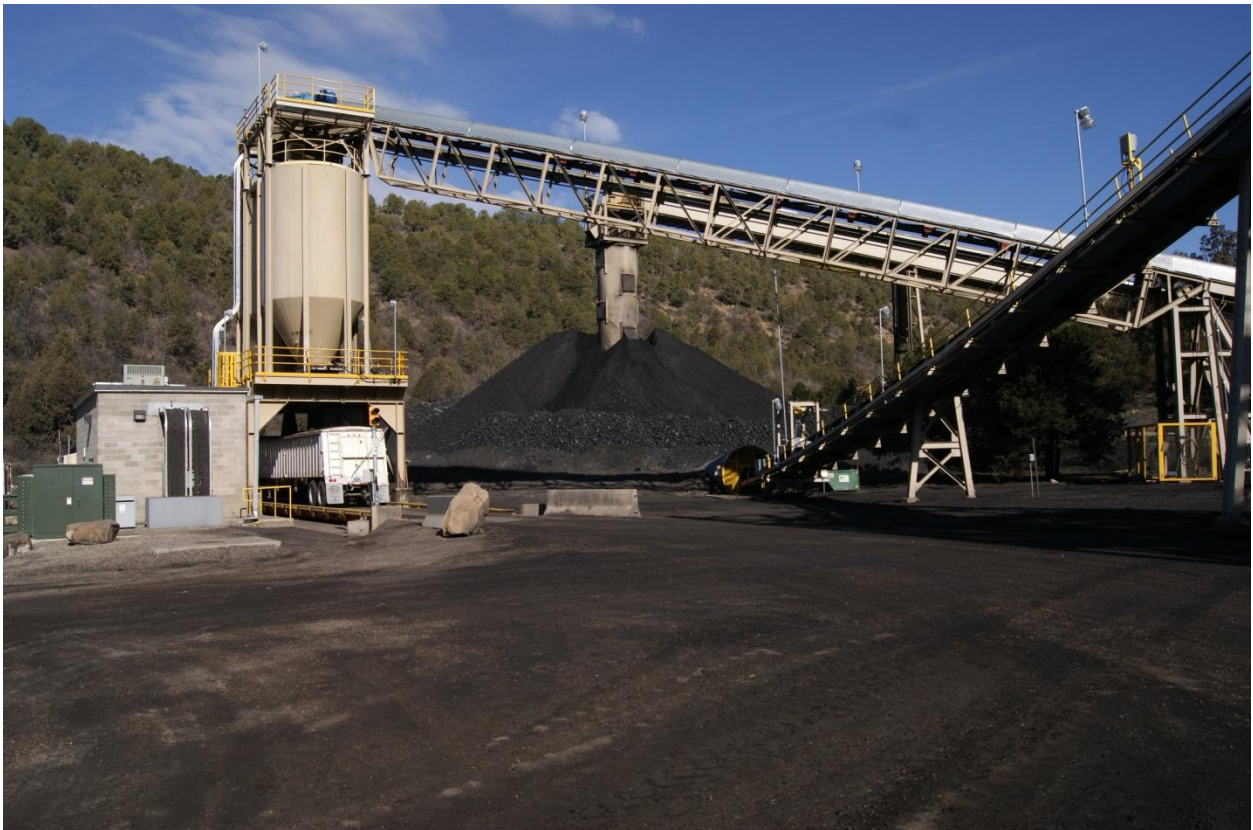
- An inventory of coal was piled at each of the two Stacker Tubes at King I (Photo 4). The screen was not running at the time of the inspection, but highway haul trucks were being loaded with coal for transport to GCC's customers.

Photo 4 – Stacker Tube #1 and truck loading/scale

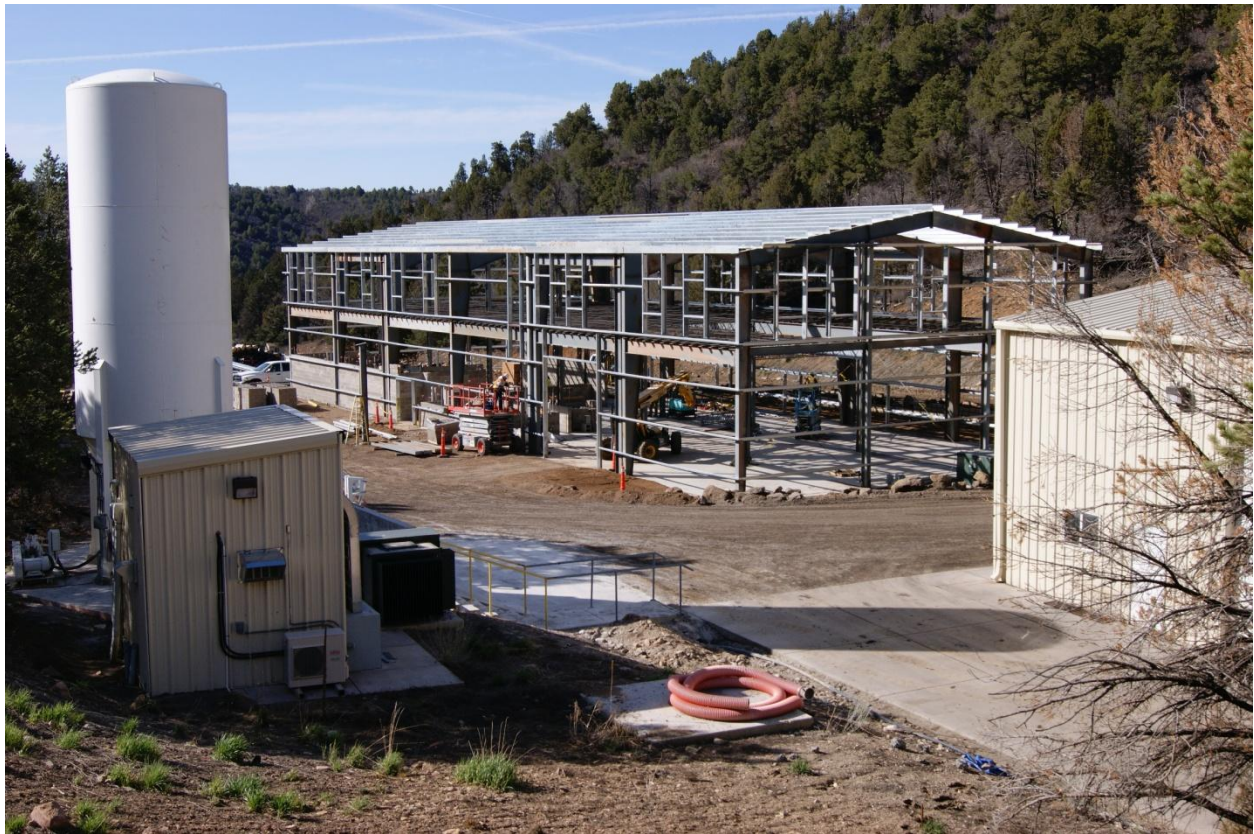
- Significant progress is being made on construction of the new office / bath house / storage building at King II (Photo 5).
- The northern tip of the western valley at King II is used as a non-coal equipment storage area. On this inspection, we observed that the volume of items stored at this location has increased, the placement is somewhat haphazard, and certain items are set extremely close to the posted disturbance boundary. There was no evidence of any hazardous materials or petroleum products. ***General "housekeeping" is recommended for this site*** (Photo 6).

Photo 5 – Building construction, as seen from water tank bench

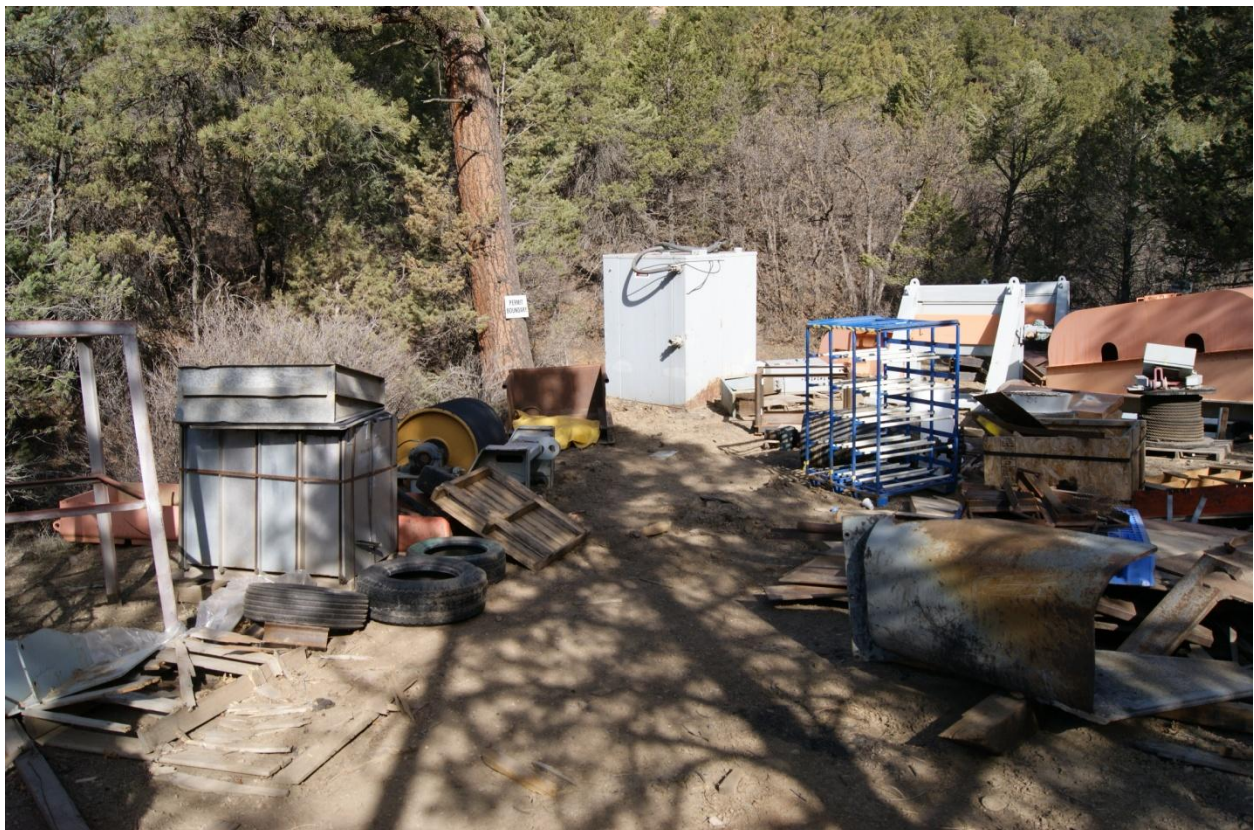
Photo 6 – Non-coal equipment storage area at King II
