**COLORADO DIVISION OF RECLAMATION, MINING AND SAFETY
COAL PROGRAM INSPECTION REPORT**

Permit Number: X-2008-142-13 Mine Name: New Horizon North Adjacent/Cypress Block Operator: Western Fuels-Colorado, LLC Operator Address: Mr. David Anderson 12050 N. Pecos Street Westminster, CO 80234	County: Montrose Operation Type: Coal exploration Permit Status: Inactive Ownership: Private
	Operator Representative Present: David Anderson
Operator Representative Signature: (Field Issuance Only)

Inspection Start Date: April 23, 2013 Inspection Start Time: 10:00 Inspection End Date: April 23, 2013 Inspection End Time: 15:30	Inspection Type: Surety Release Inspection Inspection Reason: Surety Release Requested Weather: Clear
Joint Inspection Agency: None	Joint Inspection Contacts:
Post Inspection Agency: None	Post Inspection Contacts:
Inspector(s): Elliott R. Russell Jason D. Musick	Inspector's Signature:

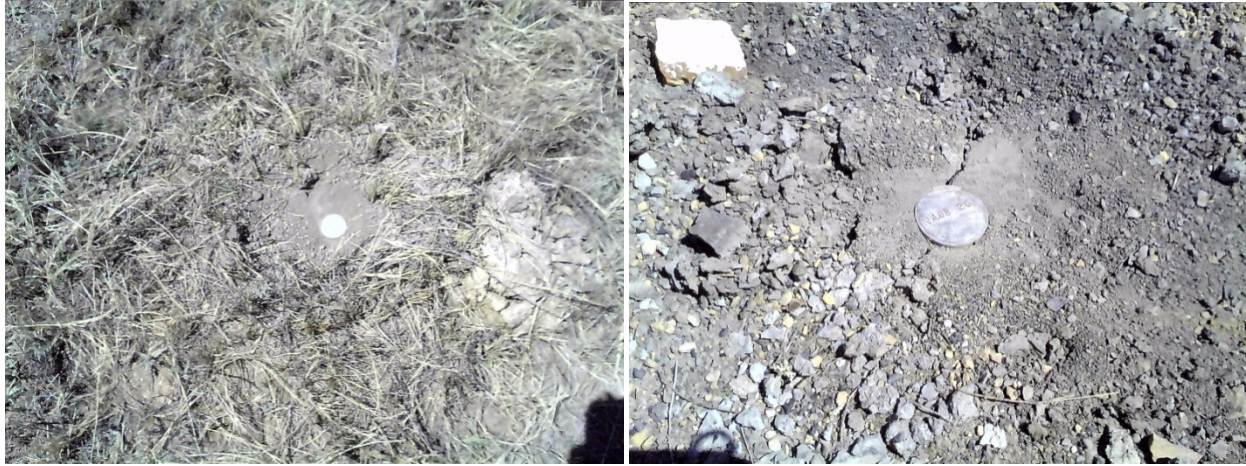
Example of sites where borehole marker was found (NA08-29 and NA08-20)

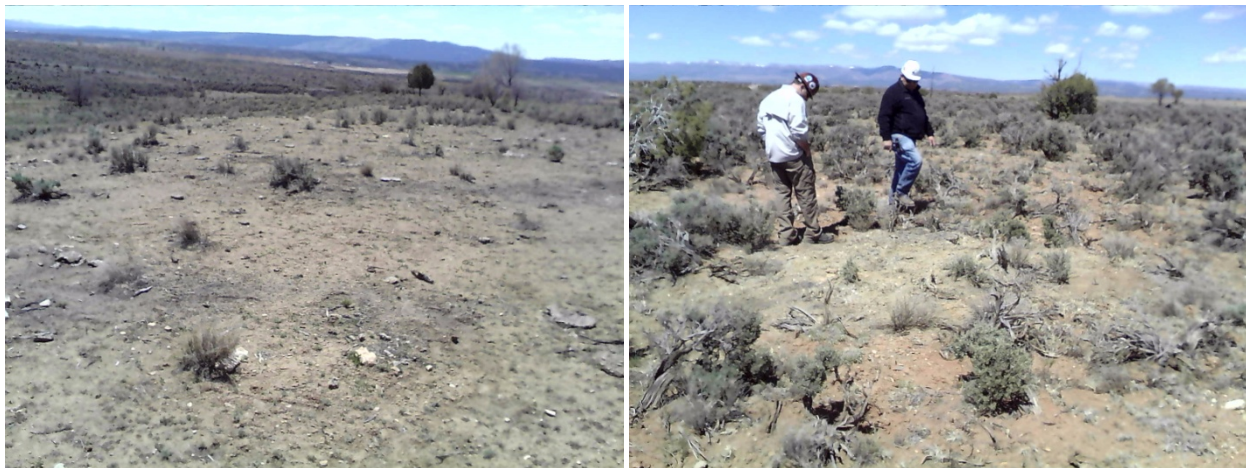
Example of sites not located in cropland (NA08-23 and CB08-34)

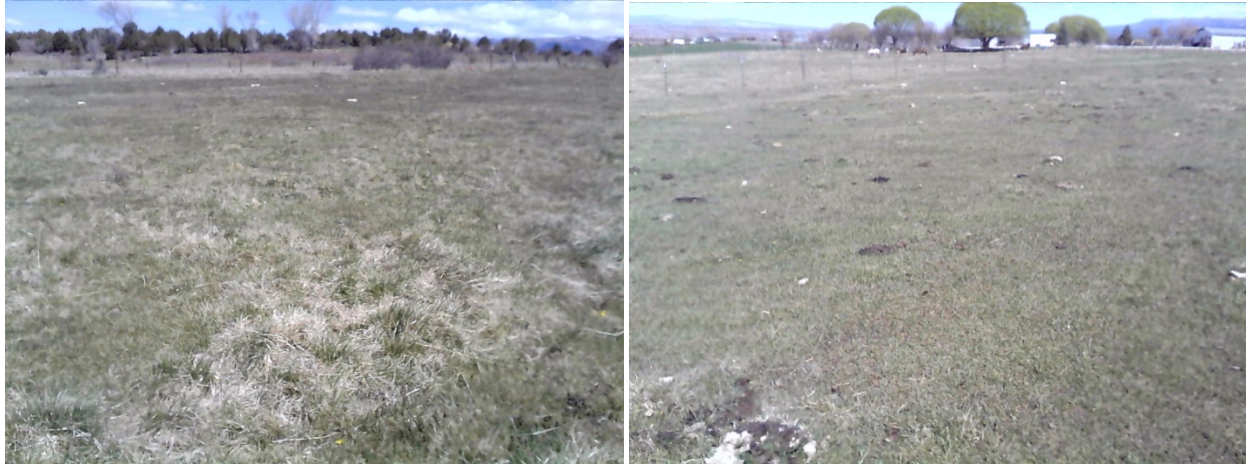
Example of sites located in cropland/pasture (NA08-5 and NA08-10)
