COLORADO DIVISION OF RECLAMATION, MINING AND SAFETY COAL PROGRAM INSPECTION REPORT

Permit Number: C-1981-022 Mine Name: Elk Creek Mine Operator: Oxbow Mining, LLC Operator Address: Mr. Jim Kiger P.O. Box 535 3737 Highway 133 Somerset, CO 81434	County: Delta, Gunnison Operation Type: Underground Permit Status: Active Ownership: Federal
	Operator Representative Present: Jim Kiger
Operator Representative Signature: (Field Issuance Only)

Inspection Start Date: April 25, 2013 Inspection Start Time: 10:00 Inspection End Date: April 25, 2013 Inspection End Time: 16:00		Inspection Type: Coal Complete Inspection Inspection Reason: Normal I&E Program Weather: Clear	
Joint Inspection Agency: None		Joint Inspection Contacts:	
Post Inspection Agency: None		Post Inspection Contacts:	
Inspector(s): Brock F. Bowles Carla V. Demasters	Inspector's Signature:

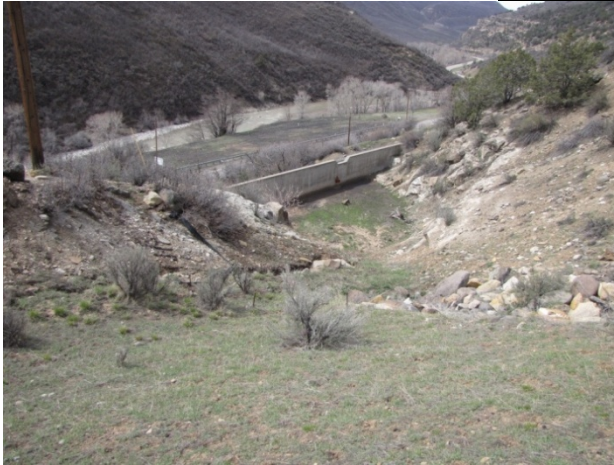
Ponds A, B, D and East Yard all contained water but none were discharging. Ponds C, E and F all were dry (photo 1). The ditch along the West Valley Haul road was free and clear of obstructions and straw bales were in good condition. Sediment control structures need to be replaced along the Pond C Light Use Road.

Photo 1 – Pond C Was Dry.

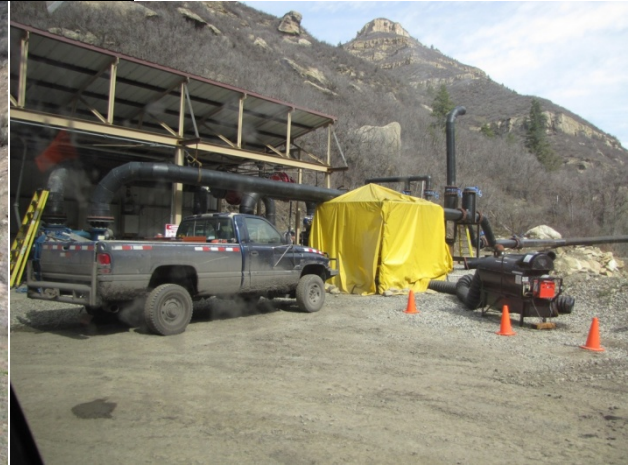
A mine atmosphere monitoring station was set up at the Elk Creek methane drainage borehole (photo 2).

Photo 2 – Mine Atmosphere Monitoring Station

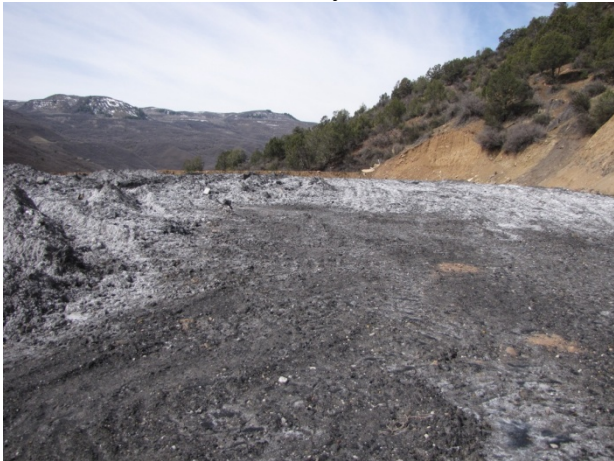
The II West Waste Pile had some loose gob stacked ready for compaction (photo 3). The lower level of the gob pile appeared to be stable. The West Valley Waste Pile appeared to be stable and did not have rills or gullies. The un-decomposed plastic netting from coconut fiber erosion matting which had been used during reclamation was rolled up by the wind (photo 4).

Photo 3 – II West Waste Pile

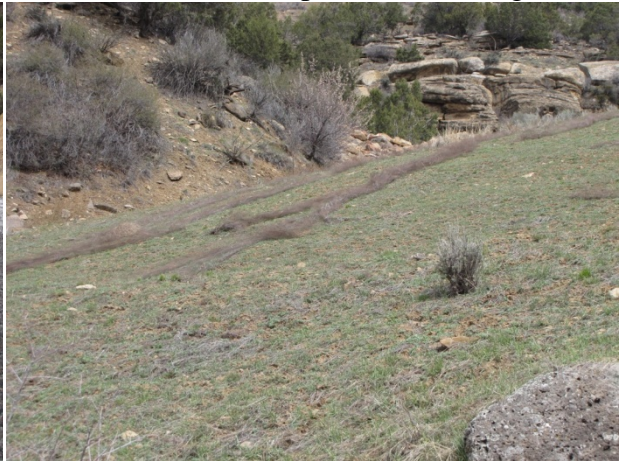
Photo 4 – West Valley Fill Gob Pile

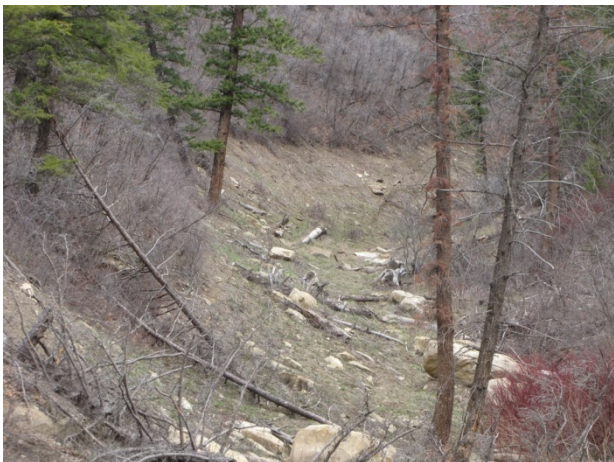
The reclaimed road for GVB-LW3-01 and GVB-LW4-03 appeared to be stable and vegetation was starting to grow (photo 5). The reclaimed road which intersects the Bear Creek Road from the south at GVB-LW10-04 appeared to be stable and vegetation was starting to grow at the intersection (photo 6). The Somerset mine portal area appeared to be stable and vegetation was starting to grow.

Photo 5 – Reclaimed Road to GVBLW3-01

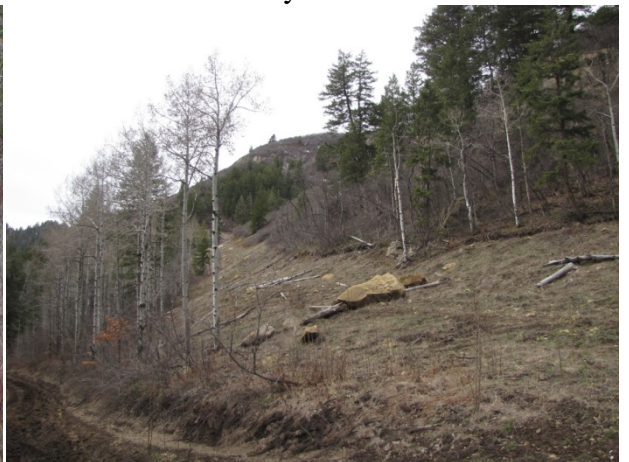
Photo 6 – Reclaimed Road Intersecting Bear Cr.
