COLORADO DIVISION OF RECLAMATION, MINING AND SAFETY COAL PROGRAM INSPECTION REPORT

Permit Number: C-1981-046 Mine Name: Sunlight Mine Operator: Garfield Energy Corporation Operator Address: X X, CO 11111	County: Garfield Operation Type: Underground Permit Status: Revoked Ownership: Private Operator Representative Present: None
Operator Representative Signature: (Field Issuance Only)

Inspection Start Date: April 24, 2013 Inspection Start Time: 13:00 Inspection End Date: April 24, 2013 Inspection End Time: 14:30		Inspection Type: Coal Complete Inspection Inspection Reason: Normal I&E Program Weather: Clear	
Joint Inspection Agency: None		Joint Inspection Contacts: 	
Post Inspection Agency: None		Post Inspection Contacts: 	
Inspector(s): Brock F. Bowles Carla V. DeMasters		Inspector's Signature:

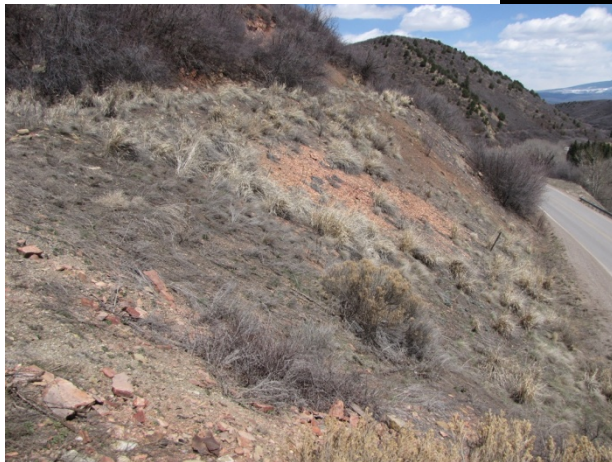
Photo 1 – Portal Area Backfill

The backfilled portal area did not have signs of slumping or cracking (photo 1). The soil above the lower fan portal is collapsing. The hole did not seem bigger than it was during a previous inspection last September 2012.

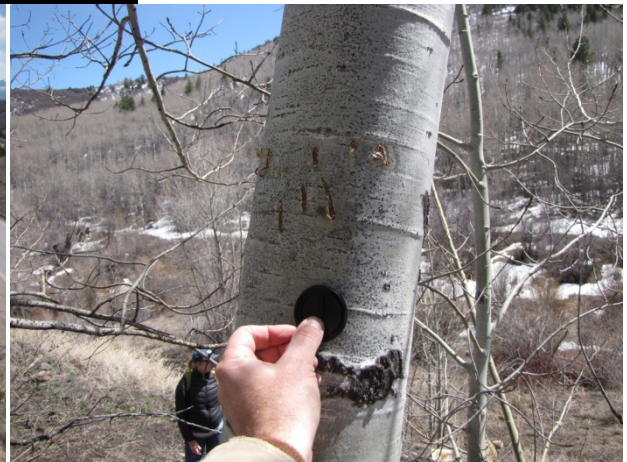
Photo 2 – Claws Marks in Aspen Tree Bark

Scratch marks were observed in the bark of an aspen tree on the lower portal area. It appeared that an animal with sharp claws climbed the tree (photo 2).

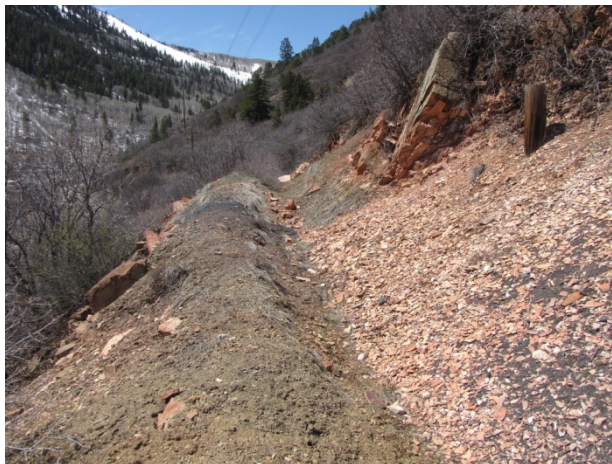
Photo 3 – Clean Water Diversion Ditch

The upper section of the clean water diversion ditch on the upper portal area was free and clear of obstructions (photo 3). The clean water diversion ditch culvert going under the county road on the western side of the mine site was almost completely obstructed (photo 4).
