COLORADO DIVISION OF RECLAMATION, MINING AND SAFETY
MINERALS PROGRAM INSPECTION REPORT
PHONE: (303) 866-3567

MINE NAME: Martin Mesa Prospecting Project	MINE/PROSPECTING ID#: P-2008-058	MINERAL: Uranium and vanadium	COUNTY: Montrose
INSPECTION TYPE: Surety Release Inspection	INSPECTOR(S): Dustin M. Czapla	INSP. DATE: April 12, 2013	INSP. TIME: 15:30
OPERATOR: Zenith Minerals LLC	OPERATOR REPRESENTATIVE: Dave Andrews	TYPE OF OPERATION: MP - Mineral Prospecting

REASON FOR INSPECTION: Surety Release Requested	BOND CALCULATION TYPE: IT.Bondcalculationtype.CD.Desc	BOND AMOUNT: \$6,450.00
DATE OF COMPLAINT: NA	POST INSP. CONTACTS: None	JOINT INSP. AGENCY: None
WEATHER: Clear	INSPECTOR'S SIGNATURE:

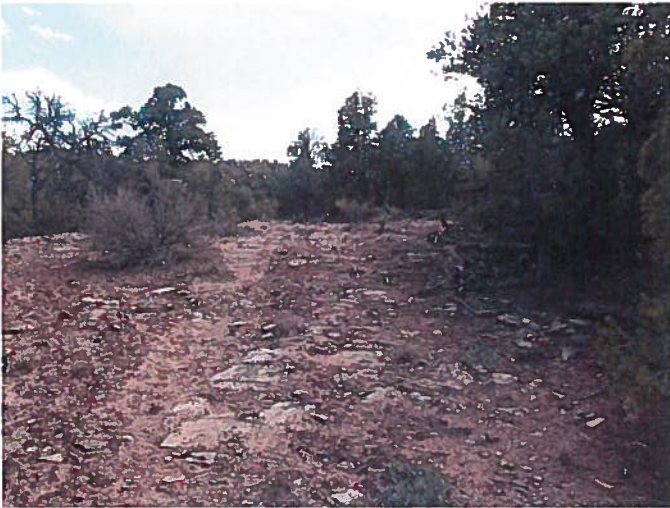
Row F1

This was a Surety Release inspection. Dave Andrews, representing the Operator, was present during this inspection. The Division inspected the site in June 2010 and found that all but two holes had been adequately reclaimed, one in line F1 and the other in line F4. These two holes were located and found to be adequately reclaimed during this inspection.
