**COLORADO DIVISION OF RECLAMATION, MINING AND SAFETY
COAL PROGRAM INSPECTION REPORT**

Permit Number: C-1981-025 Mine Name: North Thompson Creek Mine Operator: MINREC, Inc. Operator Address: Mr. James E Stover 2352 N 7th St, Ste B Grand Junction, CO 81501	County: Garfield Operation Type: Underground Permit Status: Inactive Ownership: Federal
	Operator Representative Present: Stan Muhr
Operator Representative Signature: (Field Issuance Only)

Inspection Start Date: April 26, 2013 Inspection Start Time: 09:30 Inspection End Date: April 26, 2013 Inspection End Time: 11:30	Inspection Type: Coal Partial Inspection Inspection Reason: Other Agency Request Weather: Clear
Joint Inspection Agency: Colo. Health Dept.	Joint Inspection Contacts: KC Kay Grand Junction District Office 222 South 6 th St, Room 232 Grand Junction, CO 81501
Post Inspection Agency: None	Post Inspection Contacts:
Inspector(s): Brock F. Bowles Carla V. Demasters	Inspector's Signature:

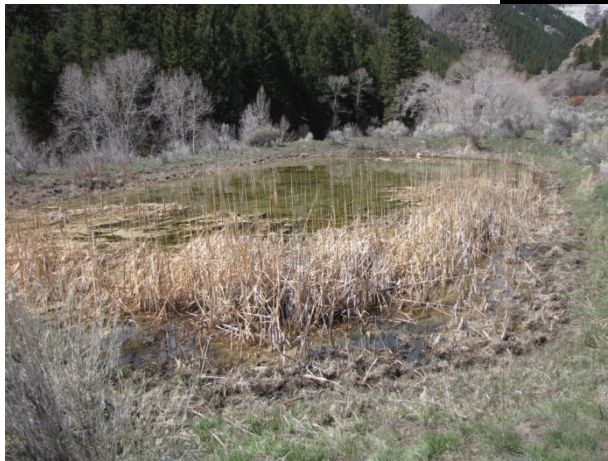
Photo 1 – Pond T1

Water was flowing from both portal discharge pipes into the long pond. The water from both discharges was clear. The long pond contained water and the banks appeared to be stable. Water was flowing from the Long Pond to T1 through the spillway pipe. Pond T1 contained water, had no ice and the banks appeared to be stable (photo 1). Water flowed from T1 to T2 through the open ditch. Pond T2 contained water, had no ice and the banks appeared to be stable (photo 2). Water was then directed to both P9 and Outfall 001A. Pond P9 contained water, had no ice and was not discharging (photo 3). The water that was directed to Outfall 001A, passed through the outfall structure and was then directed to the refuse disposal pond which is beyond the permit boundary.
