**COLORADO DIVISION OF RECLAMATION, MINING AND SAFETY
COAL PROGRAM INSPECTION REPORT**

Permit Number: C-1981-020 Mine Name: Munger Canyon Mine Operator: CAM Mining, LLC Operator Address: Mr. Corey Heaps P.O. Box 98 Loma, CO 81524	County: Garfield, Mesa Operation Type: Underground Permit Status: Permanent Cessation Ownership: Federal
	Operator Representative Present: None
Operator Representative Signature: (Field Issuance Only)

Inspection Start Date: April 30, 2013 Inspection Start Time: 09:35 Inspection End Date: April 30, 2013 Inspection End Time: 11:30		Inspection Type: Coal Partial Inspection Inspection Reason: Normal I&E Program Weather: Cloudy	
Joint Inspection Agency: None		Joint Inspection Contacts: 	
Post Inspection Agency: None		Post Inspection Contacts: 	
Inspector(s): Michael P. Boulay	Inspector's Signature: <i>Michael P. Boulay</i>		Signature Date: 5/3/13

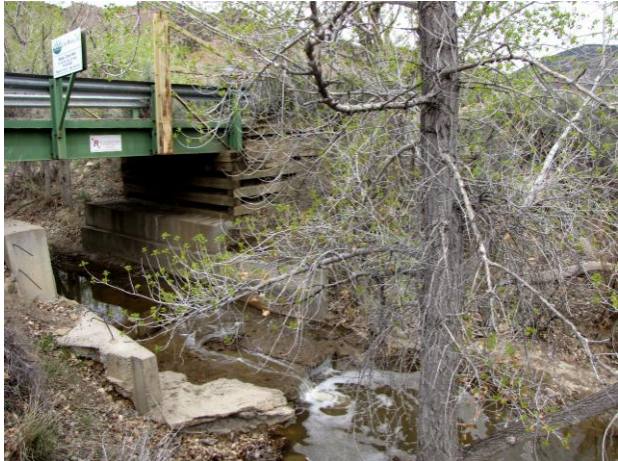
East Salt Creek was flowing with turbid water. Photograph No. 1 was taken at the mine site entrance at the East Salt Creek bridge crossing. Munger Creek was dry with a few damp areas. Ditches and culverts associated with the reclaimed waste disposal site, the cover soil stockpile, and the topsoil stockpile locations were in good condition and well maintained. The waste disposal area sediment pond was dry. The inlet and discharge structures were stable and no problems were noted.

Photo No. 1 – East Salt Creek at Mine Entrance.

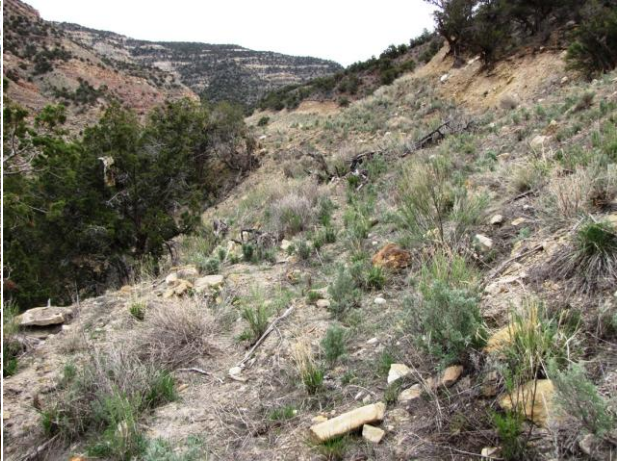
The reclaimed portal access road remains in good condition. The vegetation is beginning to green up. The shrubs are well established on the reclaimed access road. Several photographs were taken along the lower to mid portion of the former access road to demonstrate the vegetation reestablishment. Visible in the reclaimed road corridor are grasses including wheatgrass and rye, and significant stands of shrubs including big sagebrush, four wing saltbush, shadscale, and rubber rabbitbrush (see Photograph No's 2, 3 and 4). There were no signs of significant erosion or instability noted during this inspection and the site appears well maintained.

Photo No. 2 – Reclaimed access road mid-portion.

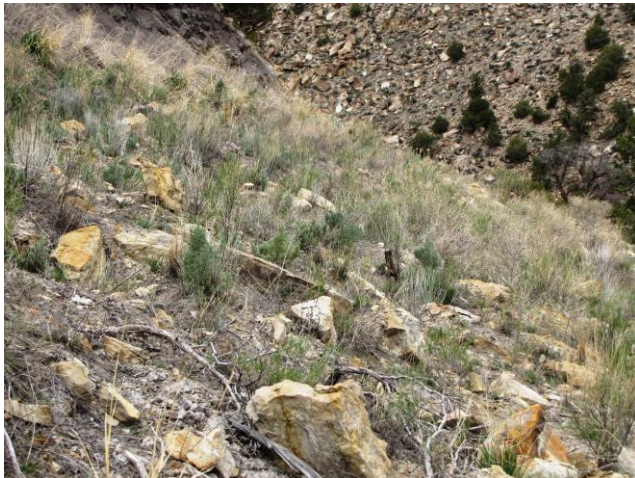
Photo No. 3 – Revegetation on reclaimed road corridor.

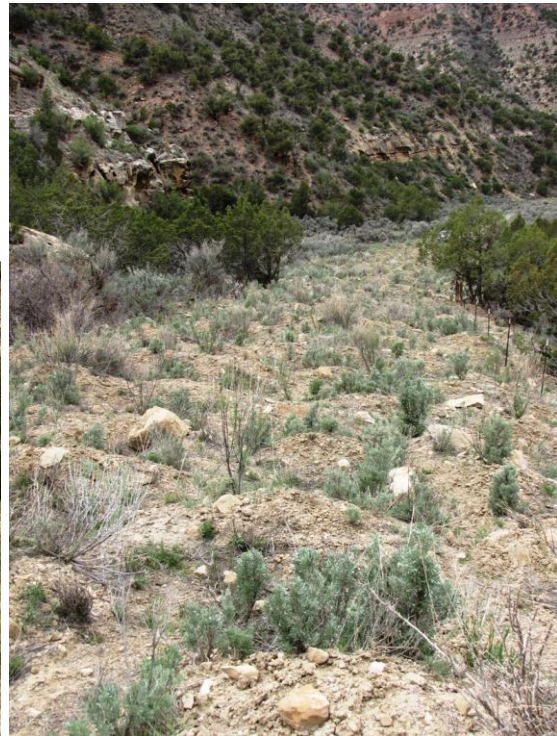
Photo No. 4 – Reclaimed access road lower-portion.
