**COLORADO DIVISION OF RECLAMATION, MINING AND SAFETY
MINERALS PROGRAM INSPECTION REPORT
PHONE: (303) 866-3567**

| MINE NAME: Benson Brothers Pig Mesa Pit | MINE/PROSPECTING ID#: M-2004-084 | MINERAL: Sand and gravel | COUNTY: Delta |
| INSPECTION TYPE: Monitoring | INSPECTOR(S): Dustin M. Czapla | INSP. DATE: May 1, 2013 | INSP. TIME: 09:30 |

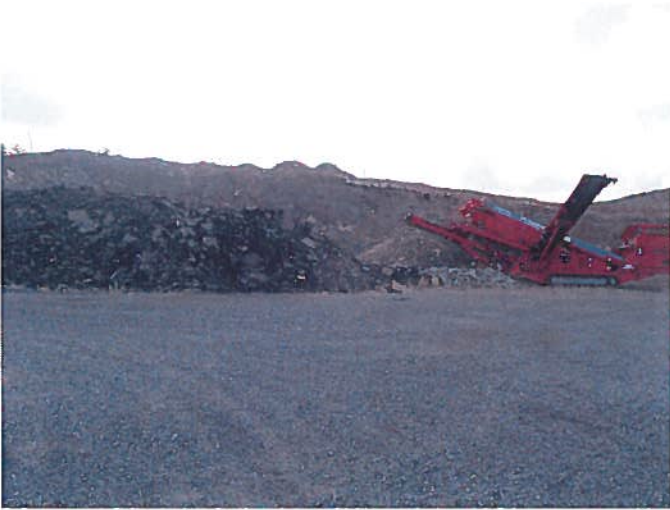
Figure 1: Asphalt stockpile to be crushed and recycled, located in the northeast part of the pit.

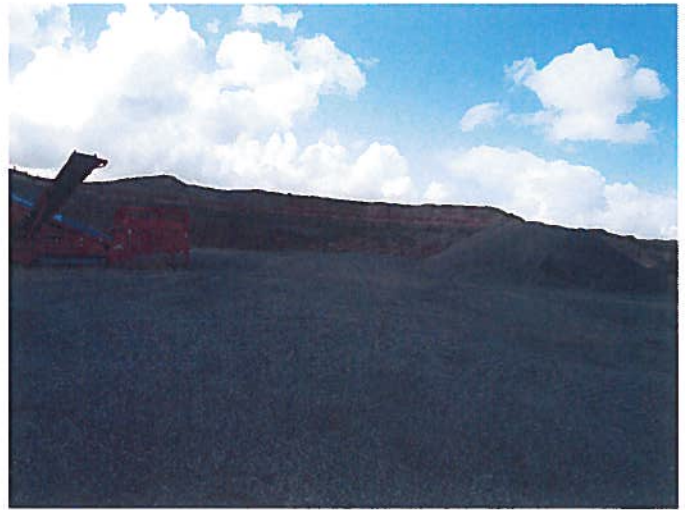
Figure 2: View from the pit floor, toward the southeast highwall.

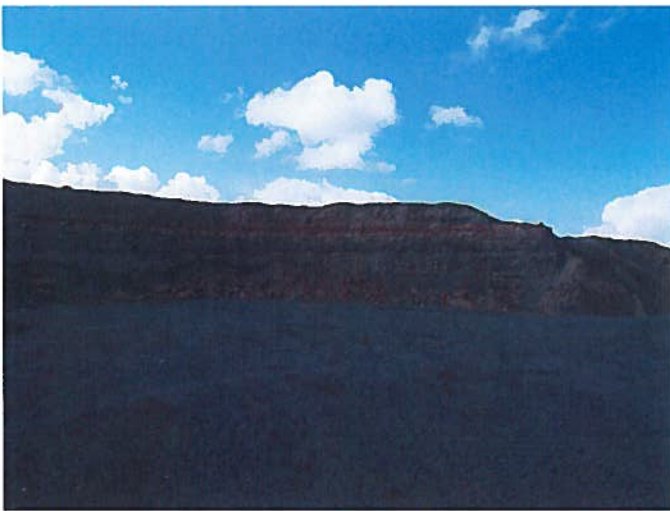
Figure 3: View from the pit floor, toward the southeast highwall.

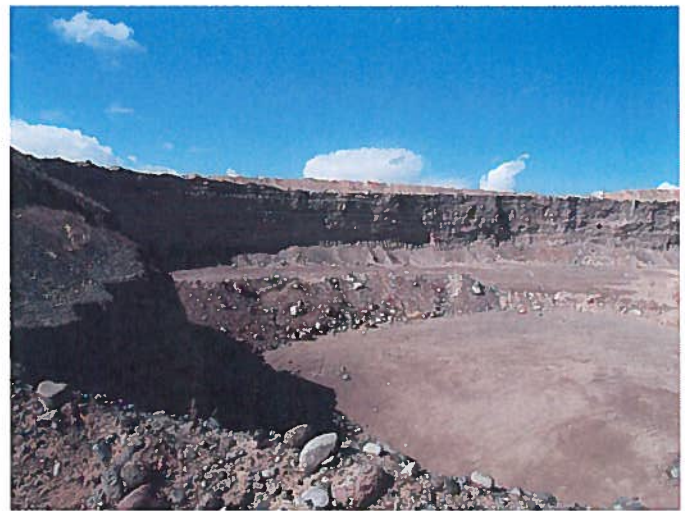
Figure 4: View from the southeast pit rim, towards the south and west highwall.

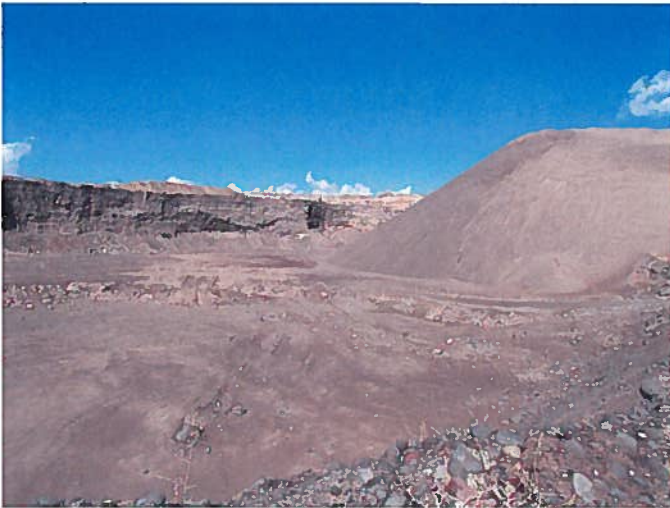
Figure 5: View from the southeast pit rim, towards the west highwall.

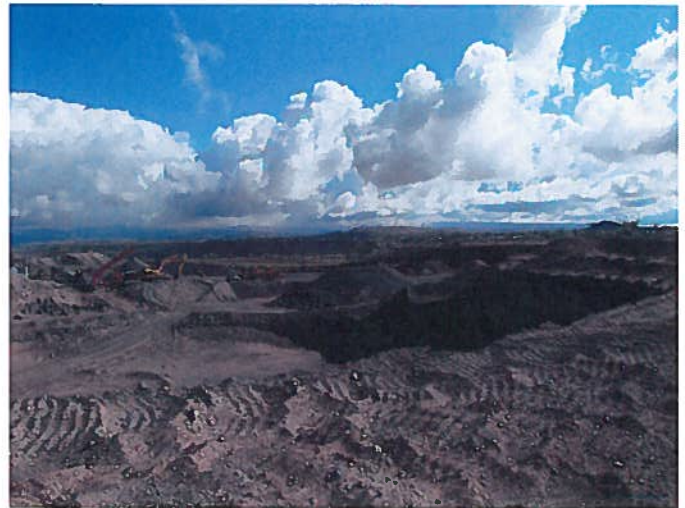
Figure 6: View from the south pit rim, towards the north.

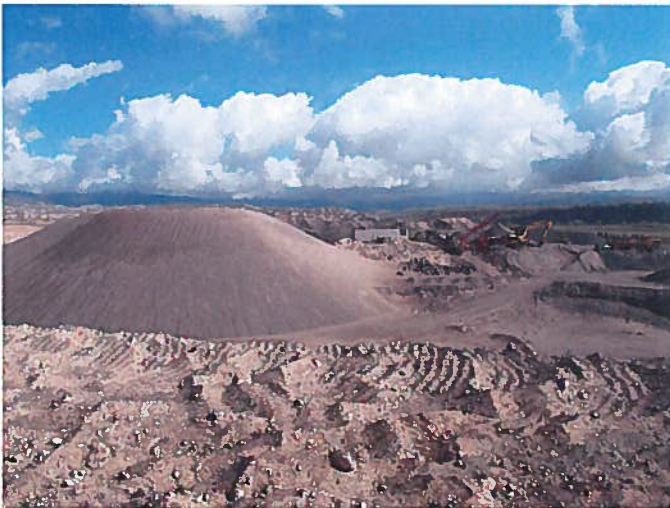
Figure 7: View from the south pit rim, towards the north.

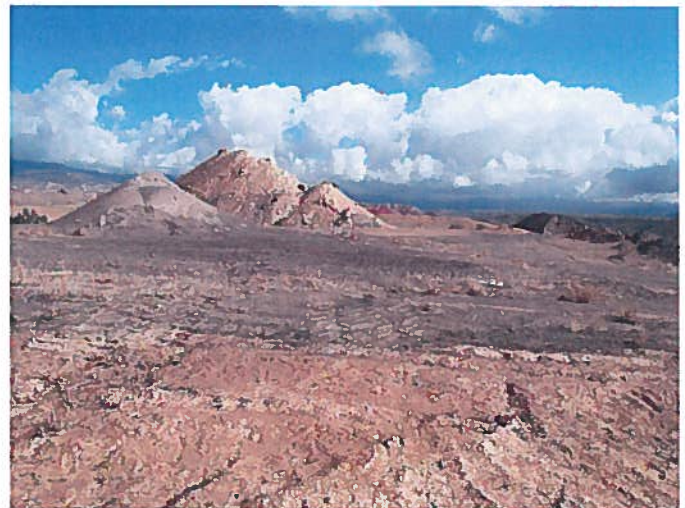
Figure 8: Topsoil storage area located on the west side of the pit.
