COLORADO DIVISION OF RECLAMATION, MINING AND SAFETY
MINERALS PROGRAM INSPECTION REPORT
PHONE: (303) 866-3567

| MINE NAME: Hallenbeck Pit No 1 | MINE/PROSPECTING ID#: M-1977-062 | MINERAL: Sand and gravel | COUNTY: Delta |
| INSPECTION TYPE: Monitoring | INSPECTOR(S): Dustin Czapla | INSP. DATE: May 1, 2013 | INSP. TIME: 09:00 |

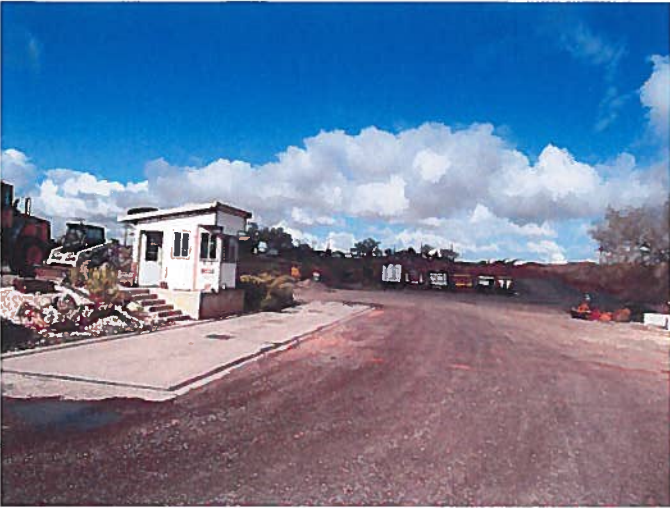
Figure 1: View facing west from the shop area.

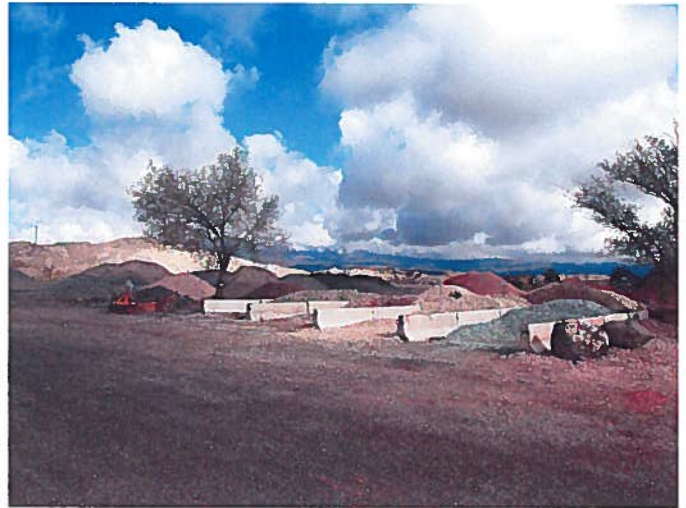
Figure 2: View facing west from the shop area.

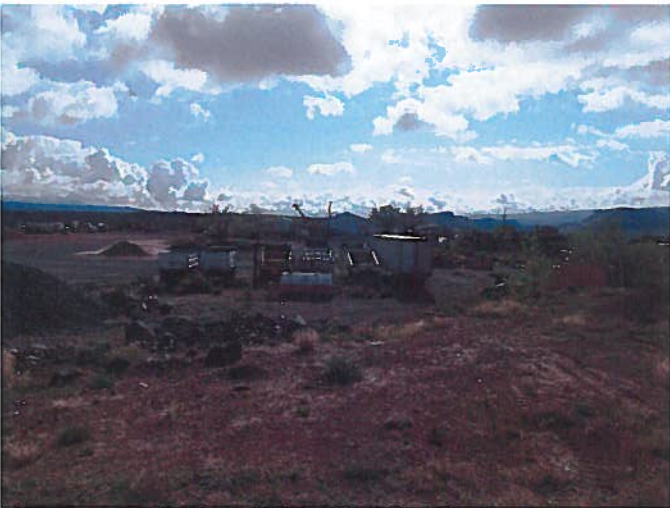
Figure 3: View facing east from the west central part of the site.

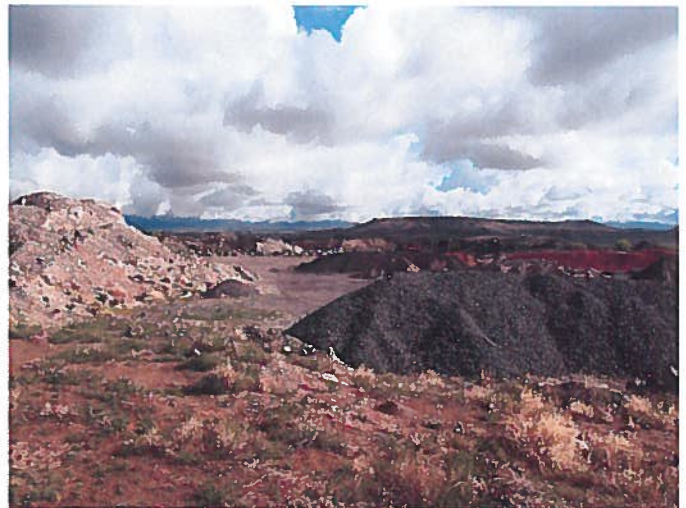
Figure 4: View facing north from the west central part of the site.

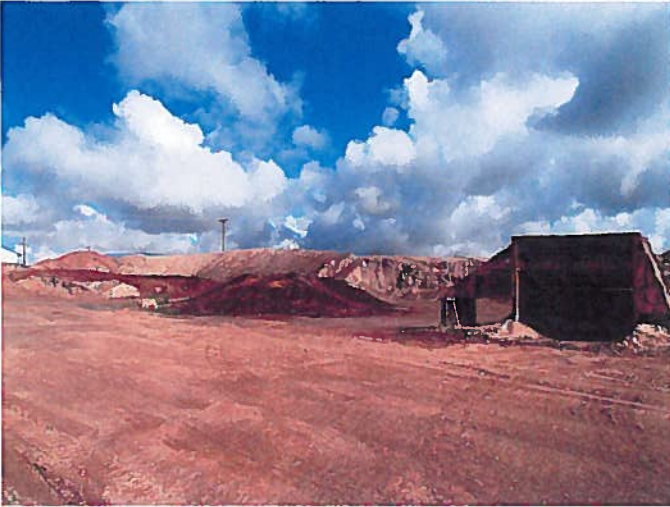
Figure 5: Mine area in the west part of the site.

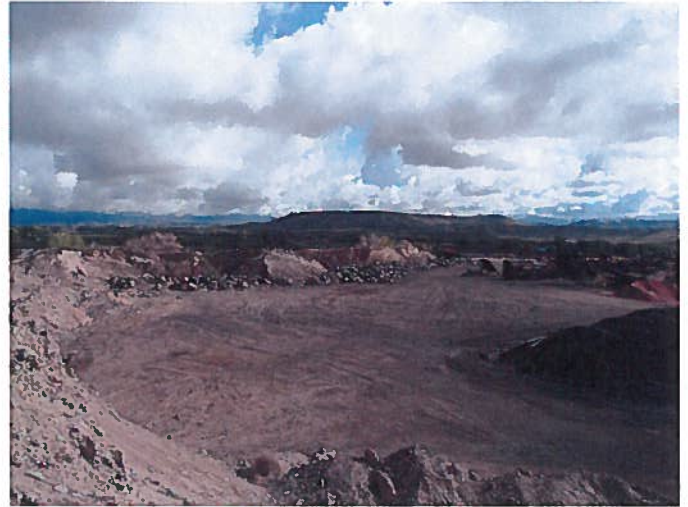
Figure 6: View towards the north part of the site.

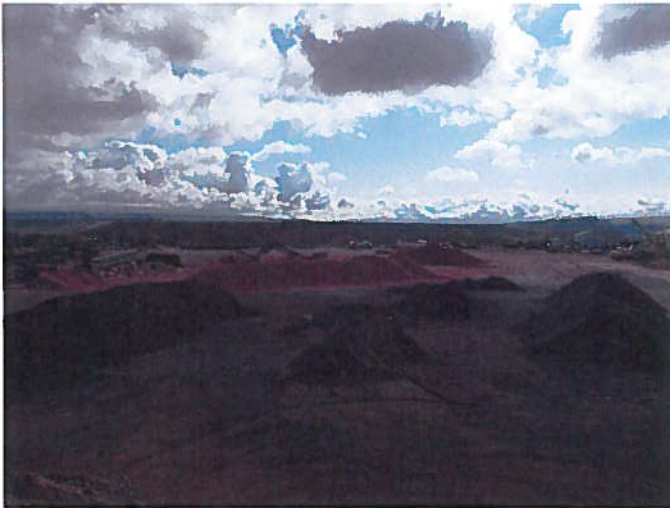
Figure 7: View from the top of the highwall, facing east.

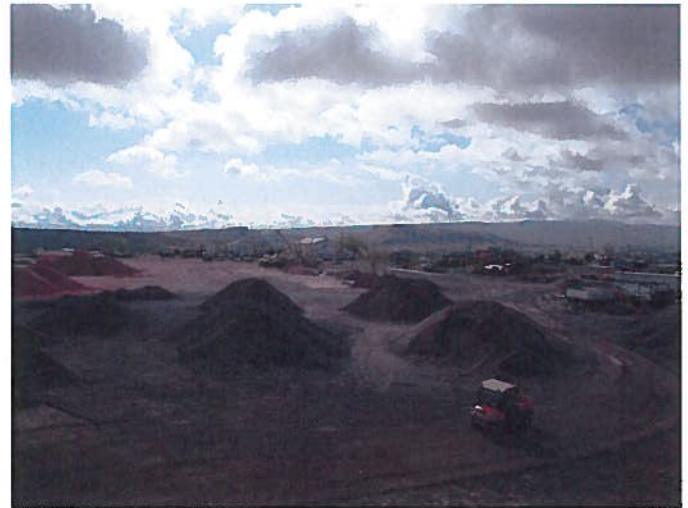
Figure 8: View from the top of the highwall, facing east.

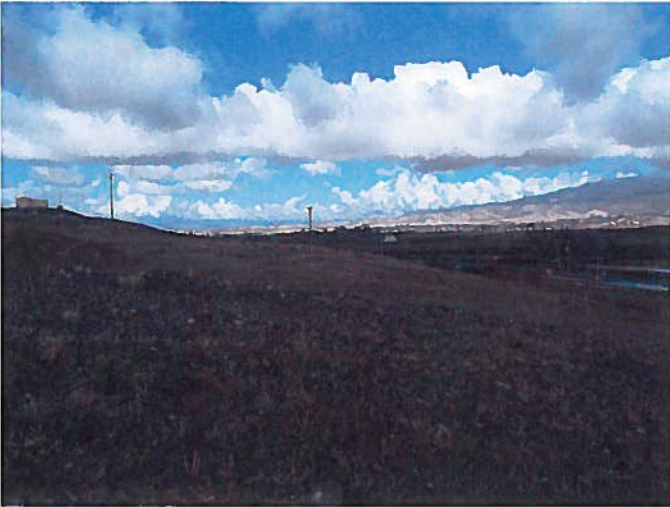
Figure 9: View of the north part of the site.

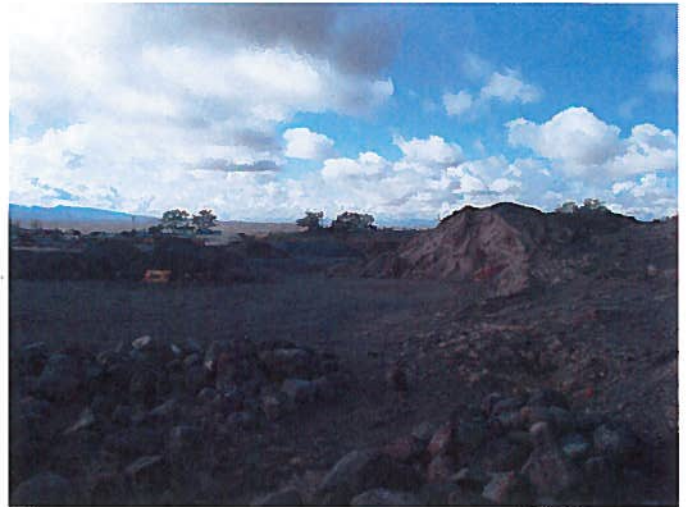
Figure 10: View facing south, from the north central part of the site.

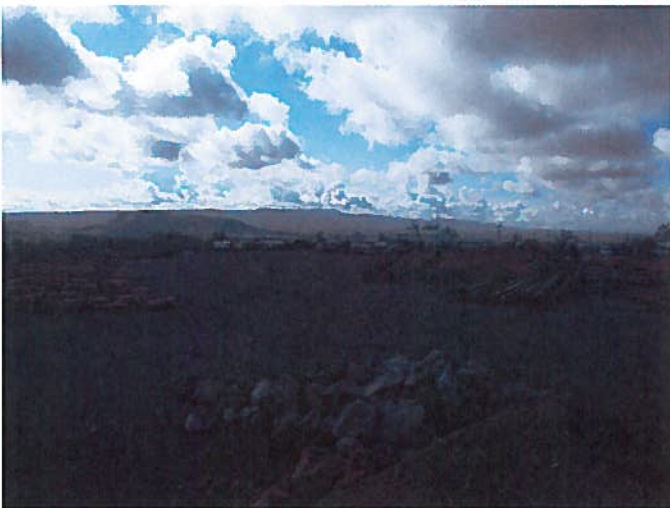
Figure 11: View facing south, from the north central part of the site.

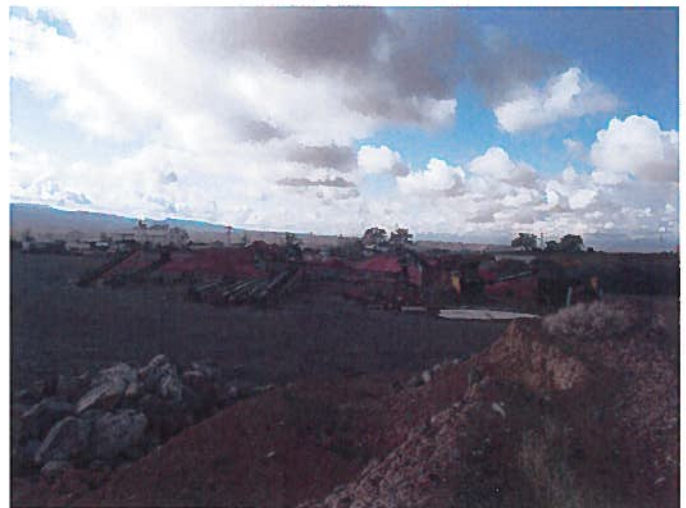
Figure 12: View facing south, from the north central part of the site.
