**COLORADO DIVISION OF RECLAMATION, MINING AND SAFETY**  
**MINERALS PROGRAM INSPECTION REPORT**  
**PHONE: (303) 866-3567**

| <b>MINE NAME:</b><br>Walker Pit | <b>MINE/PROSPECTING ID#:</b><br>M-1987-044 | <b>MINERAL:</b><br>Sand and gravel | <b>COUNTY:</b><br>La Plata |
| <b>INSPECTION TYPE:</b><br>Surety-Related Inspection | <b>INSPECTOR(S):</b><br>Kate A. Pickford | <b>INSP. DATE:</b><br>April 19, 2013 | <b>INSP. TIME:</b><br>13:30 |

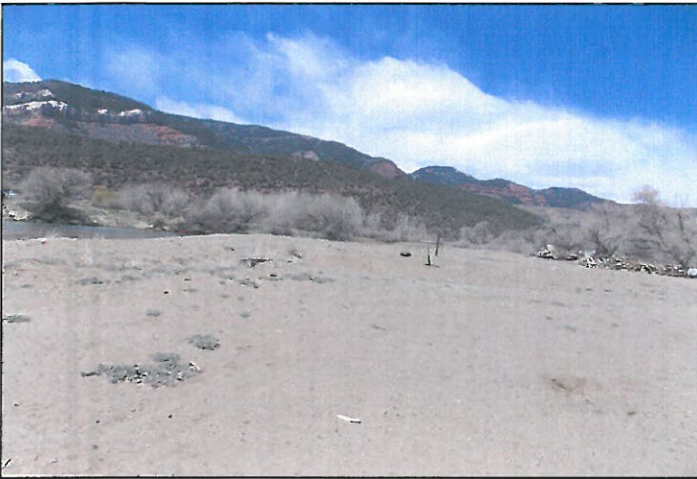
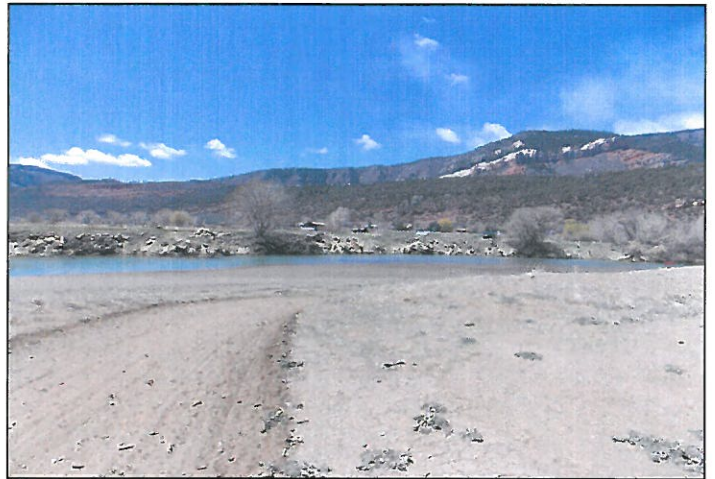
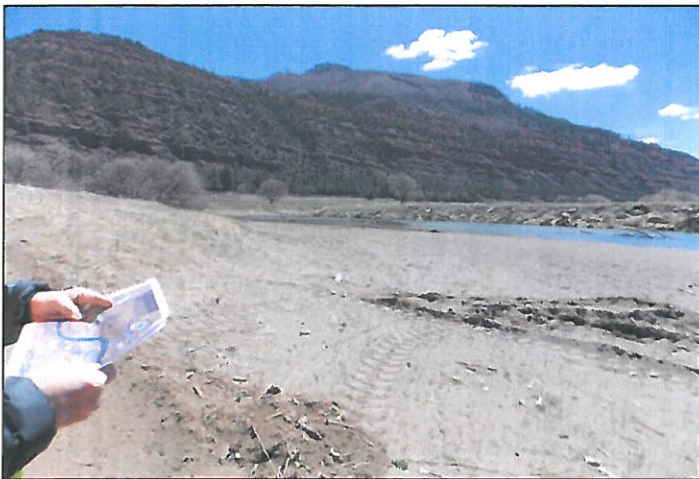
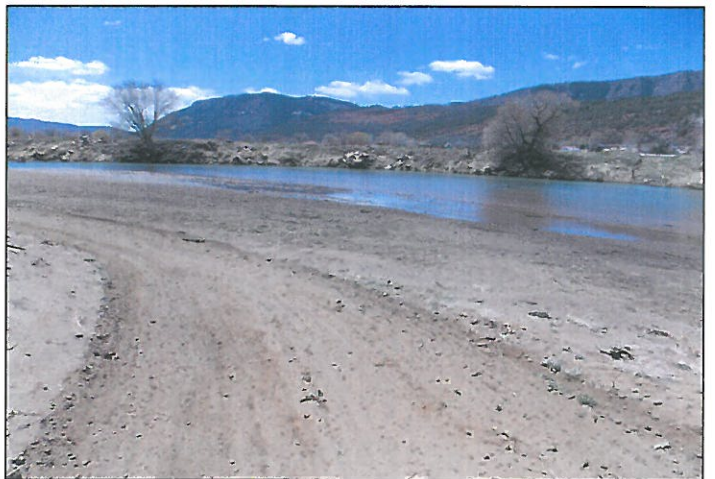
**PHOTOGRAPHS**

The site consists of a small upland area and an access road that leads down to a sand bar in/beside the river. It appears that when the site is in operation, trucks drive down to the sand bar, across it for loading and then back up on a continuation of the road.

Reclamation at the site will consist mainly of grading and revegetating the upland areas and making sure the sand bar is stable.
