COLORADO DIVISION OF RECLAMATION, MINING AND SAFETY COAL PROGRAM INSPECTION REPORT

Permit Number: C-1981-008 Mine Name: New Horizon Mine Operator: Western Fuels-Colorado, LLC Operator Address: Mr. Ross L. Gubka, P.E. P.O. Box 628 Nucla, CO 81424	County: Montrose Operation Type: Surface Permit Status: Active Ownership: Private
	Operator Representative Present: Ross Gubka
Operator Representative Signature: (Field Issuance Only) This report was issued electronically from the Division's Durango Field Office.

Inspection Start Date: May 1, 2013 Inspection Start Time: 11:30 Inspection End Date: May 1, 2013 Inspection End Time: 12:30		Inspection Type: Coal Partial Inspection Inspection Reason: Normal I&E Program Weather: Windy	
Joint Inspection Agency: None		Joint Inspection Contacts:	
Post Inspection Agency: None		Post Inspection Contacts:	
Inspector(s): Marcia L. Talvitie, P.E. Sandra L. Brown	Inspector's Signature:

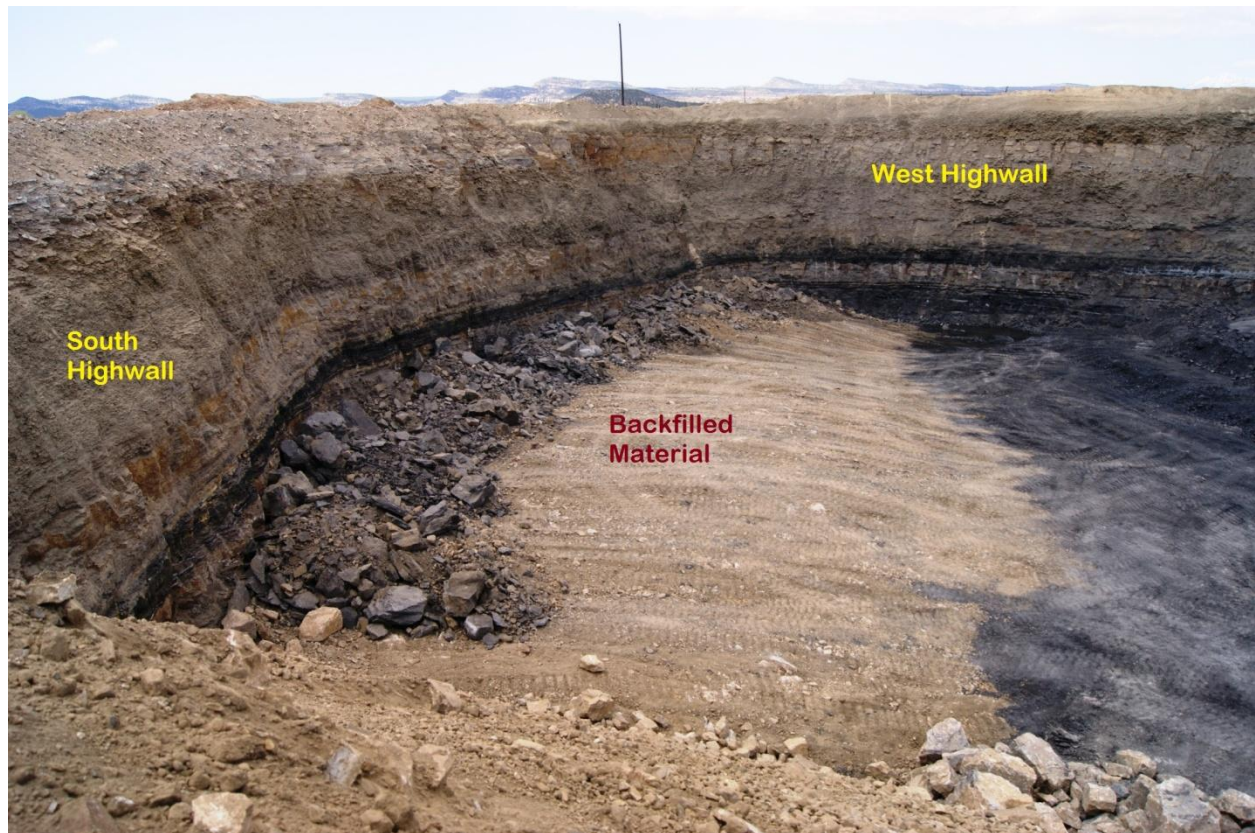
- South of BB Road, only a small area of the pit remains to be backfilled on the Morgan pit.
- To the north of BB Road, the post-mining topography on the Western Fuels property is beginning to take shape, and the operator has begun to place backfill against the southern highwall where final coal extraction operations have been already completed (Photo 1).
- Bench 2 (lower) and Bench 1 (upper) overburden have been stockpiled east of the pit for use in backfilling the final cuts on the Western Fuels property (Photo 2). Additional backfill material will be hauled from the remnant boxcut spoil pile at the far southeastern edge of the permit area - a distance of approximately 2.25 miles.

Photo 1 – Early stages of backfilling final highwall on WFC property

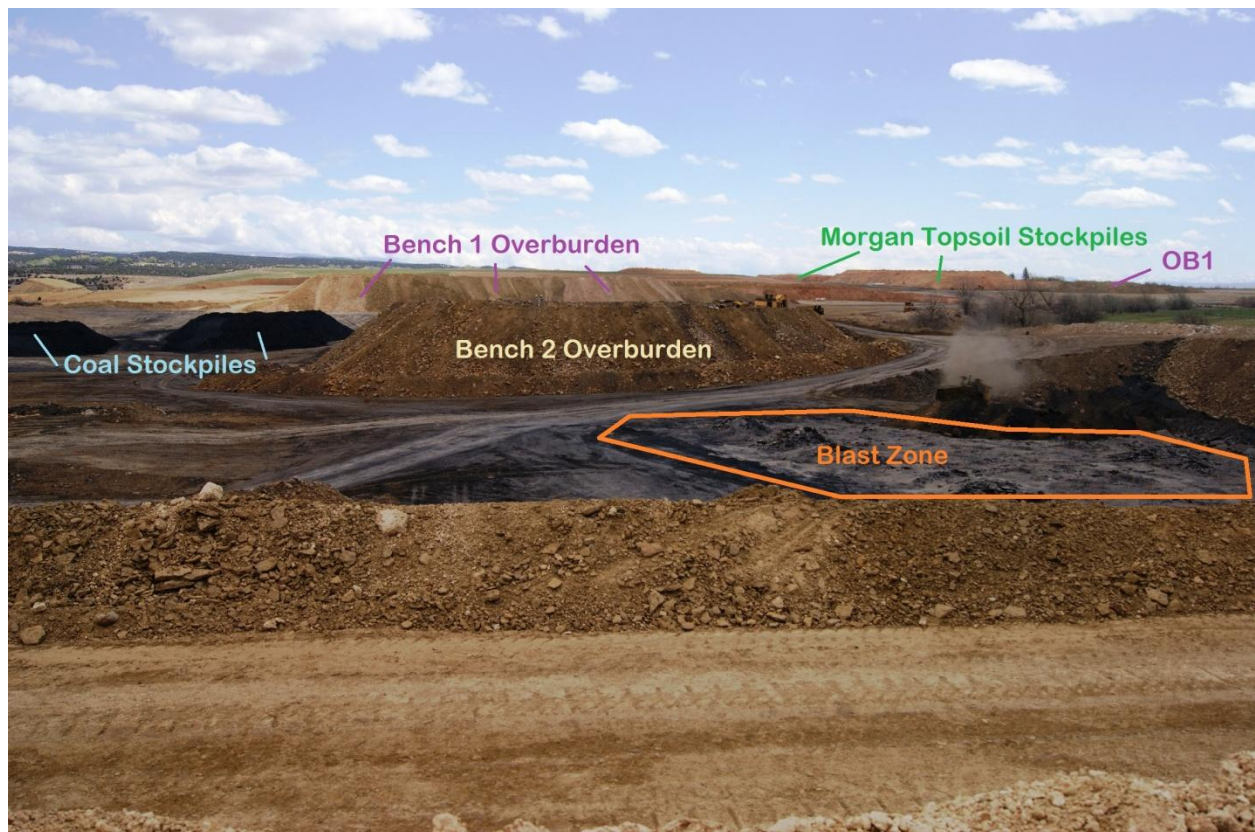
Photo 2 – Various stockpiles located behind the final pit, on WFC property (looking east)

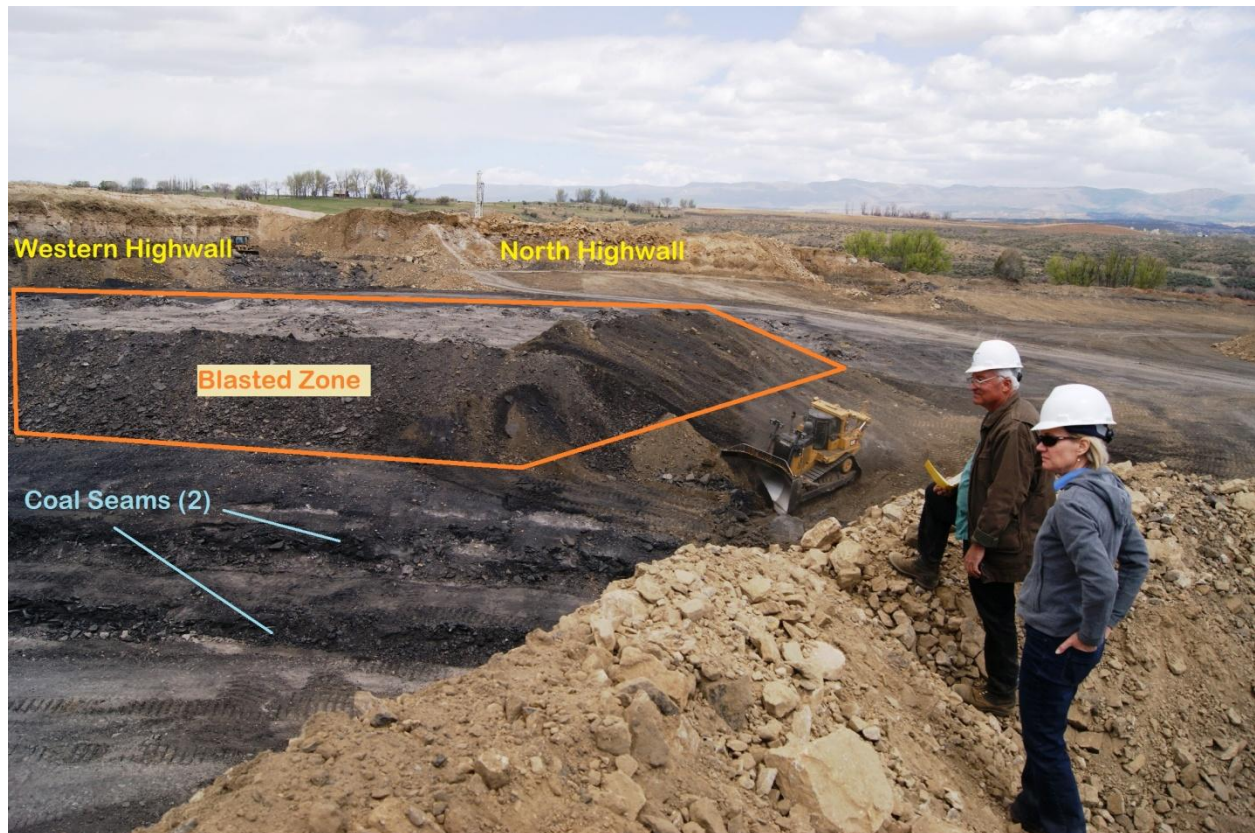
- A blast was detonated at the mine during mid-morning (Photo 3). We were not at the site, but heard the blast, together with the warning and all-clear sirens, from the New Horizon North permit area.

Photo 3 – Operations in final cut on WFC property, looking north

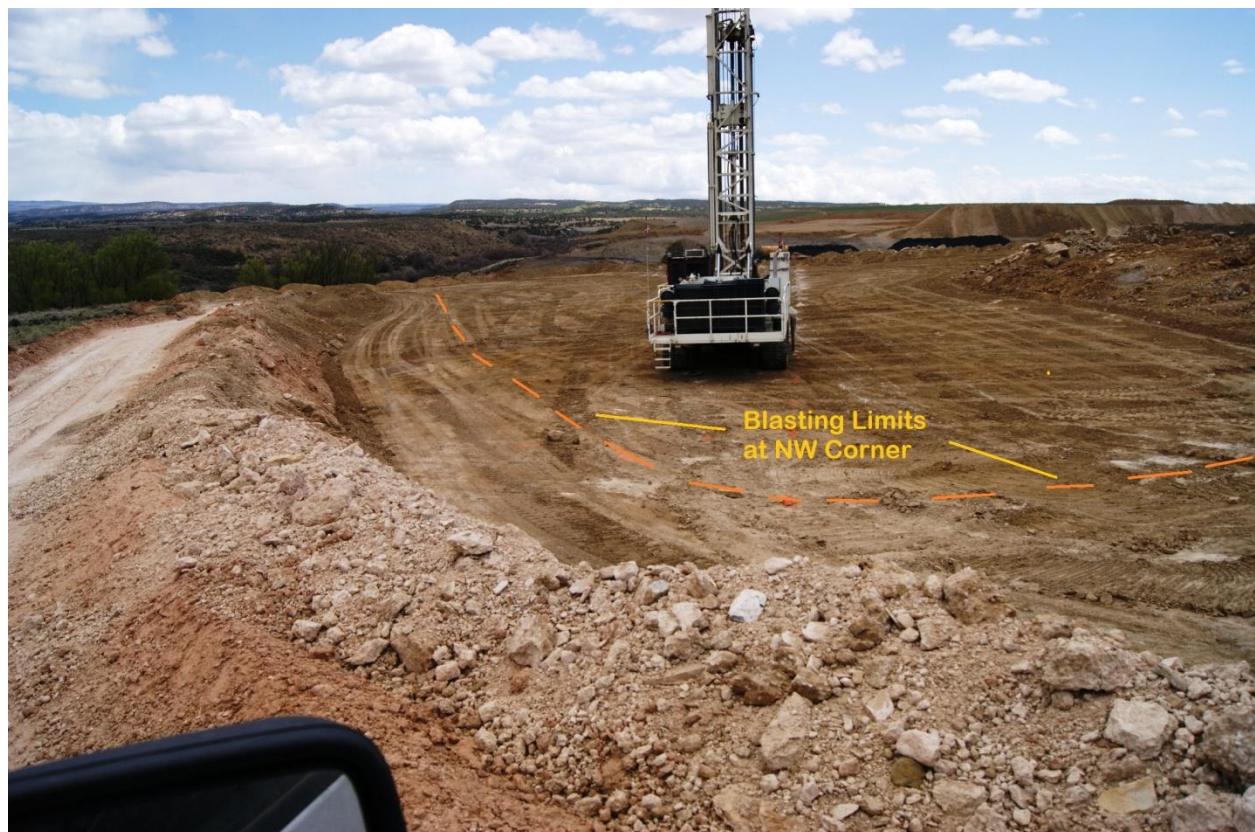
- The drill rig was parked at the time of the inspection, at the northern end of the final cut. The limit of the area that will ultimately be blasted was marked on the exposed surface with orange paint (Photo 4).

Photo 4 – Drill rig and limits of blasting for final cut
