COLORADO DIVISION OF RECLAMATION, MINING AND SAFETY COAL PROGRAM INSPECTION REPORT

Permit Number: C-1981-022 Mine Name: Elk Creek Mine Operator: Oxbow Mining, LLC Operator Address: Mr Jim Kiger P.O. Box 535 3737 Highway 133 Somerset, CO 81434	County: Delta, Gunnison Operation Type: Underground Permit Status: Active Ownership: Federal
	Operator Representative Present: Jim Kiger
Operator Representative Signature: (Field Issuance Only)

Inspection Start Date: May 7, 2013 Inspection Start Time: 13:45 Inspection End Date: May 7, 2013 Inspection End Time: 16:00		Inspection Type: Coal Partial Inspection Inspection Reason: Normal I&E Program Weather: Cloudy	
Joint Inspection Agency: None		Joint Inspection Contacts:	
Post Inspection Agency: None		Post Inspection Contacts:	
Inspector(s): Susan L. Burgmaier	Inspector's Signature:

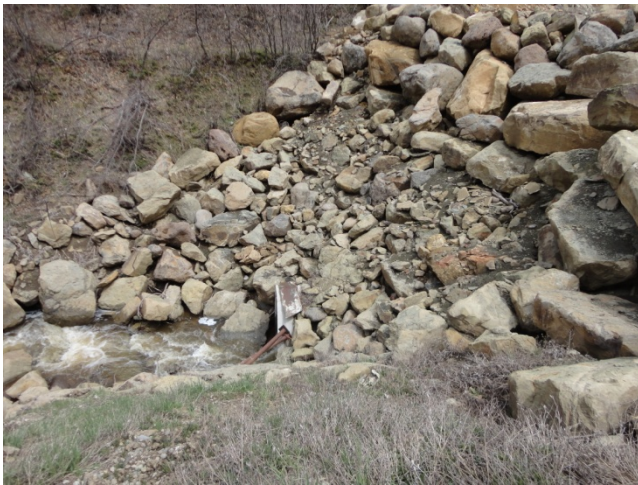
Bear Creek Fan Culvert

Sediment control structures at the Bear Creek fan site were in the midst of repair; straw bales had been removed on the lower part of the drainage channel, and the operator indicated that the bales were to be replaced in the next day or so. Bales in the upper part of the channel were in place, so sediment was being retained on the pad as designed.

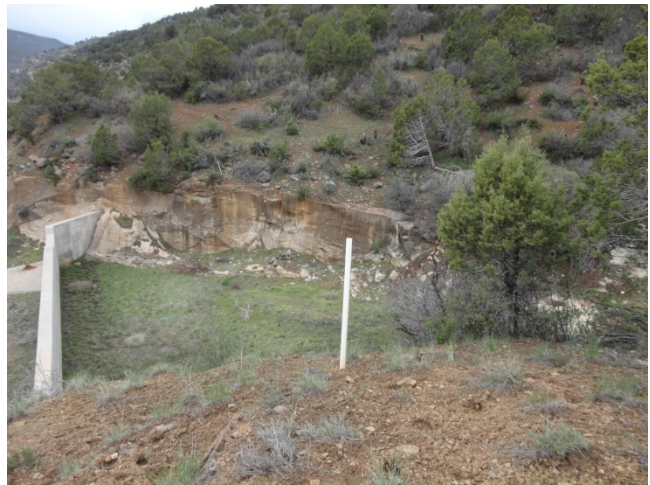
Ponds A, B, and D all held water, but none were discharging. Pond E was dry. Bear Creek and Elk Creek were both running; flow was turbid in both creeks.

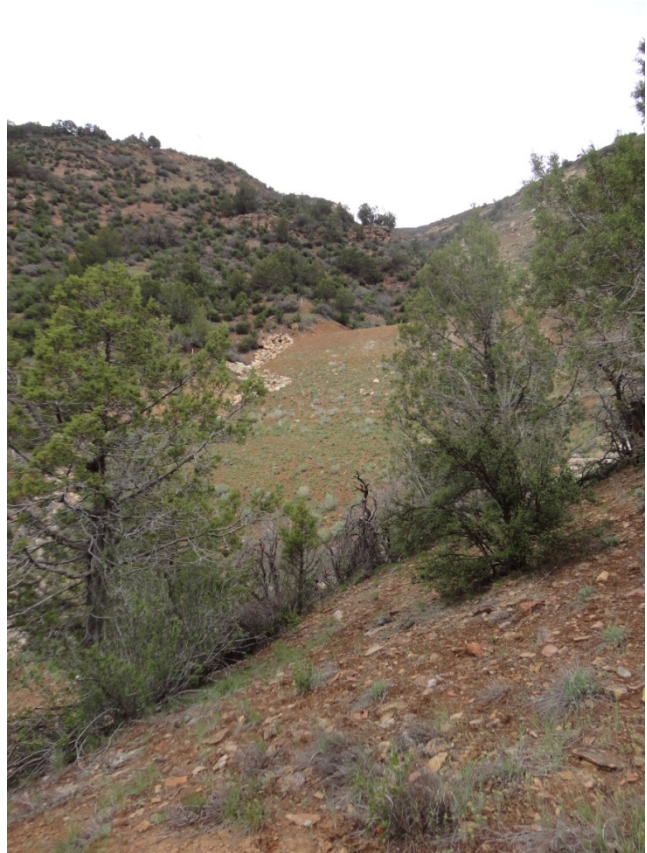
II West Refuse Facility

Grading and compaction were current on the II West Coal Refuse Facility. Gob material was temporarily stockpiled in the yard area north of the West Refuse Facility.
