# COLORADO DIVISION OF RECLAMATION, MINING AND SAFETY COAL PROGRAM INSPECTION REPORT

<b>Permit Number:</b> C-1981-038 <b>Mine Name:</b> Bowie No. 1 Mine <b>Operator:</b> Bowie Resources, LLC <b>Operator Address:</b> Mr Basil Bear P.O. Box 1488 Paonia, CO 81428	<b>County:</b> Delta <b>Operation Type:</b> Underground <b>Permit Status:</b> Active <b>Ownership:</b> Federal
	<b>Operator Representative Present:</b>  None Present
<b>Operator Representative Signature: (Field Issuance Only)</b>

<b>Inspection Start Date:</b> May 8, 2013 <b>Inspection Start Time:</b> 09:00 <b>Inspection End Date:</b> May 8, 2013 <b>Inspection End Time:</b> 14:00		<b>Inspection Type:</b> Coal Complete Inspection <b>Inspection Reason:</b> Normal I&E Program <b>Weather:</b> Raining	
<b>Joint Inspection Agency:</b>  None		<b>Joint Inspection Contacts:</b>	
<b>Post Inspection Agency:</b>  None		<b>Post Inspection Contacts:</b>	
<b>Inspector(s):</b>  Susan L. Burgmaier	<b>Inspector's Signature:</b>

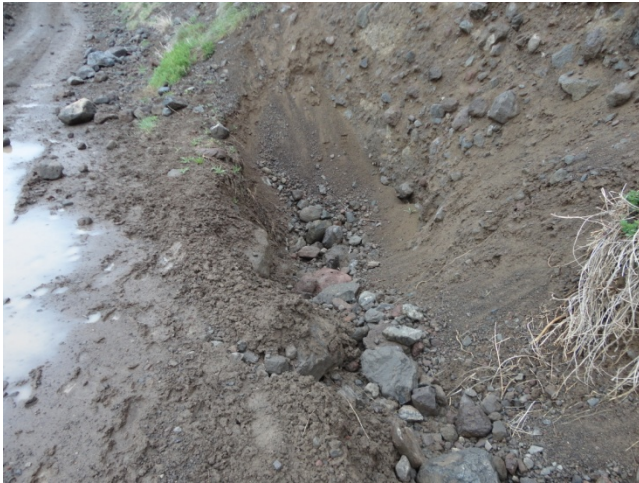
The culvert on the West Mine haul road, near the south end of the guardrail section, was blocked on the inlet side. Water was standing on the road surface. As soon as the road is dry enough to bring in equipment, this culvert will need to be cleared.

Culvert inlet on West Mine Haul Road

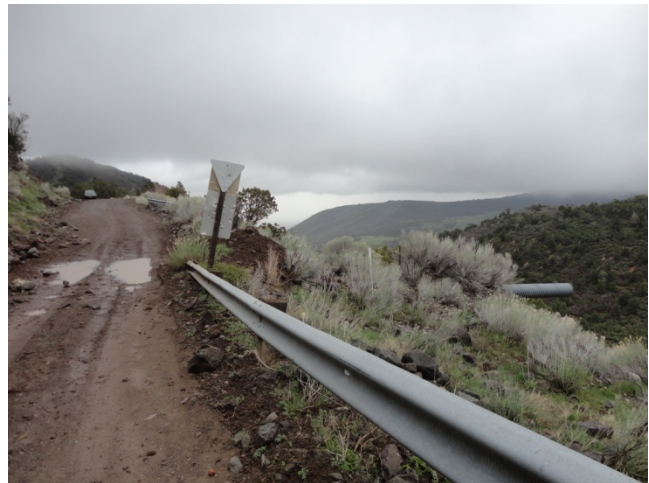
Standing water at location of blocked West Mine culvert

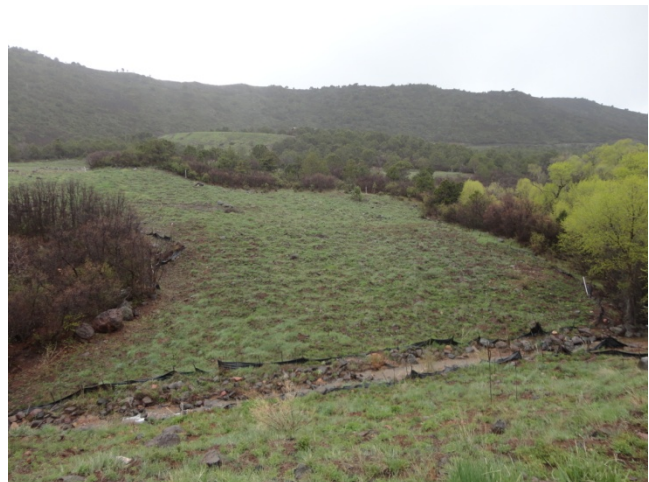
The silt fences along the East Mine haul road and along Stevens Gulch in the ROM area need to be repaired or replaced. The operator indicated that this project would be completed by temporary summer crews, expected to begin in early June.

Silt fence at ROM area on Stevens Gulch

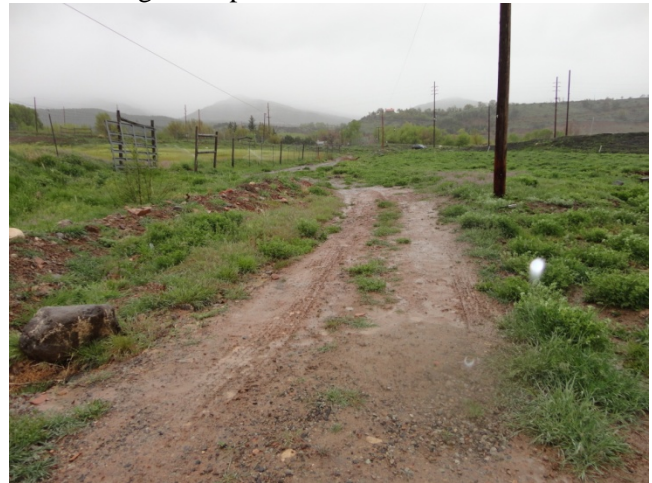
The sediment control berm at the end of the gravel storage area on the west side of the eastern portion of the loadout was not in place. It appeared that it had been worn down by travel on the adjacent roadway. The operator indicated that the neighboring landowner may have removed the berm to facilitate access to their property, and that the berm would be repaired as soon as possible. Water was running down the gravel area and pooling along the remnants of the berm.

Gravel storage area berm location (loadout)

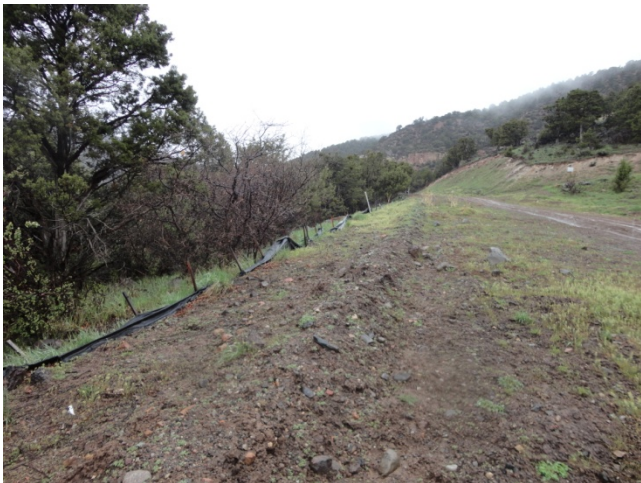
East Mine haul road silt fence

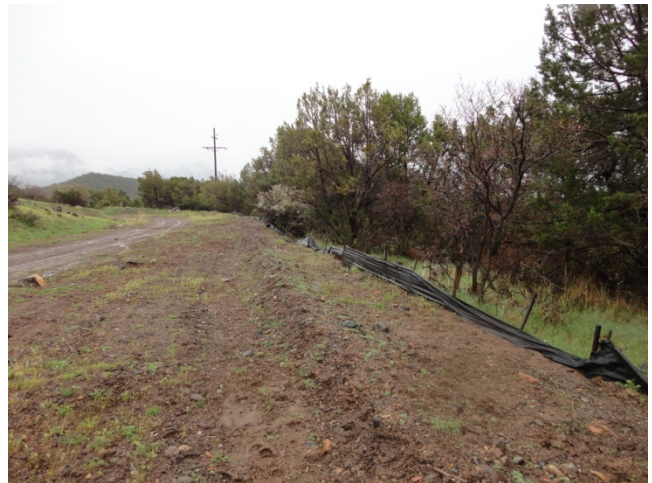
East Mine haul road silt fence

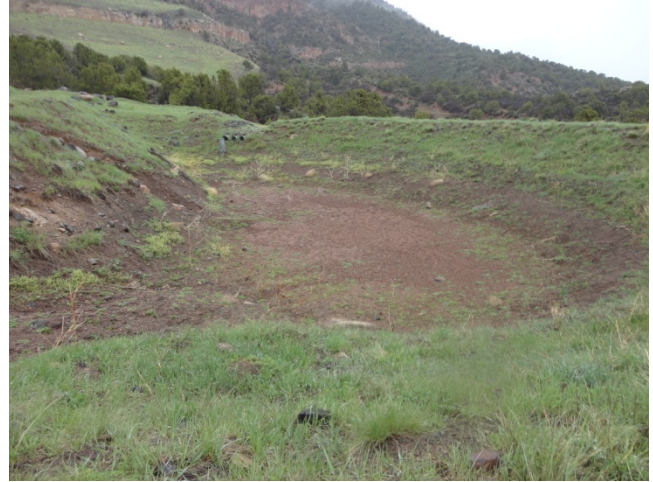
Road ditches at the East Mine were generally in good condition. Running water was not scouring along the ditch, and velocities were being controlled by sediment basins and straw bale check dams. One section of straw bale along the East Mine haul road, near the West Ridge sediment pond, will need to be replaced (only about 6" of straw remains). The operator indicated that this would also be done by temporary crews.

Straw bales in need of repair along East Mine road

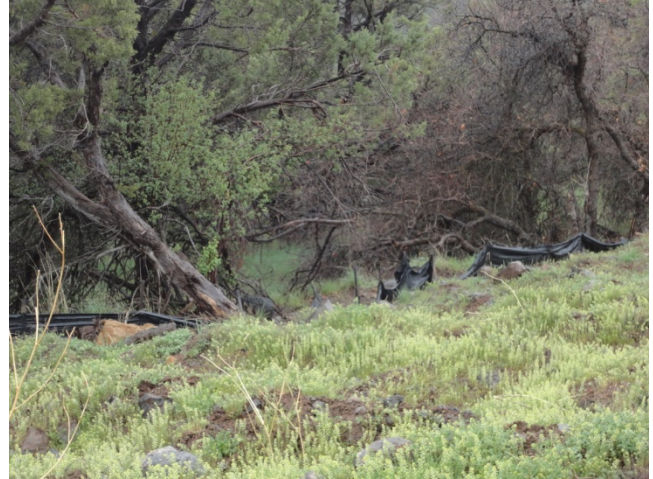
The outlet of the road drainage culvert that brings water from the west side to the east side of the road, near the West Ridge refuse area, showed signs of downcutting. This outfall was discussed with the operator after the inspection. He indicated that the ditch would either be repaired or the culvert removed. Before any repairs or modifications are implemented, the approved permit application should be reviewed and revised if necessary.

West Ridge refuse area and lower ditch to pond
