COLORADO DIVISION OF RECLAMATION, MINING AND SAFETY COAL PROGRAM INSPECTION REPORT

Permit Number: C-1981-033 Mine Name: Bear Mine Operator: Bear Coal Company, Inc. Operator Address: Mr Daniel Bear 1326 War Emblem Lane Rock Springs, WY 82901 **County:** Gunnison **Operation Type:** Underground **Permit Status:** Permanent Cessation **Ownership:** Federal

Inspection Start Date: May 7, 2013 Inspection Start Time: 16:00 Inspection End Date: May 7, 2013 Inspection End Time: 14:30			Inspection Type: Coal Partial Inspection Inspection Reason: Normal I&E Program Weather: Raining		
Joint Inspection Agency:		Joint Inspection Contacts:			
None					
Post Inspection Agency:		Post Inspection Contacts:			
None					
Inspector(s):	Inspector's Signature:		nature: Signature Date:		
Susan L. Burgmaier	Surand	Brug	May 8, 2013

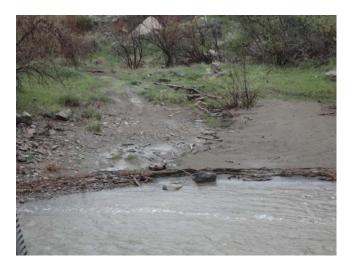
The sediment pond was muddy, but not holding water. The treatment pond held water and was discharging the North Fork of the Gunnison River. The Edwards Portal seep was flowing to the treatment pond.

Seep flowing to North Fork of the Gunnison

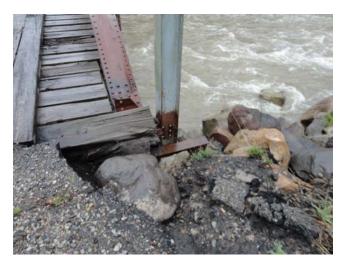
Number of <u>Partial</u> Inspection this Fiscal Year: 9 Number of <u>Complete</u> Inspections this Fiscal Year: 3 The bridge that provides access to the site is in very poor condition, and is likely unsafe for vehicular travel. Large holes (triangular, 3' x 3' on southeast corner) have developed on the east end of the bridge, where the river bank is eroding away from the structure. The hole on the southeast corner is large enough for a vehicle tire to become lodged. Similar holes are developing on the west end, though not as large. Planking across the bridge is rotting out, especially on the east end.

Northeast corner of bridge abutment

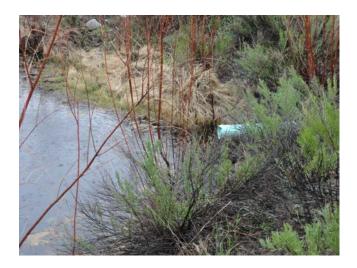
Treatment Pond
