COLORADO DIVISION OF RECLAMATION, MINING AND SAFETY COAL PROGRAM INSPECTION REPORT

Permit Number: C-1980-007 Mine Name: West Elk Mine Operator: Mountain Coal Company, LLC Operator Address: Ms Kathleen G Welt P.O. Box 591 Somerset, CO 81434	County: Delta, Gunnison Operation Type: Underground Permit Status: Active Ownership: Federal
	Operator Representative Present: None
Operator Representative Signature: (Field Issuance Only) None – Issued from Denver Office

Inspection Start Date: April 19, 2013 Inspection Start Time: 12:24 Inspection End Date: April 19, 2013 Inspection End Time: 12:27		Inspection Type: Aerial Inspection Inspection Reason: Normal I&E Program Weather: Clear	
Joint Inspection Agency: None		Joint Inspection Contacts: None	
Post Inspection Agency: None		Post Inspection Contacts: None	
Inspector(s): James R. Stark Harry B. Ranney	Inspector's Signature:

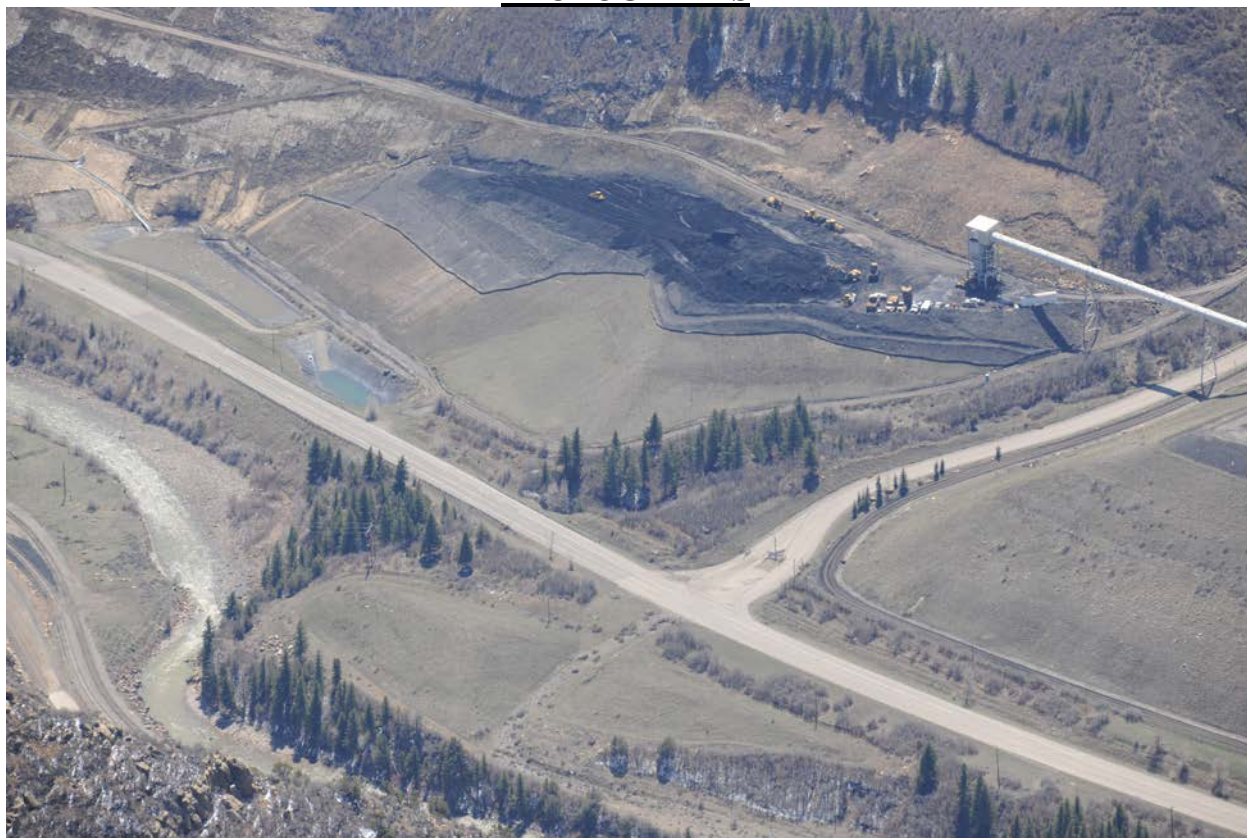
- The east cell of the RPE Pond was full and there was a small amount of water in the west cell. Both pond embankments were well vegetated and stable and no erosional problems were noted. West Elk is currently using the water from the RPE pond in the processing plant. They have a pump on the edge of the east cell and pump water through overland pipe.

PROCESSING WASTE (cont.) - The reclaimed slopes on the RPE were well vegetated and stable and no erosional problems were noted. There were numerous piles of uncompacted, ungraded refuse but the operator appeared to be doing work on grading and compacting this refuse. They were also loading some of this refuse and hauling it to the RPEE.

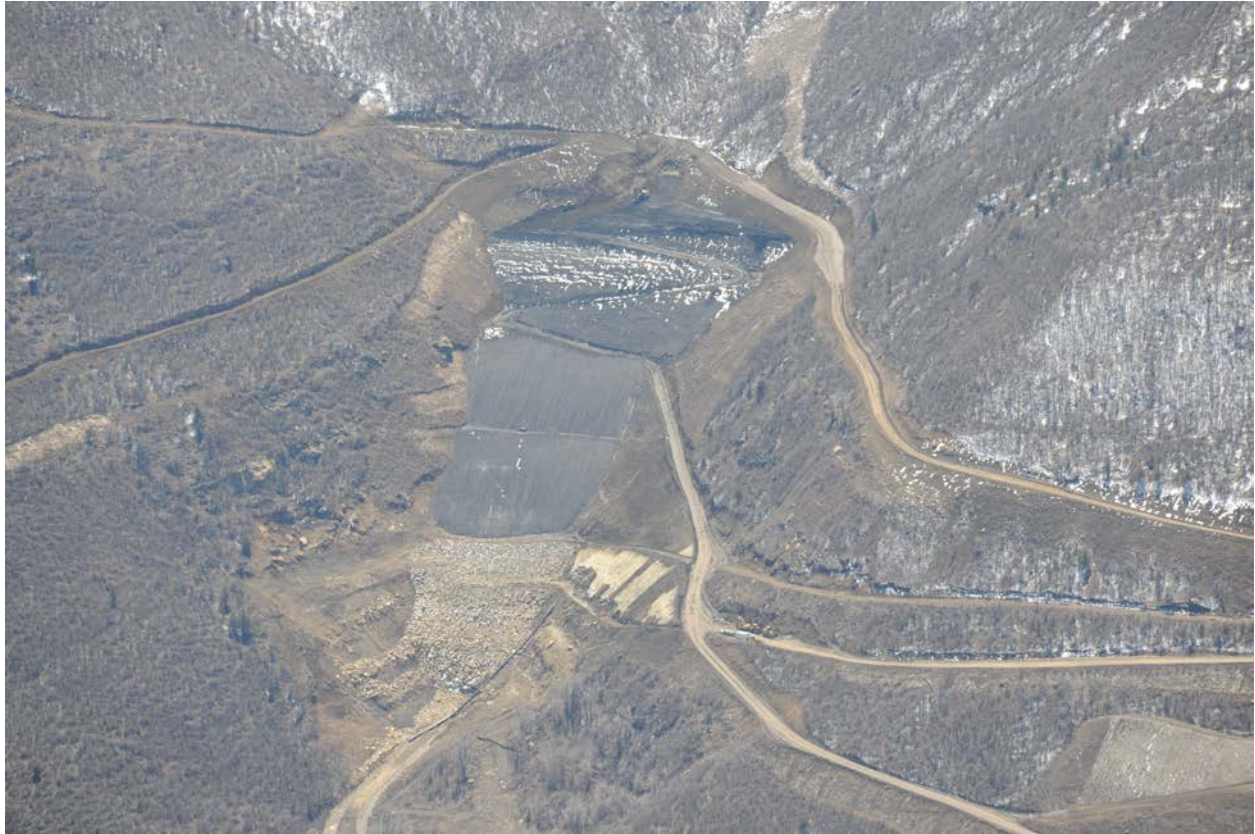
- The first two lifts of the RPEE were well graded and stable and no erosional problems were noted. West Elk is waiting to cover these two lifts until they determine if they can place more refuse here. The third lift also appears to be complete with the exception of the haul road, which runs through this lift. The third lift is also stable and well graded. West Elk was currently working on dumping, spreading and compacting refuse on the fourth lift. There were a few small piles of refuse that need to be spread and compacted but they were actively working the pile. The underdrain extends up the draw approximately 50 feet from where refuse is being spread and compacted. As the pile progresses up the draw, West Elk completes additional sections of the underdrain. The Rock and colluvial buttresses of the RPEE were also stable at the time of the inspection.

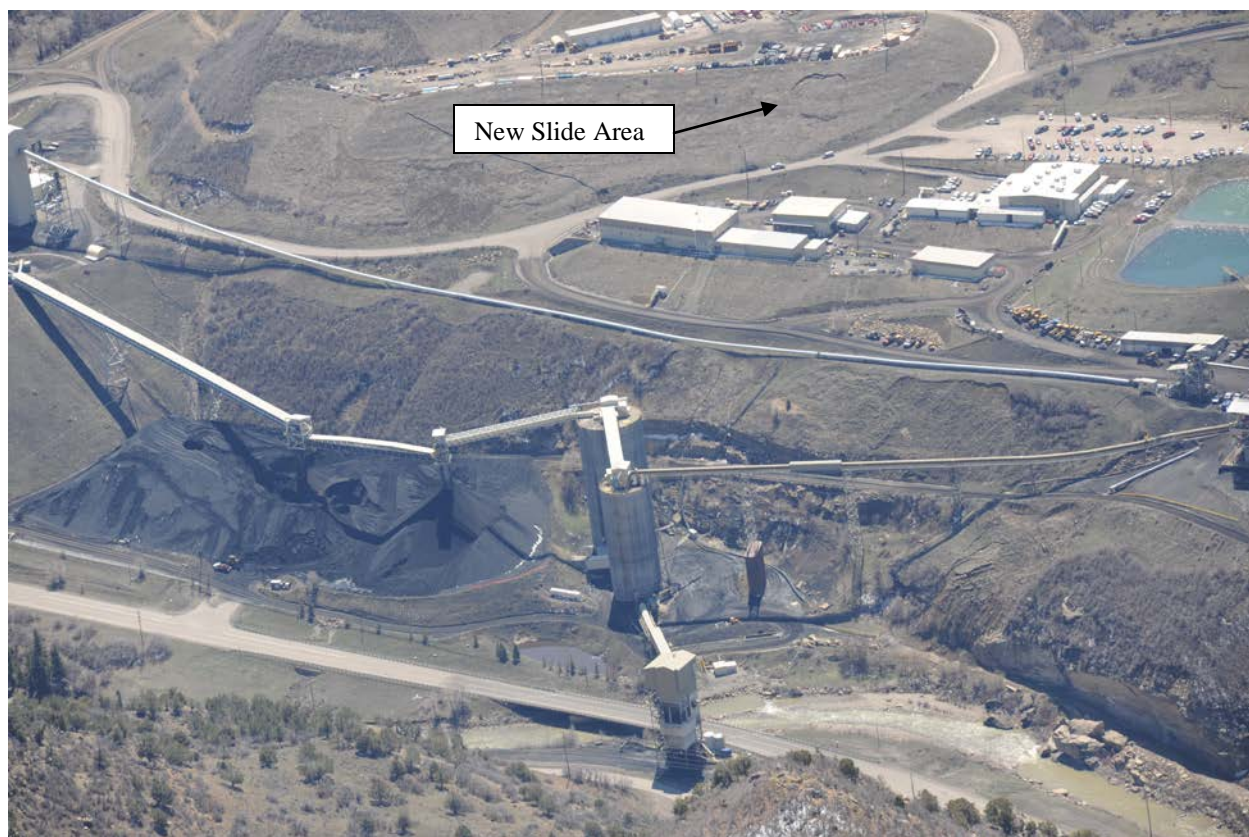
Facilities Area

- A small slide has occurred south of the facilities area just below the large material storage bench below the mine portals. The slide is less than one acre in area. West Elk will remediate this slide once conditions on the ground allow.

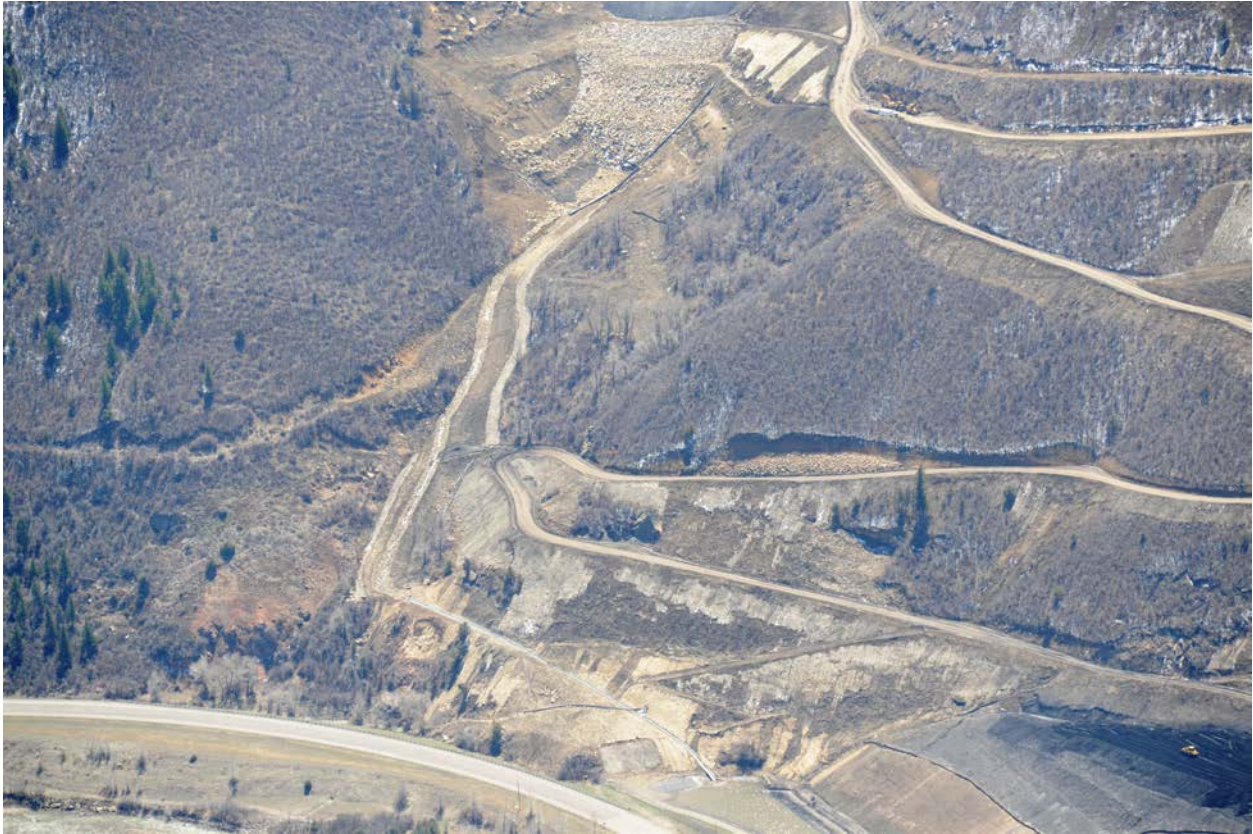
HR-1 Slide area

- The HR-1 slide area had some movement of both the coconut fiber matting and the underlying topsoil. Some of this material washed down to the base of the slide remediation area. None of the topsoil material went off site and none of the material went into the RPE pond. The movement was only on the surface and the remediated slide area remains stable. West Elk will salvage this material and either stockpile it or replace it. This will be done once the conditions on the ground allow, as it is currently very wet, with snow and rain still falling.
