## COLORADO DIVISION OF RECLAMATION, MINING AND SAFETY COAL PROGRAM INSPECTION REPORT

| <b>Permit Number:</b> C-2010-089<br><b>Mine Name:</b> New Horizon North Mine<br><b>Operator:</b> Western Fuels-Colorado, LLC<br><b>Operator Address:</b><br>Mr. David G. Anderson<br>12050 N. Pecos St., Suite 100<br>Westminster, CO 80234 | <b>County:</b> Montrose<br><b>Operation Type:</b> Surface<br><b>Permit Status:</b> Active<br><b>Ownership:</b> Private |

| <b>Inspection Start Date:</b> May 1, 2013<br><b>Inspection Start Time:</b> 08:30<br><b>Inspection End Date:</b> May 1, 2013<br><b>Inspection End Time:</b> 11:30 | <b>Inspection Type:</b> Coal Partial Inspection<br><b>Inspection Reason:</b> Normal I&E Program<br><b>Weather:</b> Windy |

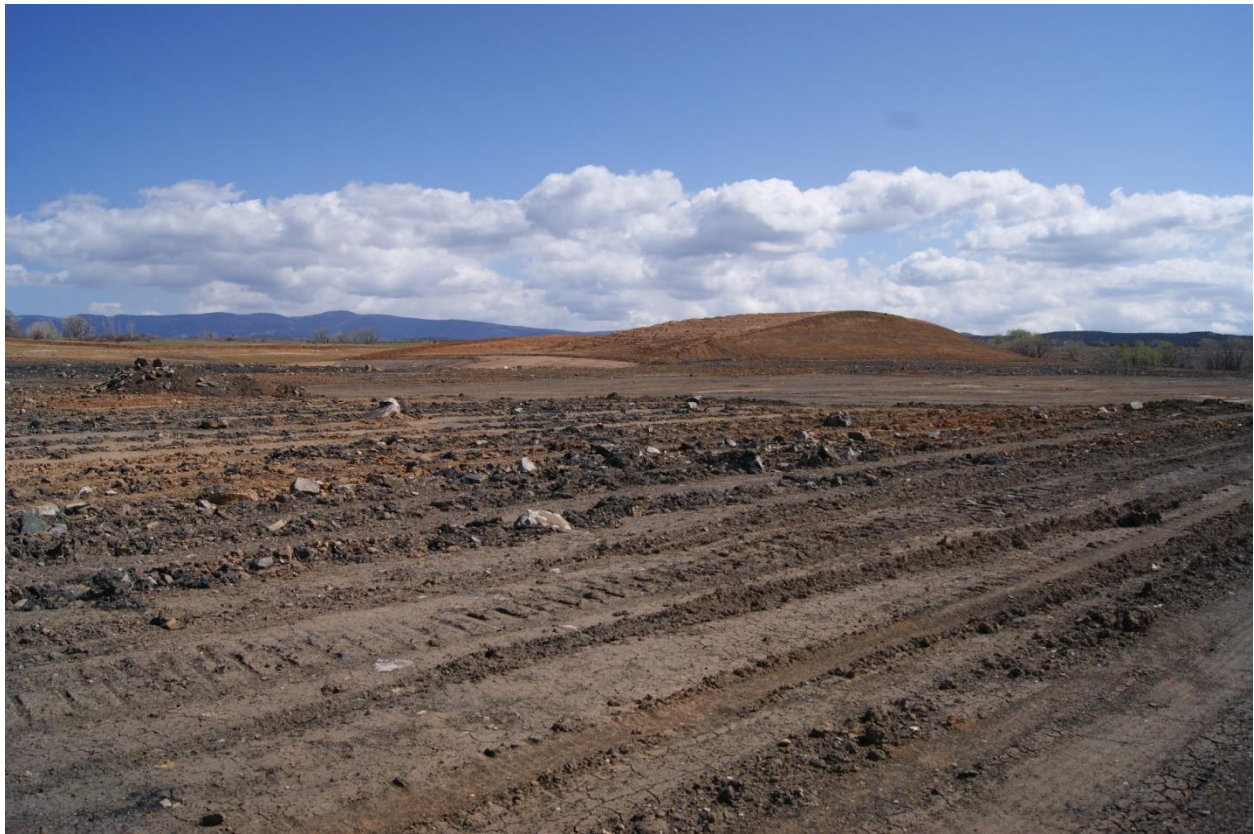
- Mr. Gubka said that WFC is continuing to work through the emissions modeling process with the Air Pollution Control Division of the CDPHE as a necessary step in being granted an emissions permit for the mine.
- The area from which topsoil was stripped has been roughened by ripping with a bulldozer (Photo 1). This was done with the goal of reducing any potential erosion of the area by wind or water.
- WFC is the owner of the property immediately south of the permit area. This area was previously mined by the Edna Coal Company (Navajo Mine) and Peabody Coal Company

Photo 1 – Surface roughening, looking NE toward REC stockpile

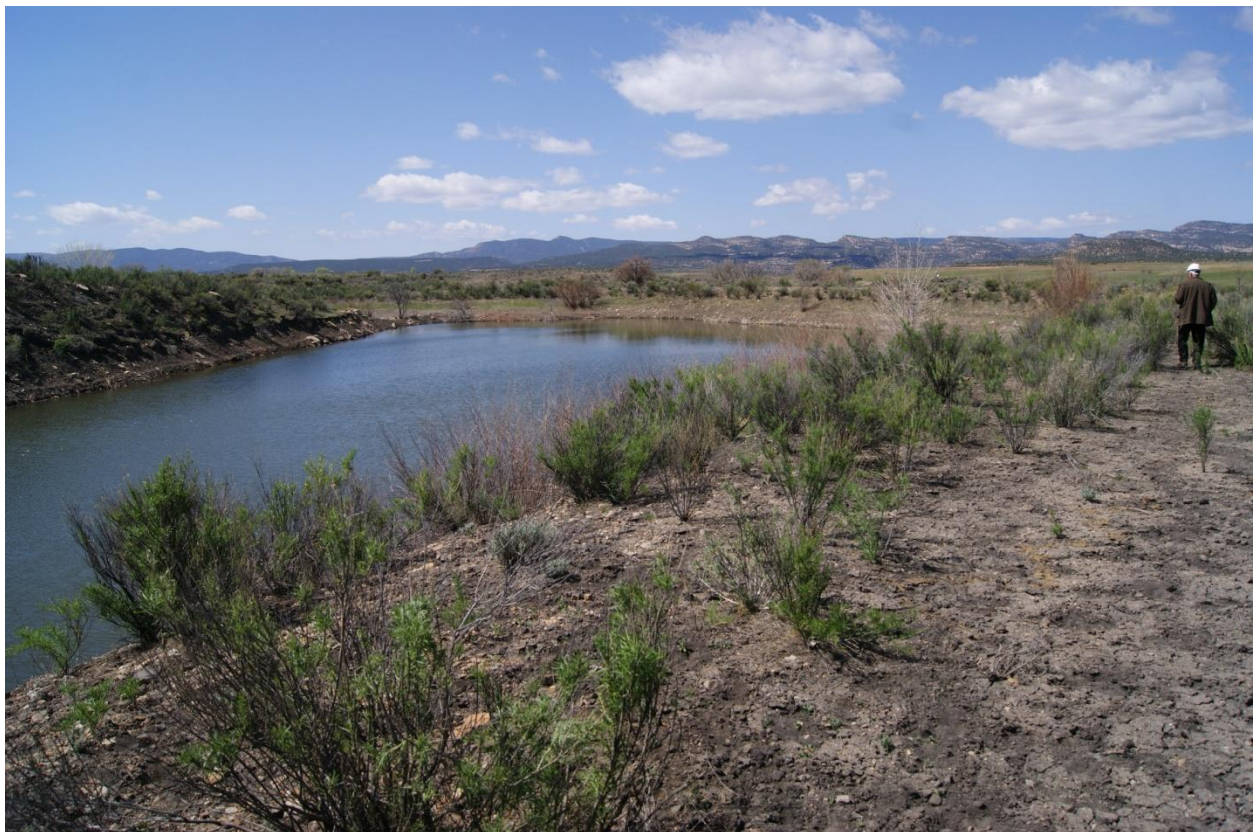
(Nucla Mine). A sediment pond (001) on this property (Photo 2) was approved as a permanent feature, and WFC may use water from this pond to perform dust control at the New Horizon North Mine. We walked along the pond's dam, and Mr. Gubka showed us the location at the southern end where the company would potentially install a pump. The tentative plan is for water to be pumped out of this pond to be piped northward (a distance of approximately 0.5 miles) along an existing two-track road. The pipeline would then cross beneath AA Road into the permit area.

Photo 2 – Nucla Mine Pond 001, looking south

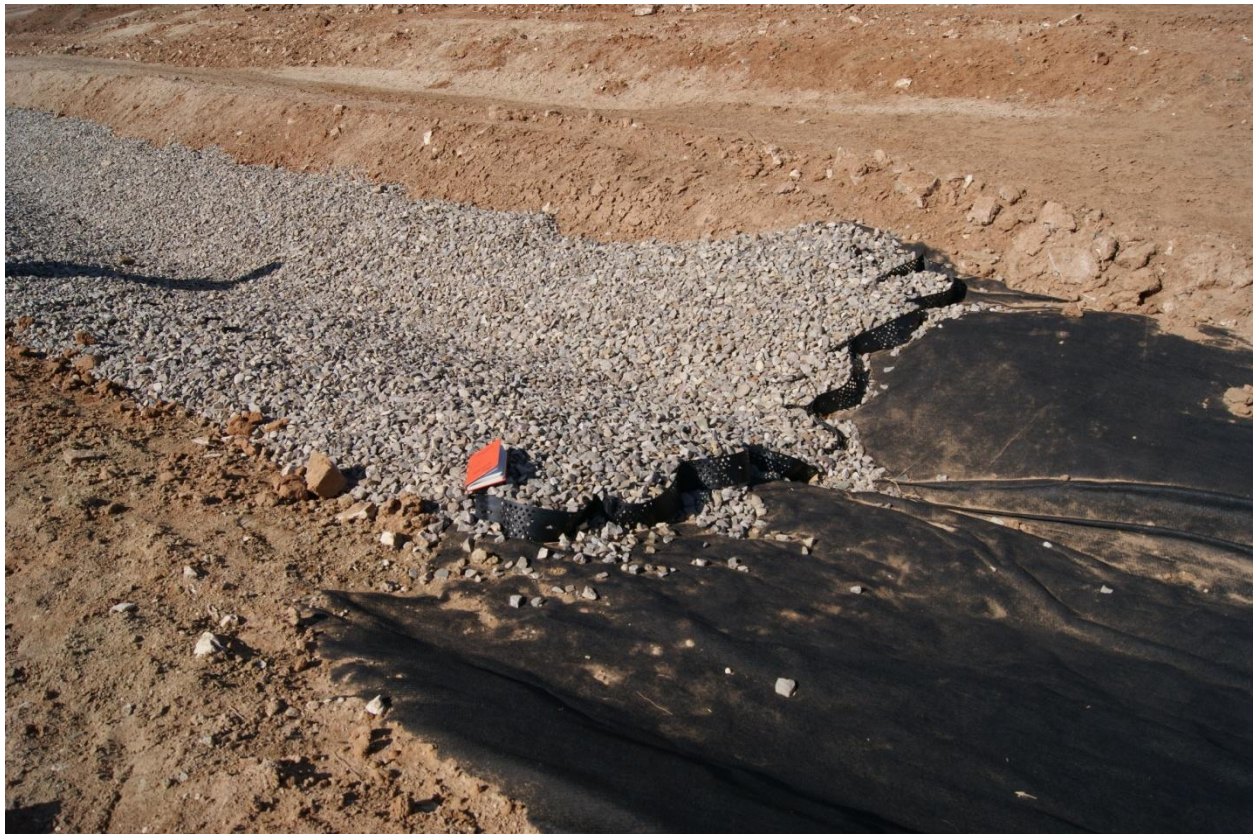
- Construction of these ditches was also accomplished in 2012. The original design (found in Appendix 2.05.3(4)-1 of the PAP) called for a flat-bottom ditch, rip-rapped where the gradient was greater than 2 percent. The ditches were constructed in a V-bottom configuration, and are lined throughout most of their length (Photo 3). Lining consists of a base layer of woven geotextile, followed placement of a celled material approximately four inches deep. The cells were then filled with crushed gravel that appears to have been washed. For the steeper segments, where the ditches enter the pond, further protection is provided by the installation of 36-inch corrugated metal half-pipes (Photo 4).

- Field measurements made on the West ditch showed that the lined sections are approximately 9 feet wide, with the depth varying between 12 and 16 inches. The run-down into the SW corner of the pond was 8%, while the East ditch's drop into the pond's SE corner was sloped at 26%.

Photo 3 – V-Bottom Ditch Lining

- Because the construction of the ditches is different than what was originally approved, updated information will need to be included in the PAP. ***Please submit an application for a Technical Revision to the permit to address the as-built configuration of Ditches NHN-001-East and -West.***

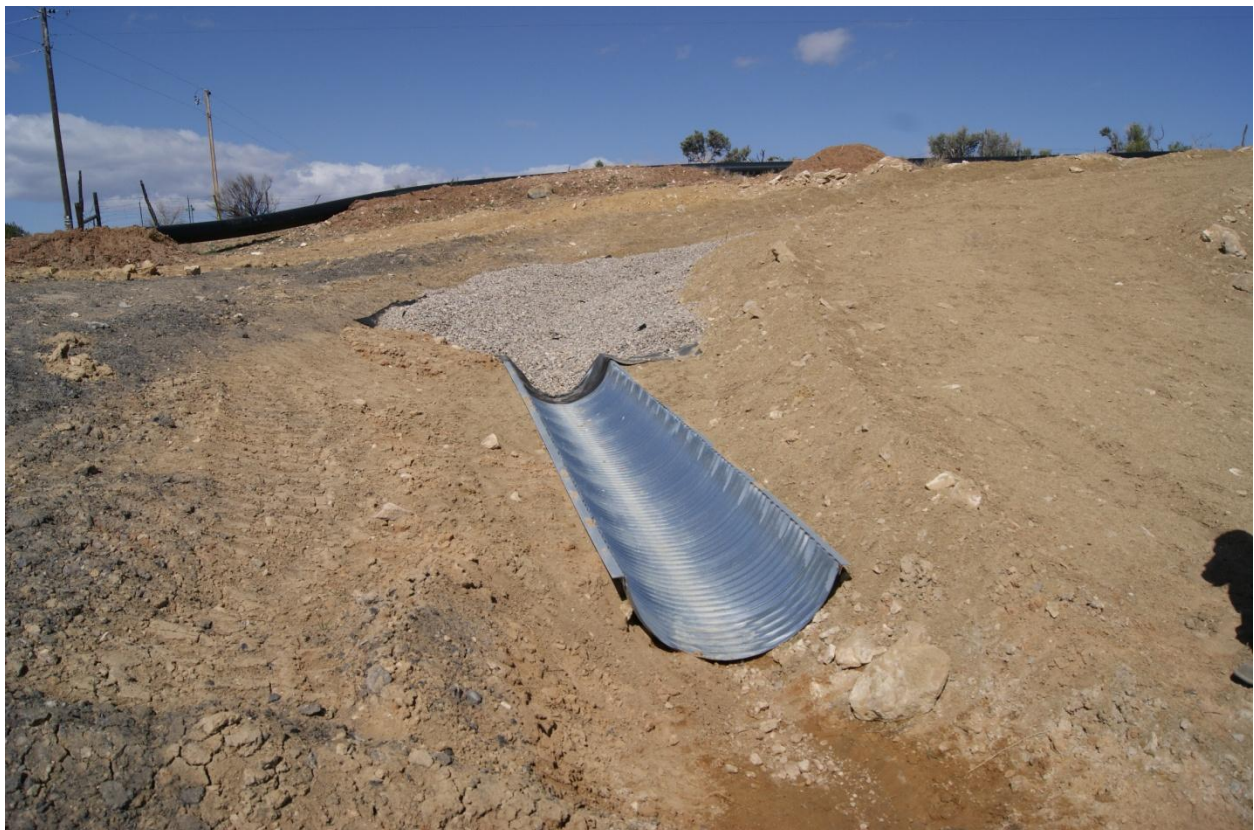
Photo 4 – 36-inch half-pipe run-down – SW corner of Pond NHN-001

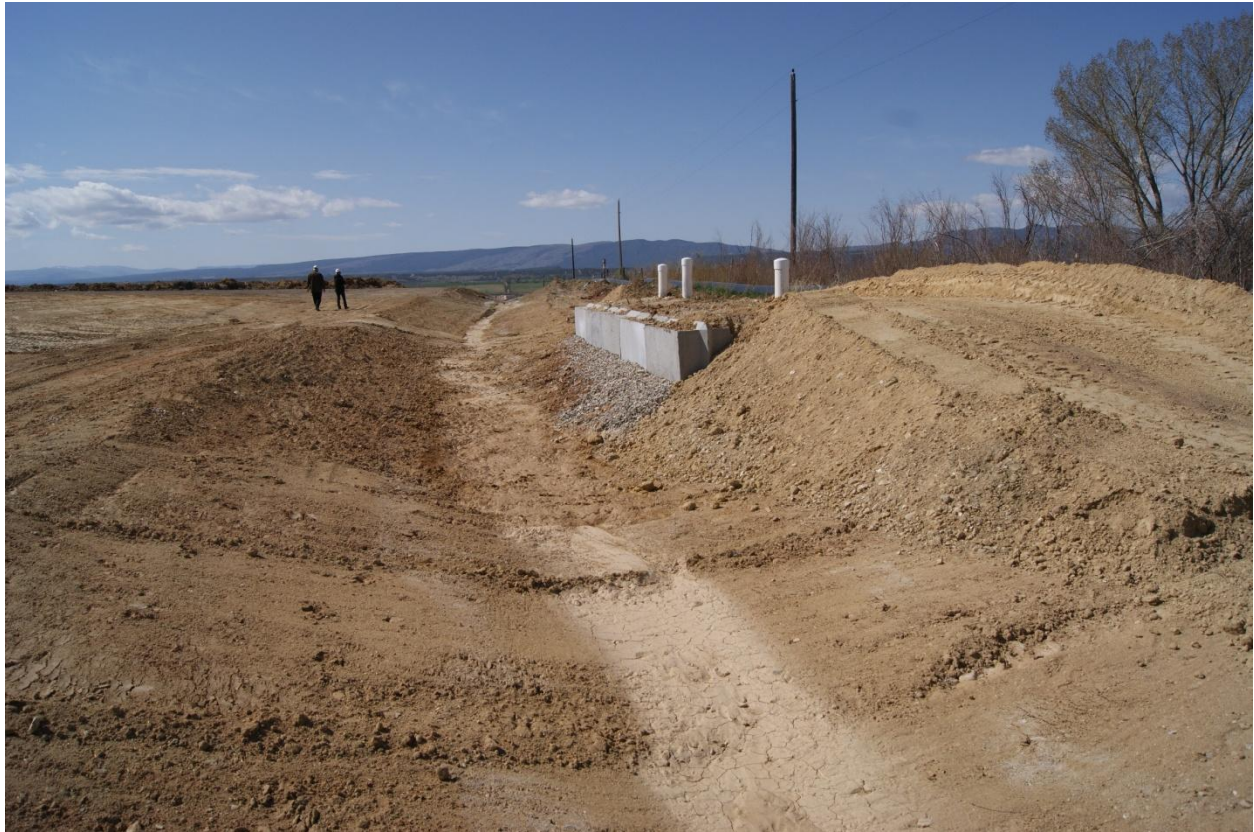
- The three Monitoring Wells located along the western permit boundary were left somewhat exposed once the surrounding topsoil had been stripped away. WFC has subsequently built-up the area immediately adjacent to the wells, both for protection of the wells and to enable access for sampling (Photo 5).

Photo 5 – Monitoring wells, and flatter portion of Ditch NHN-001-West, looking south

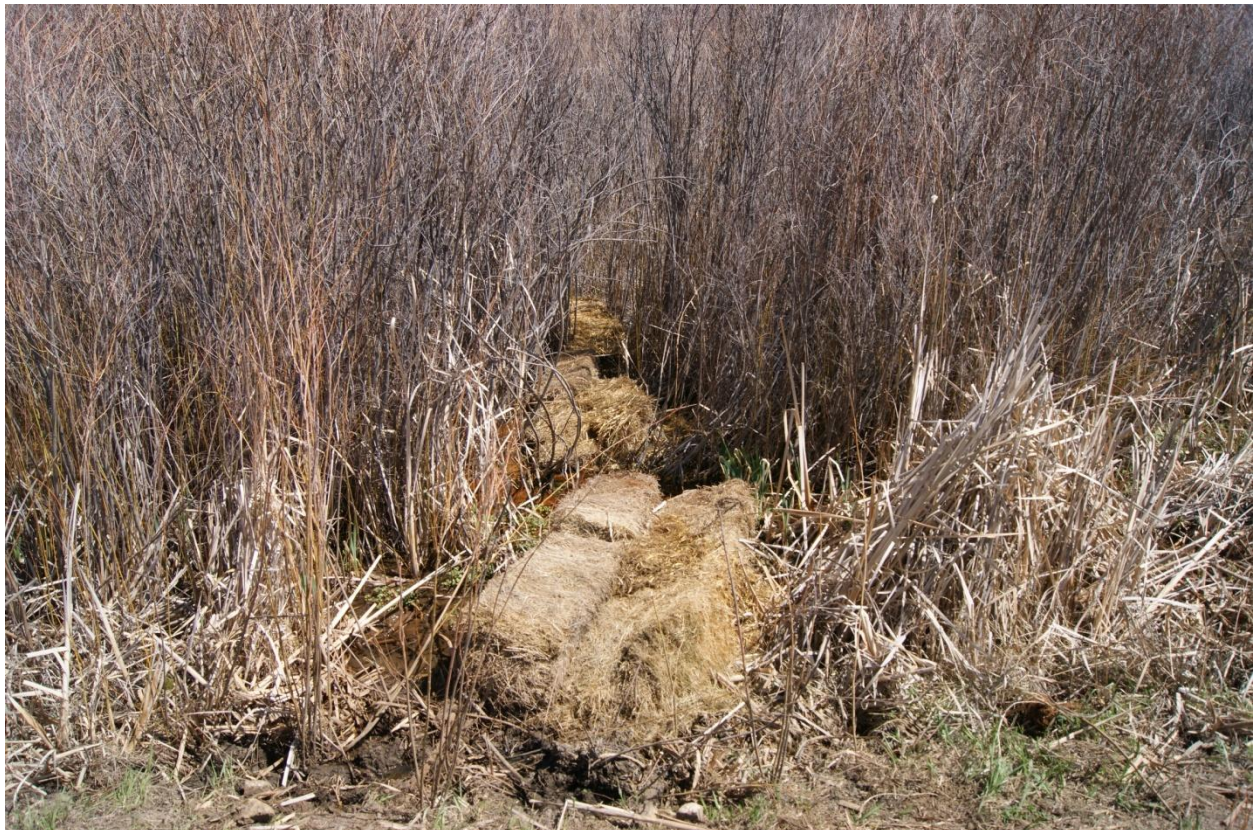
- The southern portion of the permit area was previously mined with Peabody's Nucla Mine. The spoil spring for this area is located approximately 0.23 miles south of AA Road, due south of Pond NHN-001. Mr. Gubka showed us the spring's location on our way to the old Pond 001. The flow is expressed along the northern side of a west-east trending drainage. Cattails and other water-loving plants are present, and although no single point source can be identified, the operator has attempted to condense the flow to a single stream with the use of straw bales, for the purpose of sampling (Photo 6).

Photo 6 – Spoil Spring

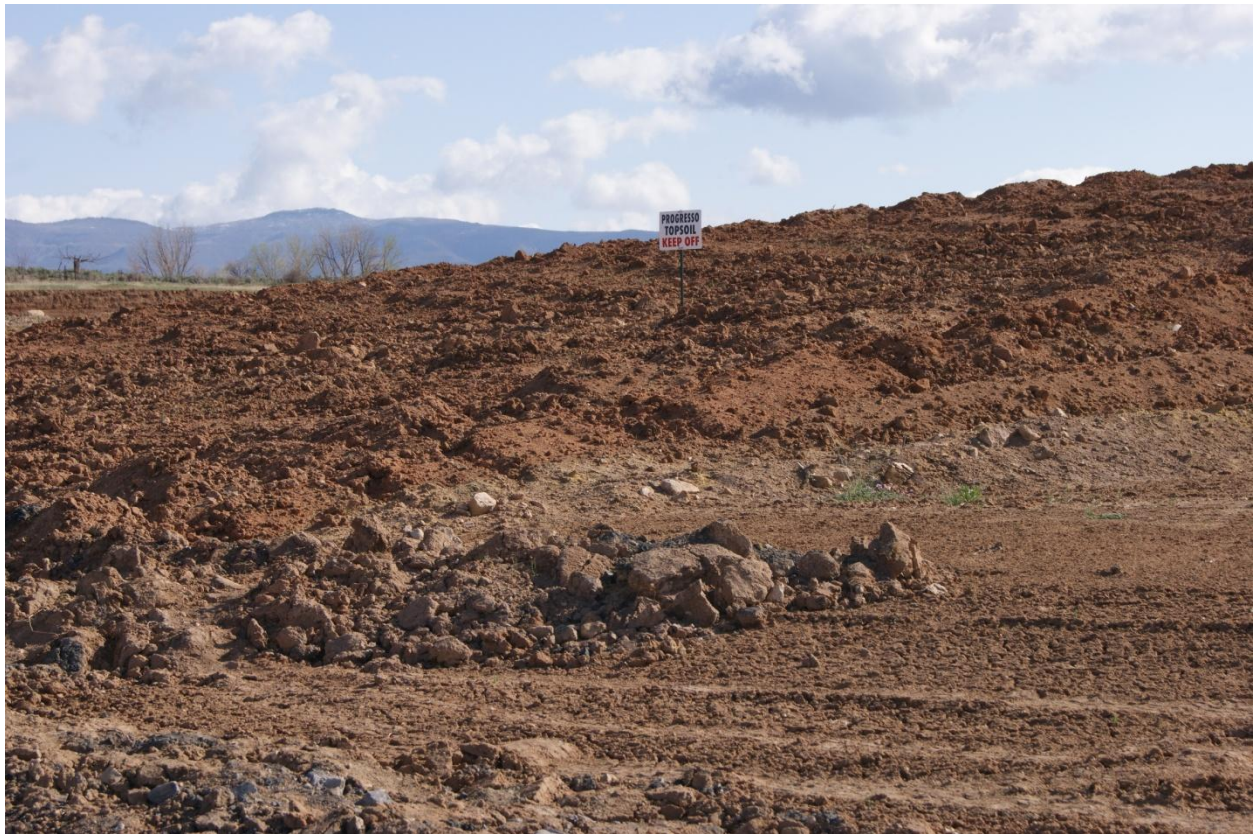
- Each of the topsoil stockpiles was posted with signs identifying its contents and warnings to "Keep Off" (Photo 7).
- Pile surfaces were roughened to combat erosion and encourage the development of vegetative cover.

Photo 7 – Topsoil sign – Progresso soil

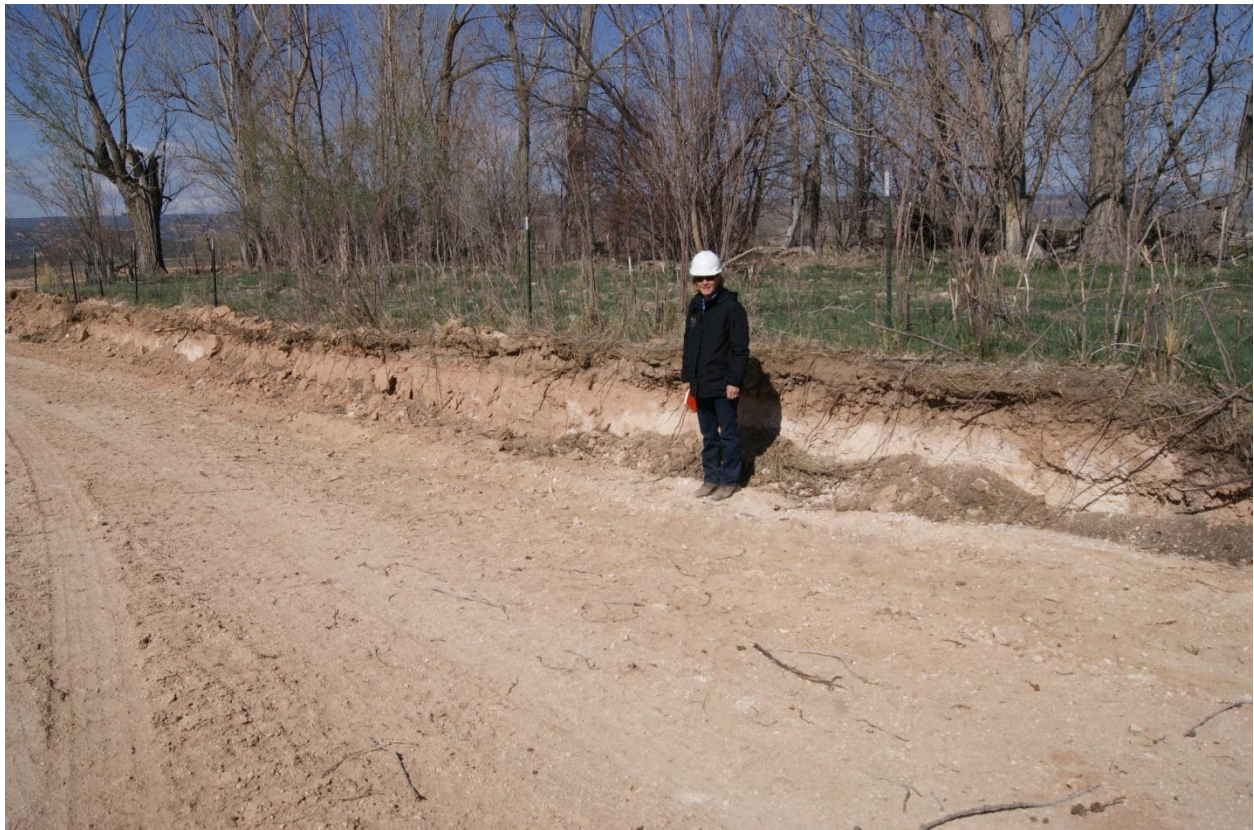
- Along the northern edge of the area from which soil has been salvaged, we were able to observe the variability in topsoil thickness. Soils are thin to non-existent atop the rocky area toward the eastern side of the permit area, but the thickness increased to as much as three feet (estimated) in parts of the central and western portions (Photo 8).

Photo 8 – Topsoil depth – northern limit of area that has been stripped
