**COLORADO DIVISION OF RECLAMATION, MINING AND SAFETY  
COAL PROGRAM INSPECTION REPORT**

<b>Permit Number:</b> C-1980-007 <b>Mine Name:</b> West Elk Mine <b>Operator:</b> Mountain Coal Company, LLC <b>Operator Address:</b> Ms Kathleen G Welt P.O. Box 591 Somerset, CO 81434	<b>County:</b> Delta, Gunnison <b>Operation Type:</b> Underground <b>Permit Status:</b> Active <b>Ownership:</b> Federal
<b>Operator Representative Present:</b>  Kathy Welt and Jessica Loveland	
<b>Operator Representative Signature: (Field Issuance Only)</b>  N/A – Report Issued from Denver Office

<b>Inspection Start Date:</b> April 30, 2013 <b>Inspection Start Time:</b> 08:00 <b>Inspection End Date:</b> April 30, 2013 <b>Inspection End Time:</b> 12:30	<b>Inspection Type:</b> Coal Partial Inspection <b>Inspection Reason:</b> Normal I&E Program <b>Weather:</b> Clear
<b>Joint Inspection Agency:</b>  None	<b>Joint Inspection Contacts:</b>  None
<b>Post Inspection Agency:</b>  None	<b>Post Inspection Contacts:</b>  None
<b>Inspector(s):</b>  James R. Stark	<b>Inspector's Signature:</b>

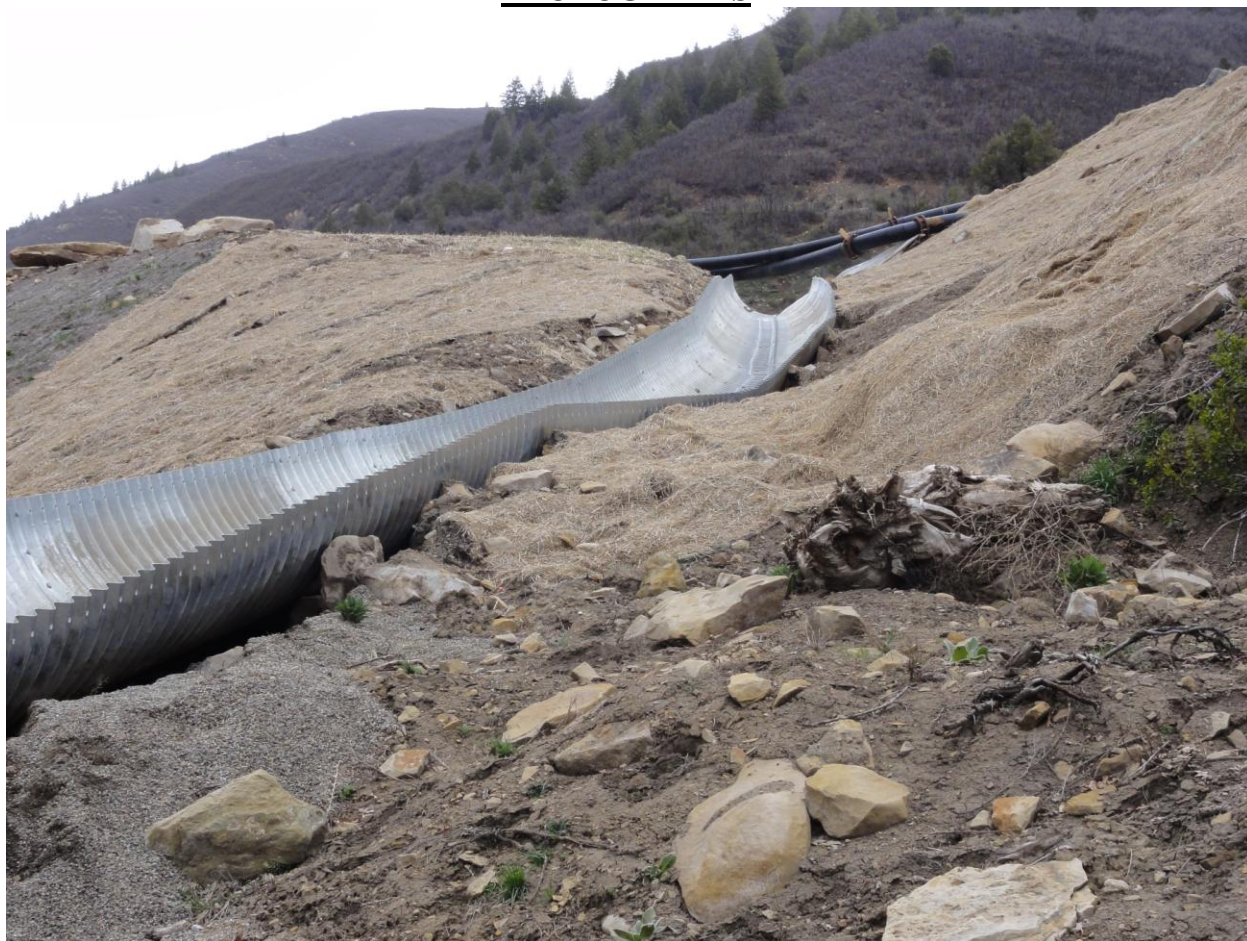
- The portions of the RPEE ditch that were visible from the buttress area appeared to be clean and stable. Conditions did not allow for a closer inspection of these ditches. The half-culvert that flows from the RPEE ditch into the RPE pond appears to have a small amount of side and under cutting. This will need to be closely monitored by the operator to ensure its long term stability.

Half culvert at outlet of RPEE ditch side-cutting

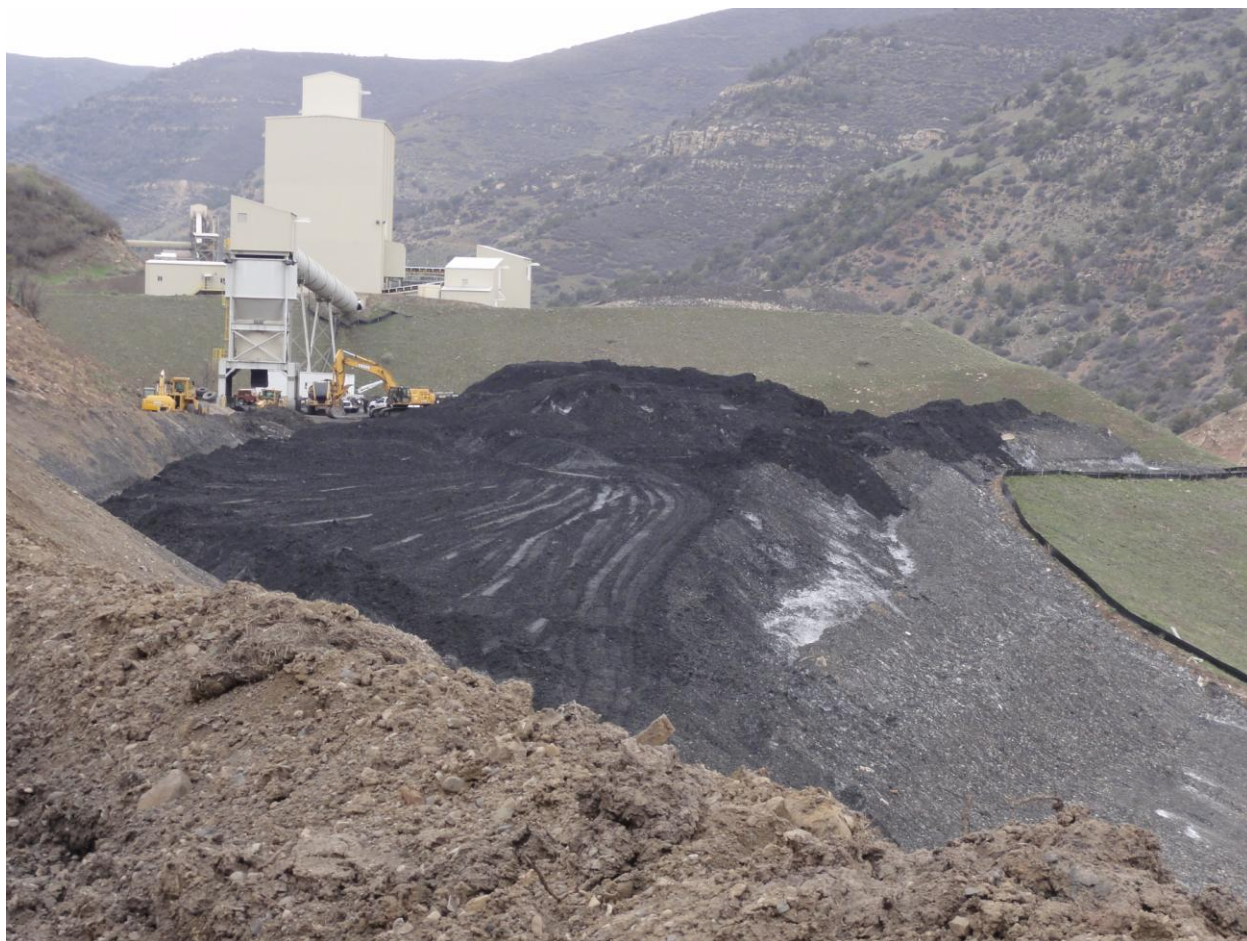
- There were several piles of refuse dumped on the east side of the RPE that have not yet been spread. The remaining areas of the RPE were all well graded and appeared to be stable. The pile appeared to be properly graded and there was no water pooling on the surface of the pile. The area between the refuse bin and the haul road was dry and there was some dust when the wind would blow. The operator needs to ensure that the area is kept watered to keep fugitive dust down. The reclaimed lifts of the RPE were well vegetated and stable.

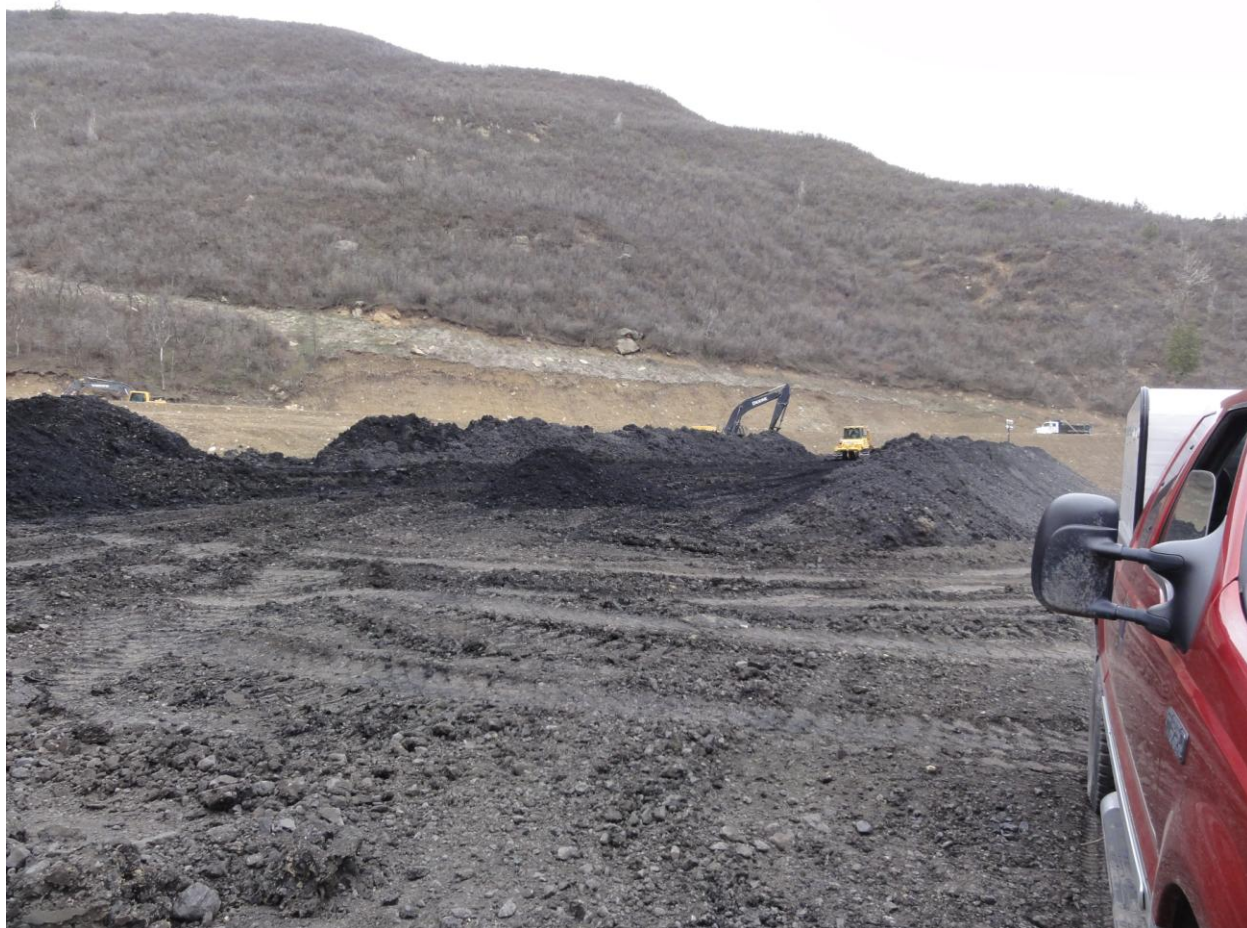
- The operator was working on the fourth lift of the RPEE at the time of the inspection. They were actively hauling, spreading and compacting refuse. They were also working on excavating and drying refuse material in this lift that did not meet required compaction results. The pile was well graded and stable and no erosional problems were noted on the pile. There was no water pooling on the surface of the pile. The outcrops of the first three lifts were well graded and stable and no erosional problems were noted on these lifts. The Phase IA buttress was stable and no problems were noted. West Elk will begin constructing the Phase IB portion of the buttress this summer. The haul road to the RPEE was stable, with no rutting or erosional problems noted. The roadside ditches were generally clean.

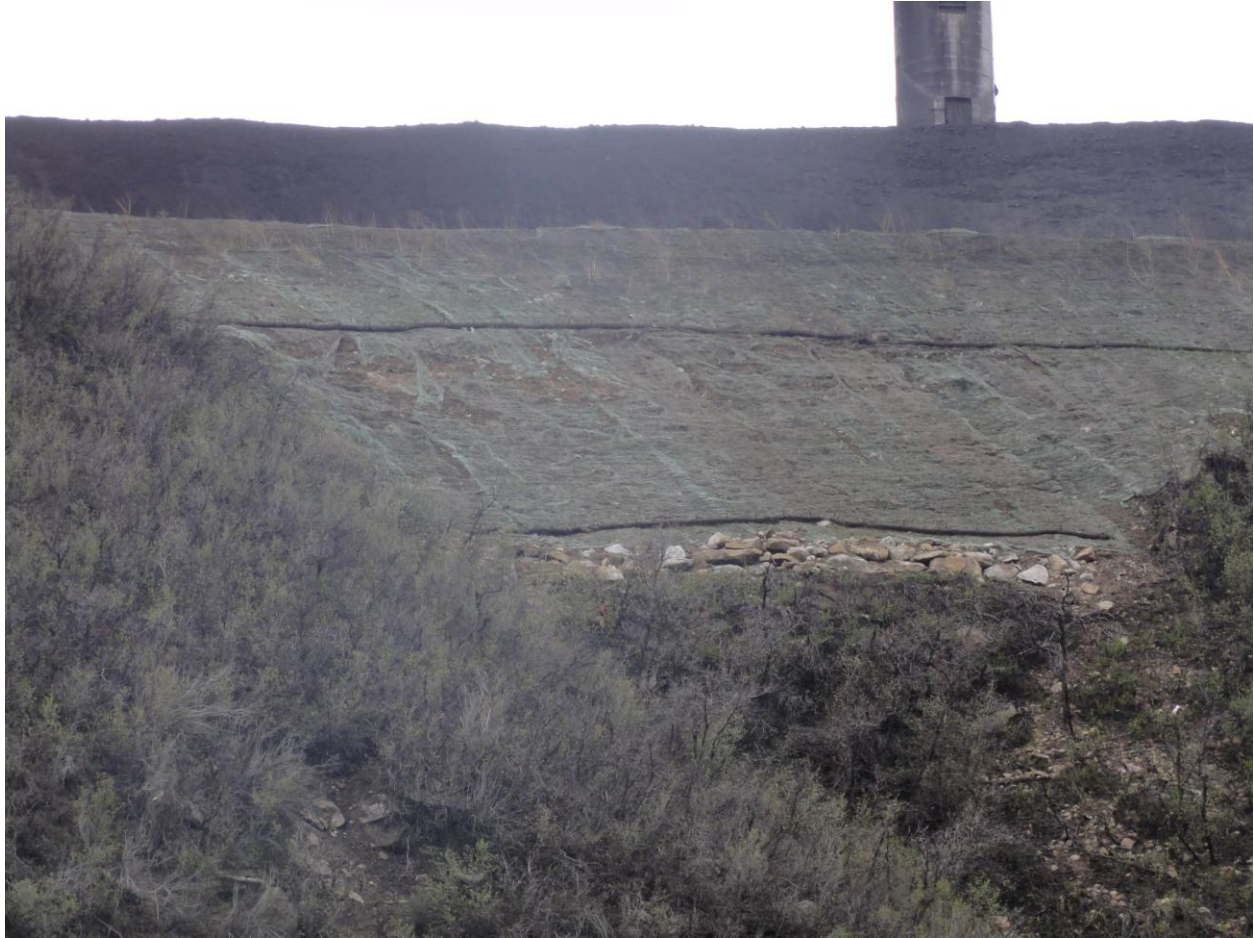
- The ST-02 slide area that was repaired last year remains stable. There has been some movement of the coconut fiber matting but the surface material remains in place.

ST-02 repaired slide area

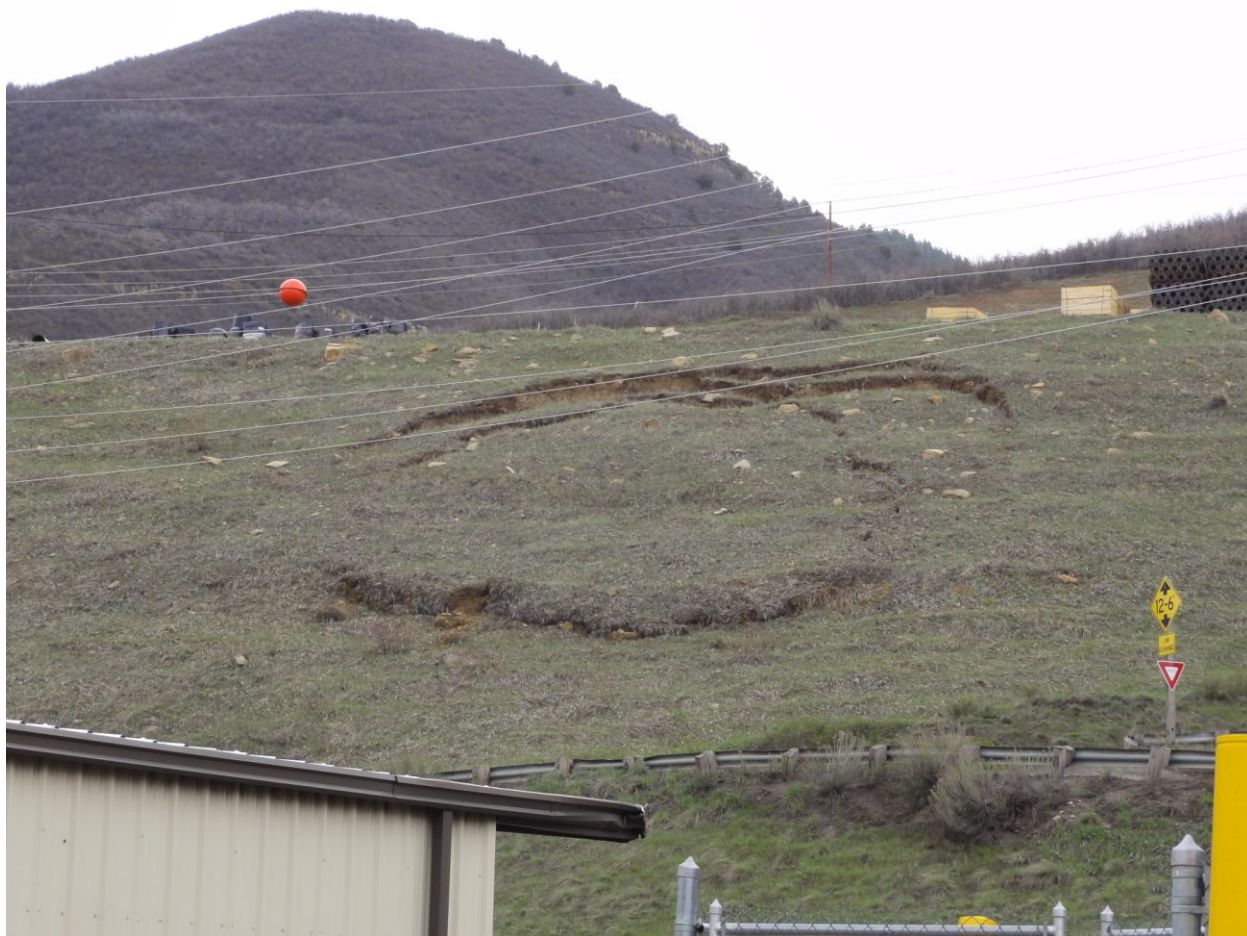
- There is a small slide that has developed on the slope below the material storage bench south of the facilities area and east of the portals. This slide was less than an acre in size. West Elk is aware of the slide and is monitoring it and will repair it as soon as ground conditions allow.

New slide below material storage bench

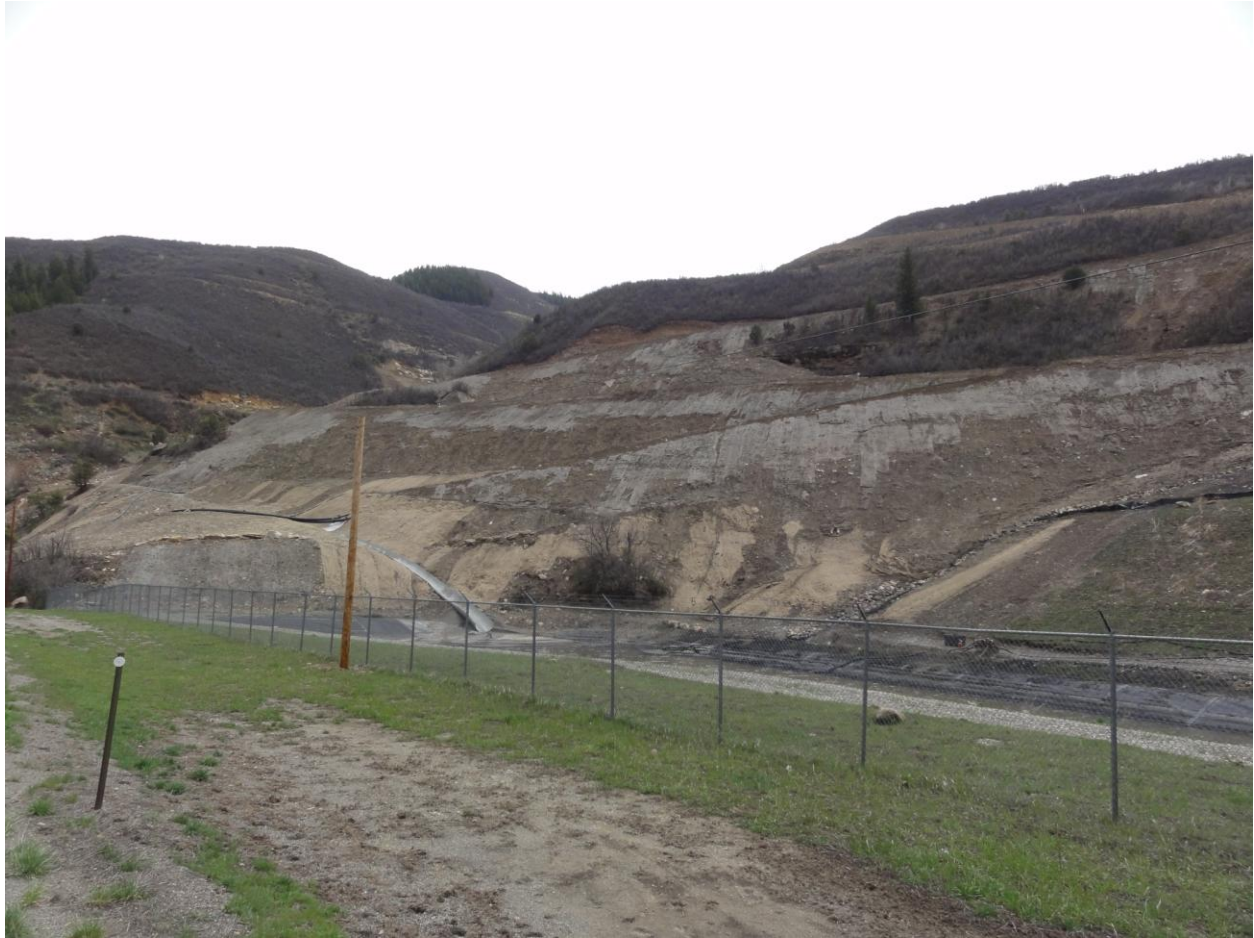
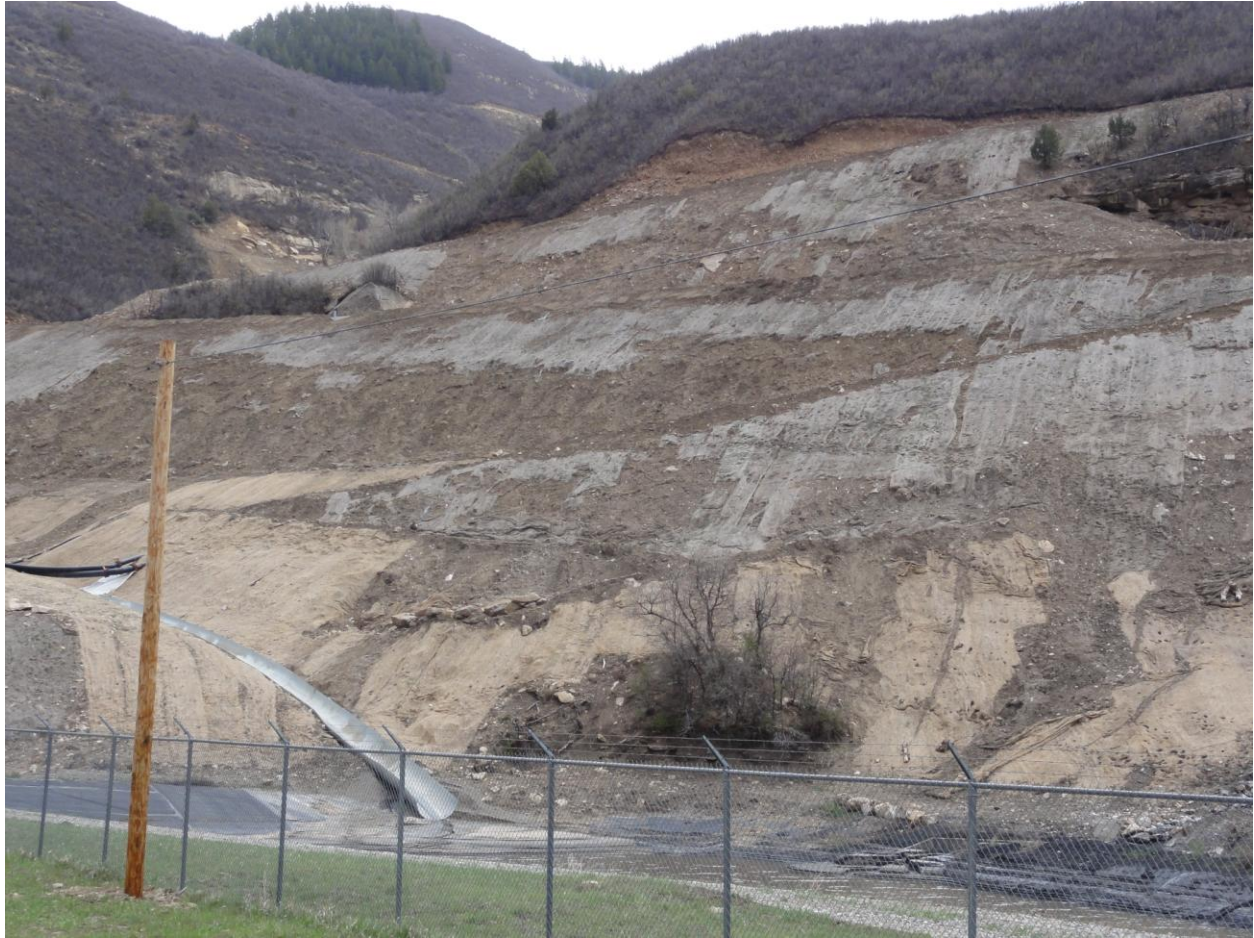
HR-1 slide area

- The HR-01 slide area has had some movement of some of the surface material in response to the runoff and rains this spring. None of this material has moved off-site and none of the material went into the RPE pond. West Elk will work on cleaning up and replacing this material once the conditions on the ground allow. While there was some movement on the surface, the repaired slide area remains stable. There was also a small amount of flow out of the pipe from the rock drain. This was flowing into the half-culvert that flows into the RPE pond.
