**COLORADO DIVISION OF RECLAMATION, MINING AND SAFETY
COAL PROGRAM INSPECTION REPORT**

Permit Number: C-1980-005 Mine Name: Seneca II Mine Operator: Seneca Coal Company, LLC Operator Address: Mr Roy Karo P.O. Box 670 Hayden, CO 81639	County: Routt Operation Type: Surface Permit Status: Inactive Ownership: Private
	Operator Representative Present: Scott Cowman
Operator Representative Signature: (Field Issuance Only)

Inspection Start Date: May 7, 2013 Inspection Start Time: 08:00 Inspection End Date: May 7, 2013 Inspection End Time: 10:00	Inspection Type: Coal Complete Inspection Inspection Reason: Normal I&E Program Weather: Raining
Joint Inspection Agency: None	Joint Inspection Contacts:
Post Inspection Agency: None	Post Inspection Contacts:
Inspector(s): Jason D. Musick	Inspector's Signature:

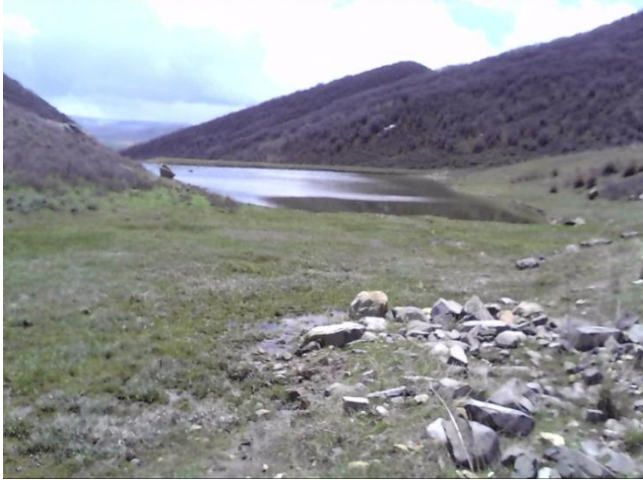
Drainage Control 4.05.1, 4.05.2, 4.05.3; Siltation Structures 4.05.5, 4.05.6; Discharge Structures 4.05.7, 4.05.10; Diversions 4.05.4; Effluent Limits 4.05.2; Ground Water Monitoring 4.05.13; Surface Water Monitoring 4.05.13; Drainage – Acid and Toxic Materials 4.05.8; Impoundments 4.05.6, 4.05.9; Stream Buffer Zones 4.05.18: Pond 008 was stable with .15 discharge through the 12” baski flume at the time of the inspection. Embankments are stable and well vegetated. The water in the pond and through the discharge was clear, with the exception of a large sediment plume near the southwest edge of the pond which was receiving runoff from a natural drainage across the Pond 008 access road during the rainfall. No problems were noted.

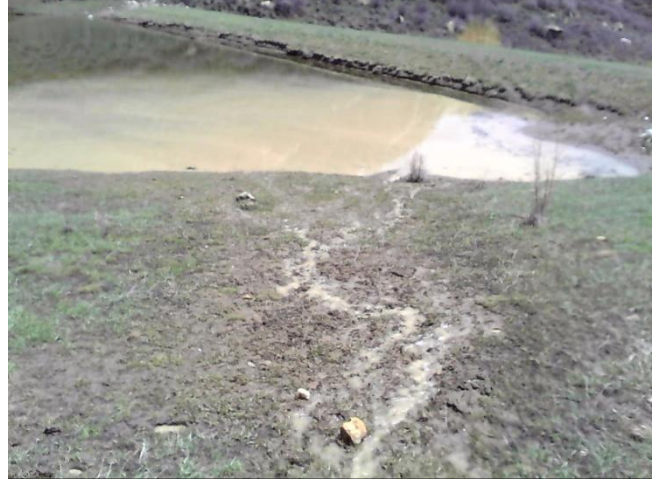
Sediment Plume at Pond 008

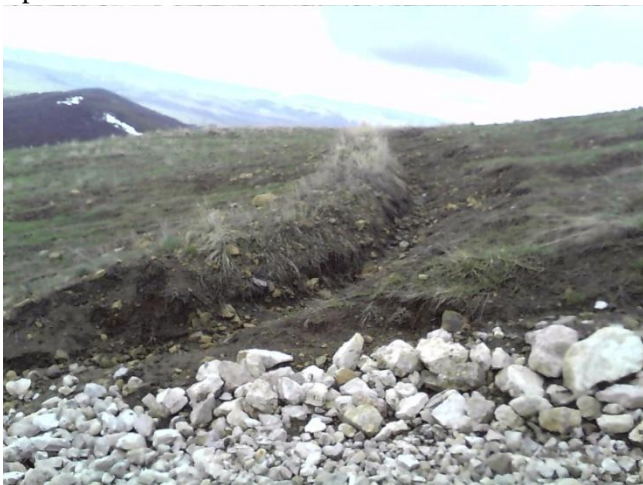
V-Ditches 1, 2, 3, 4 and 5 were stable with no problems noted. Small erosional features were observed in the area north of SIIPM-8 between V-ditches 1 and 2. The features were in an area of recent disturbance created during the repairs to SIIPM-8.

V- Ditch #2 into SIIPM-8

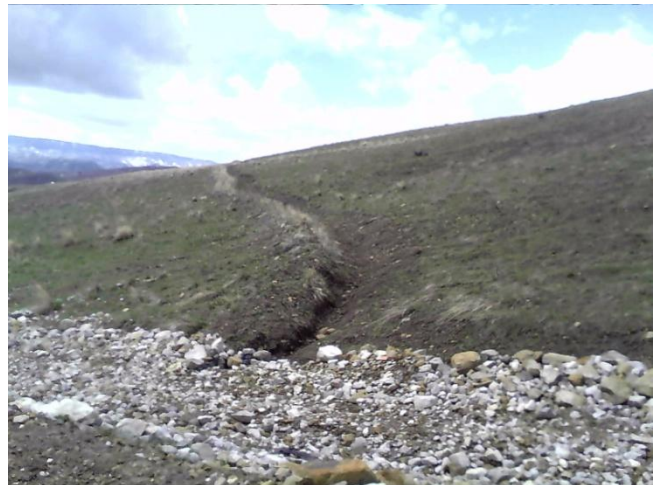
V-Ditch #3 into SIIPM-8

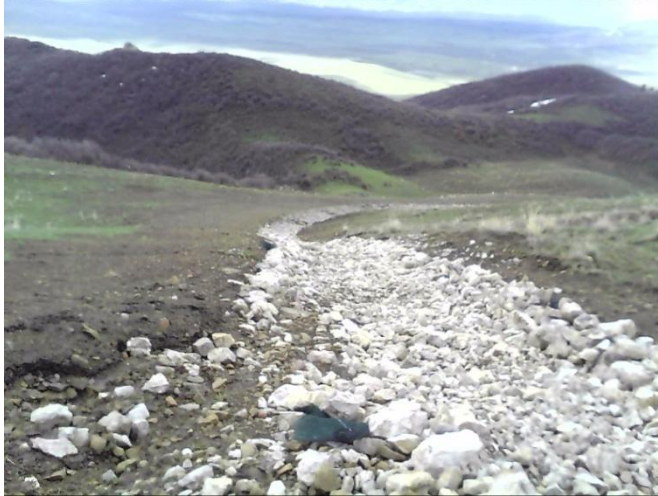
SIIPM-08

Established drainage SIIPM-8 was stable with no problems noted. The areas of repair work disturbance remain bare with a small amount of vegetative growth observed. The disturbed areas will require monitoring for the development of rills and gullies due to low vegetation establishment.

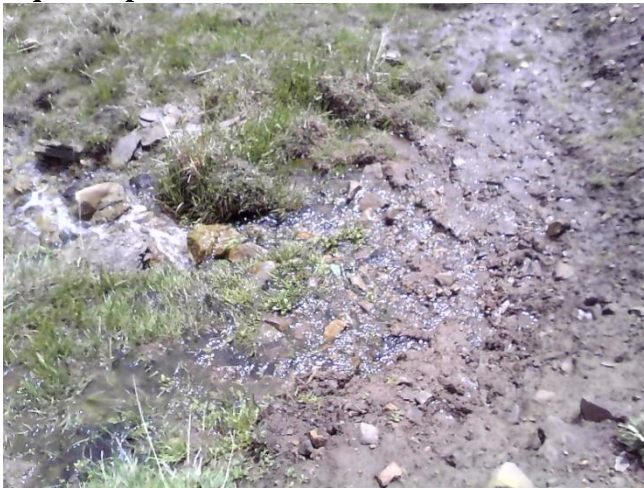
Spoil Spring 009 was flowing into Pond 008 at the time of the inspection. **Water was flowing from the second well up from Pond 008 in the series of 5 wells. This well head along with the third well head in the series was damaged at the time of the inspection. No water was flowing from the third well. These well will require repair.**

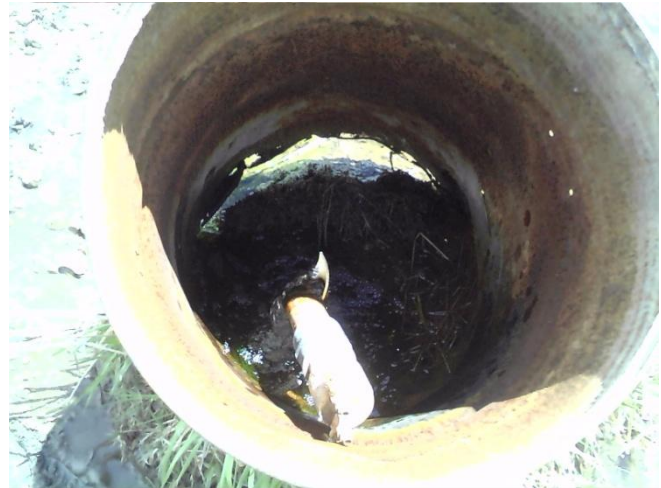
Damaged Well Head
