# COLORADO DIVISION OF RECLAMATION, MINING AND SAFETY COAL PROGRAM INSPECTION REPORT

Permit Number: C-2009-087 Mine Name: Peabody Sage Creek Mine Operator: Peabody Sage Creek Mining, LLC Operator Address: Mr B. Scott Cowman P.O. Box 250 36600 Routt County Road 27 Hayden, CO 81639	County: Routt Operation Type: Underground Permit Status: Active Ownership: Federal  Operator Representative Present: Scott Cowman
Operator Representative Signature: (Field Issuan	nce Only)

Inspection Start Date: May 7, 2013 Inspection Start Time: 10:00 Inspection End Date: May 7, 2013 Inspection End Time: 15:00		Inspection Type: Coal Complete Inspection Inspection Reason: Normal I&E Program Weather: Raining		
Joint Inspection Agency:		Joint Inspection Contacts:		
None				
Post Inspection Agency:		Post Inspection Contacts:		
None				
Inspector(s):	Inspector	r's Sig	nature: Signature Date:	
Jason D. Musick	have	of.	5/14/2013

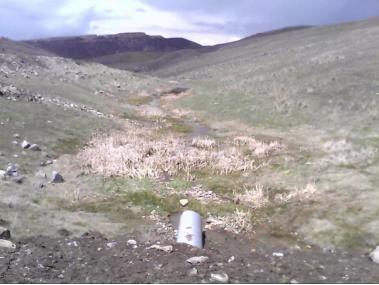
Lower Sump Outlet

Lower Sump Riser Pipe

The primary spillway of the Lower Sump was damaged due to ice over the winter. The repair work to the riser pipe has been completed and the lower sump was holding water and discharging at the time of the inspection. Seeding will be required in the areas of disturbance due to the repair work.
