COLORADO DIVISION OF RECLAMATION, MINING AND SAFETY
MINERALS PROGRAM INSPECTION REPORT
PHONE: (303) 866-3567

MINE NAME: Whitewater Pit 500	MINE/PROSPECTING ID#: M-1977-129	MINERAL: Sand and gravel	COUNTY: Mesa
INSPECTION TYPE: Monitoring	INSPECTOR(S): Travis H. Marshall	INSP. DATE: May 3, 2013	INSP. TIME: 09:30
OPERATOR: Whitewater Building Materials	OPERATOR REPRESENTATIVE: Ed Gardner and Mark Gardner	TYPE OF OPERATION: 112c - Construction Regular Operation

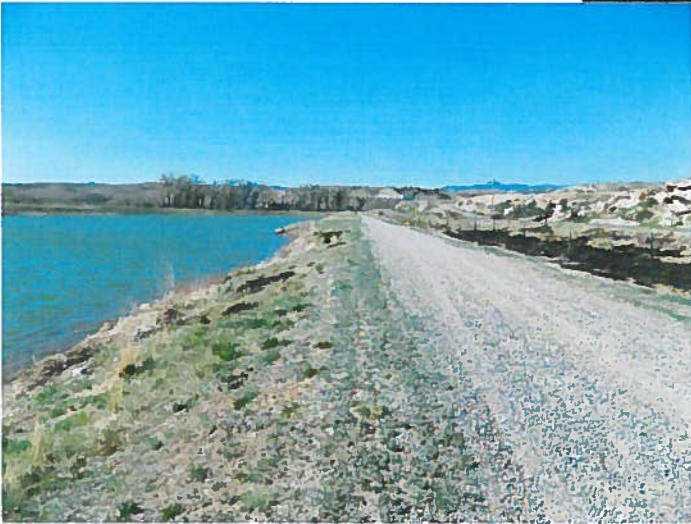
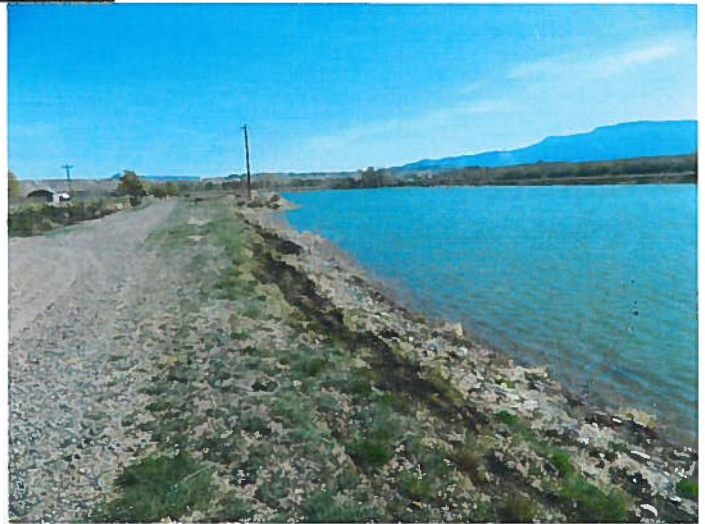
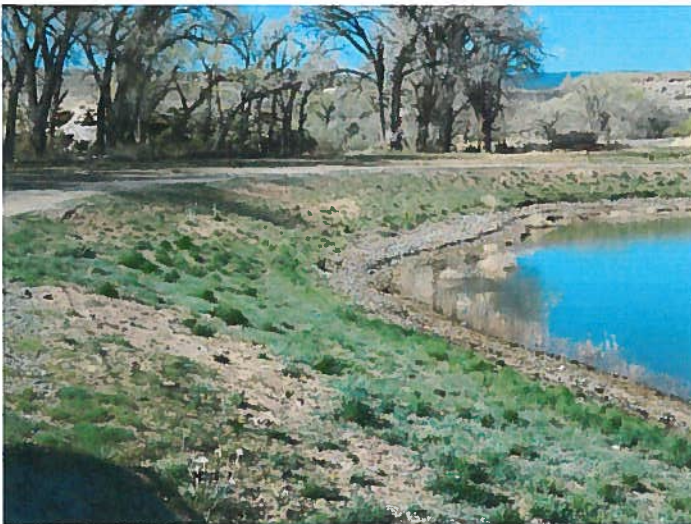
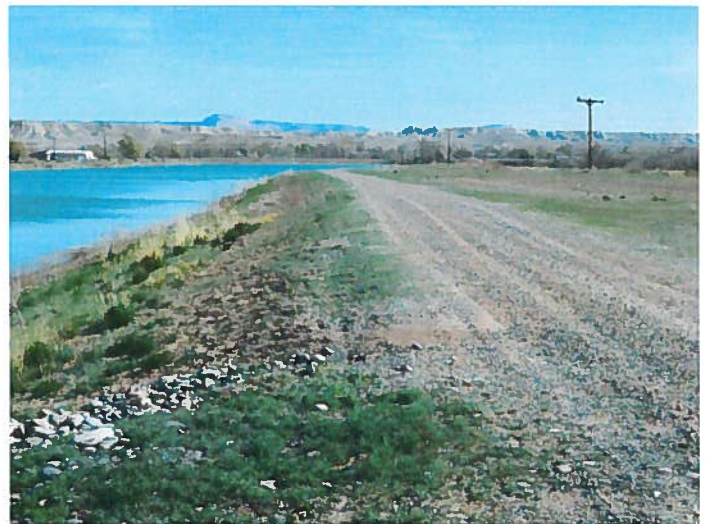
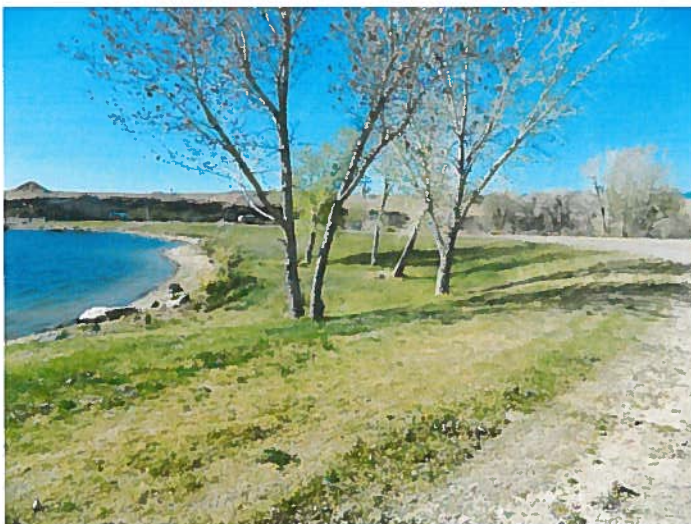
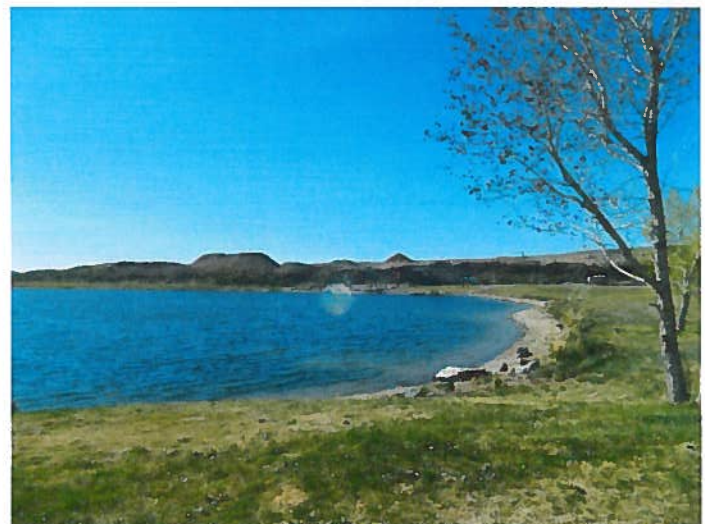
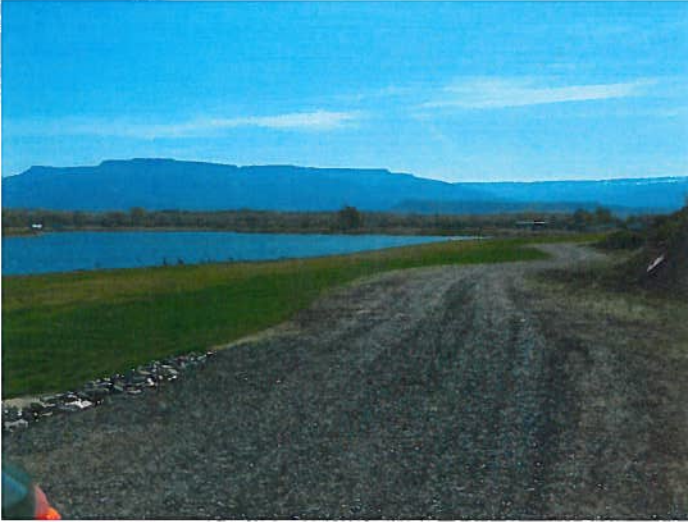
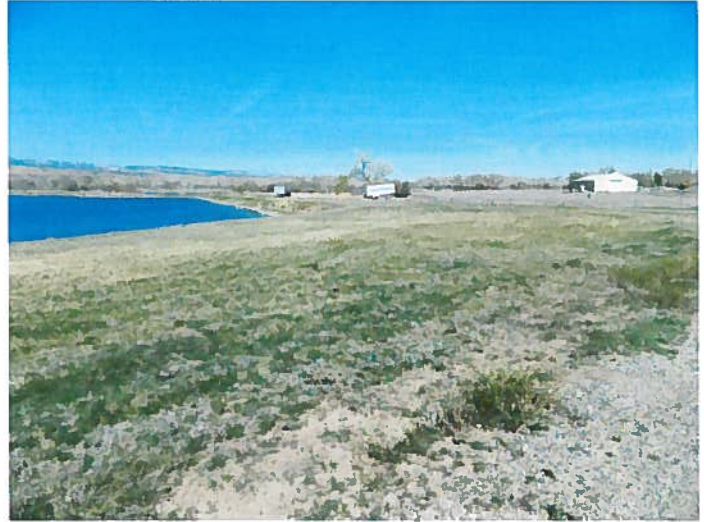
Conditions Observed in Stage 2 – Part A – This Portion of the permitted area is owned by Shawn Ridgley. All sloping appeared to be no steeper than the required 3H:1V. Adequate vegetation was observed.

Conditions Observed in Stage 2 – Part B – This Portion of the permitted area is owned by James McCurter. All sloping appeared to be no steeper than the required 3H:1V. The adequate vegetation was observed.
