COLORADO DIVISION OF RECLAMATION, MINING AND SAFETY COAL PROGRAM INSPECTION REPORT

Permit Number: C-1982-056 Mine Name: Foidel Creek Mine Operator: Twentymile Coal, LLC Operator Address: Mr Jerry Nettleton 29515 Routt County Road No. 27 Oak Creek, CO 80467	County: Routt Operation Type: Underground Permit Status: Active Ownership: Federal
Operator Representative Present: Brian Watterson	
Operator Representative Signature: (Field Issuance Only)

Inspection Start Date: May 8, 2013 Inspection Start Time: 08:00 Inspection End Date: May 9, 2013 Inspection End Time: 13:00	Inspection Type: Coal Complete Inspection Inspection Reason: Normal I&E Program Weather: Raining
Joint Inspection Agency: None	Joint Inspection Contacts:
Post Inspection Agency: None	Post Inspection Contacts:
Inspector(s): Jason D. Musick	Inspector's Signature:

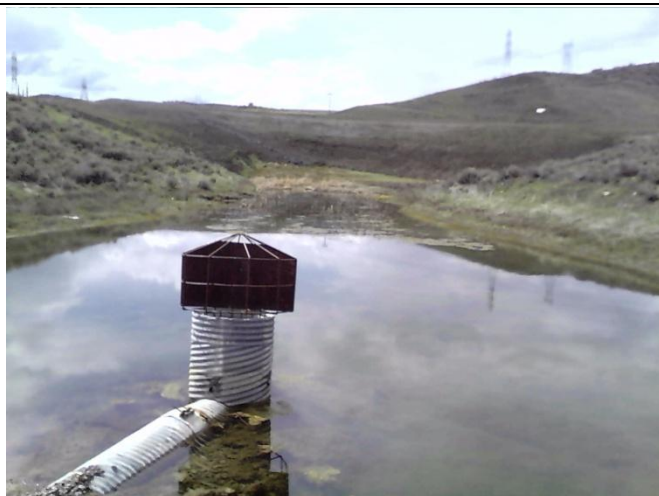
Fish Creek Tipple Pond

At the time of the inspection TC was discharging to Fish Creek at Site 115, the Fish Creek Borehole site. The discharge is due to a failed pump, which has forced TC to tie into the water pipe from 18 LT and send the water underground at the Fish Creek Borehole. The construction of the 18 LT pipe is currently bonded under the Foidel Creek Mine Permit.

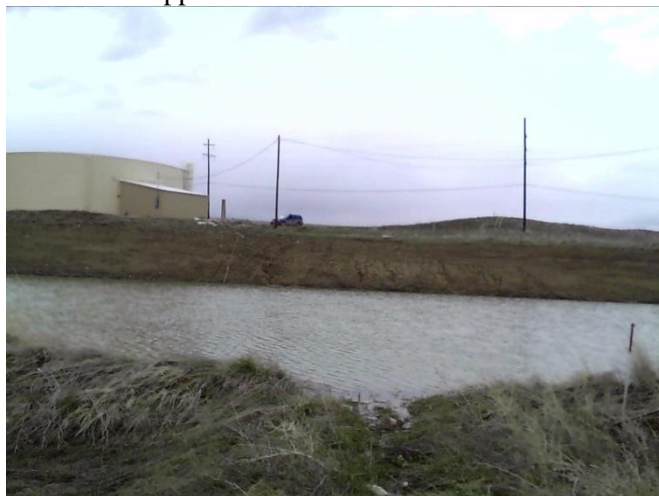
- Non-coal waste (old culvert) in the ditch between the emergency and primary spillways of Pond F should be removed.
- The silt fence at the Pond D outlet will require re-established as designed.
- The south embankment of the 6MN Sediment pond is bare with rills beginning to form. This embankment will require seeding and monitoring for rill and gully development.

6MN Sediment Pond Embankment Slope

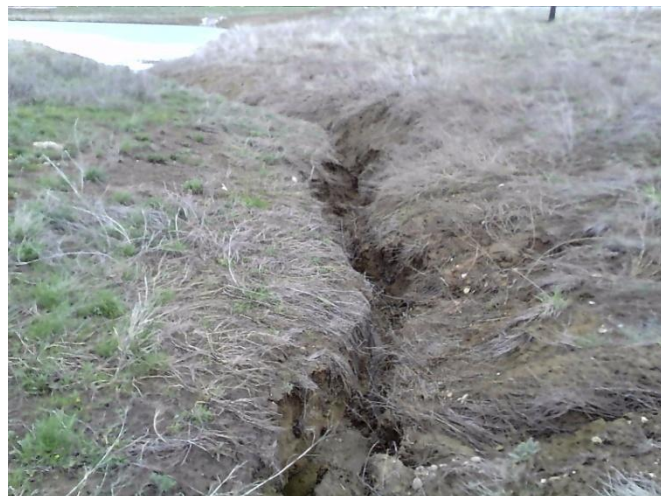
6MN Diversion Ditch to 6MN Sediment Pond

- Heavy down-cutting was observed at the 6MN Pad diversion ditch to the 6MN sediment pond, with gullies on the slopes of the 6MN pad to the collection ditch. This area will need to be address to repair erosion features.

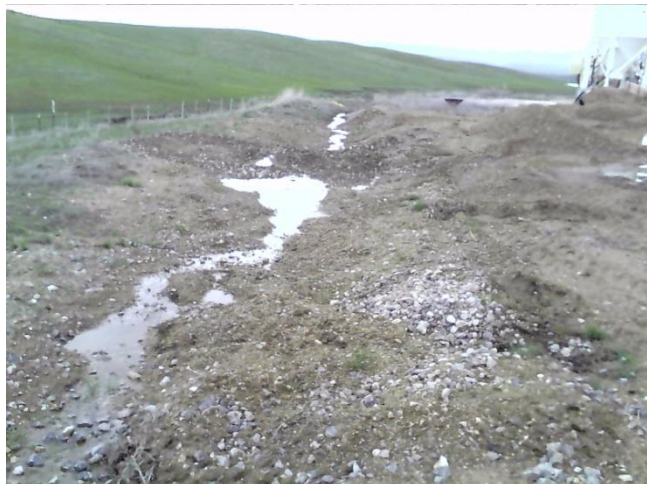
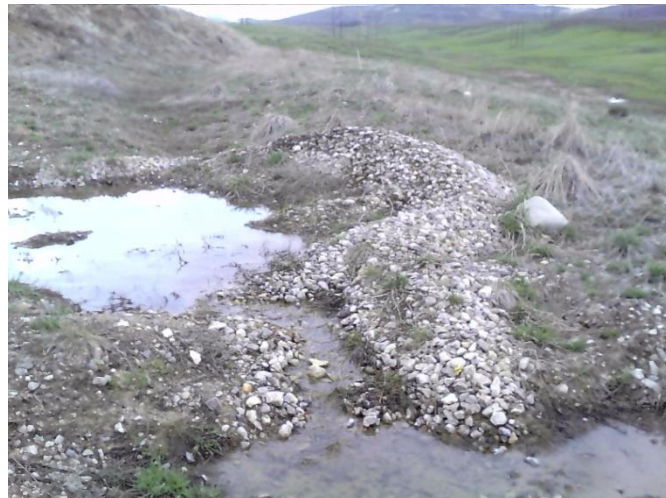
Material in 6MN Diversion Ditch

- Material has been spilled or dumped in the 6MN diversion ditch at the Rock dust tank at 6MN pad. This material will need to be removed from the ditch to ensure flow.

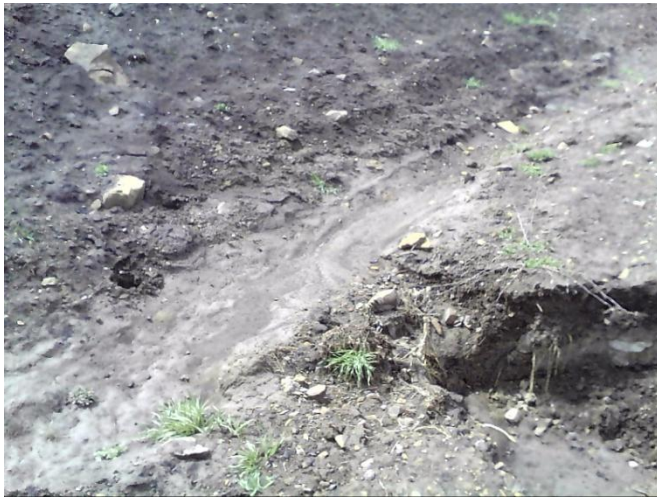
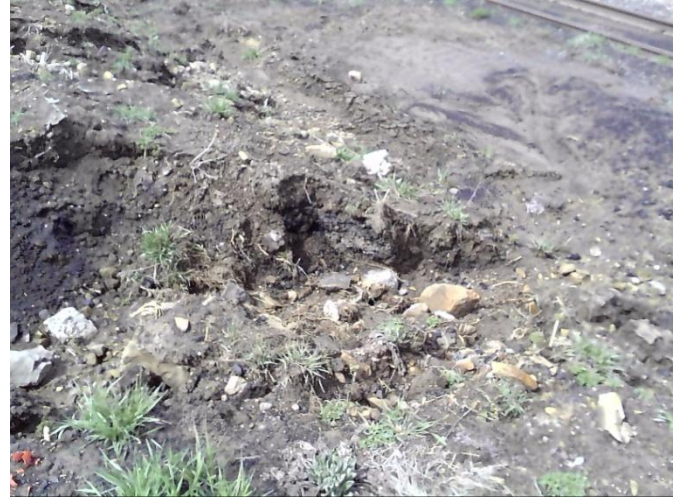
- The containment ditch west of the Fish Creek Tipple Pad has been breached. In addition, erosion features were observed on the out slopes of the ditch that will require maintenance.

Fish Creek Tipple Ditch Damage

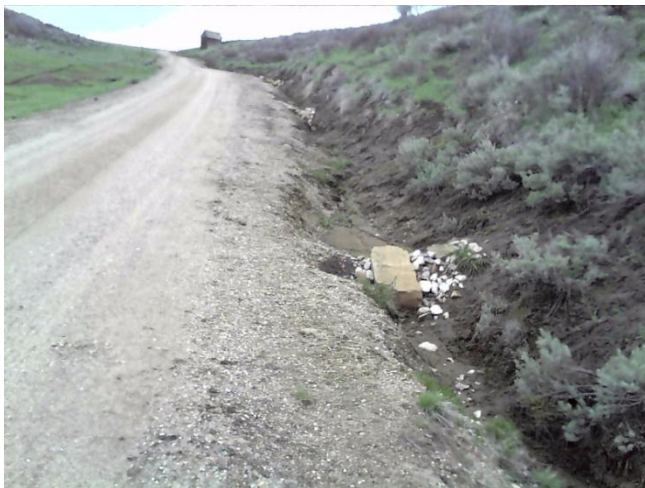
- The outlet of third culvert from the northern most end of the 18RT access road is blocked and will require maintenance.
- The 18RT access roadside ditch continues to cut into the road. The ditch will need to be addressed to ensure stability of the road.

18RT Access Road Ditch

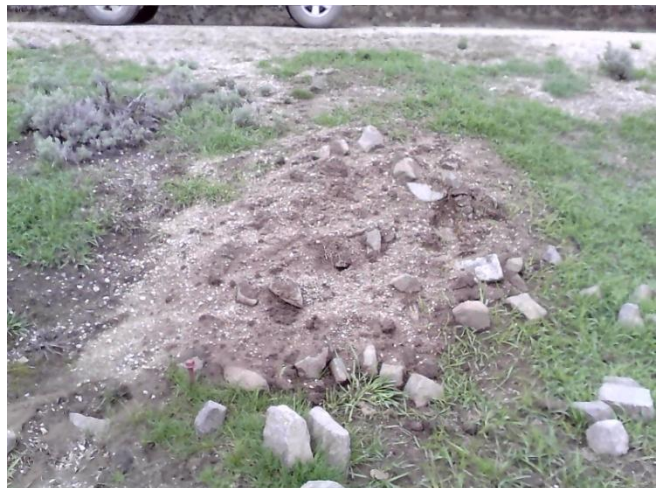
18RT Access Road Blocked Culvert

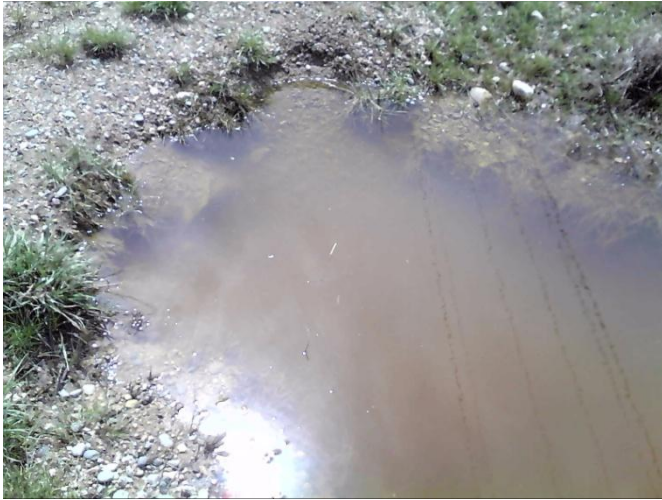
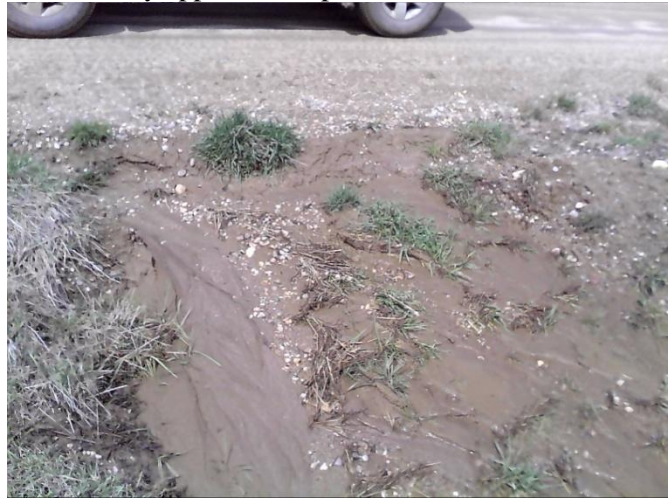
Culvert at 6MN Access Road

- An unidentified culvert along the 6MN access road was blocked at the outlet. This culvert required

maintenance. In addition, this culvert is not identified on the currently approved Map 24.

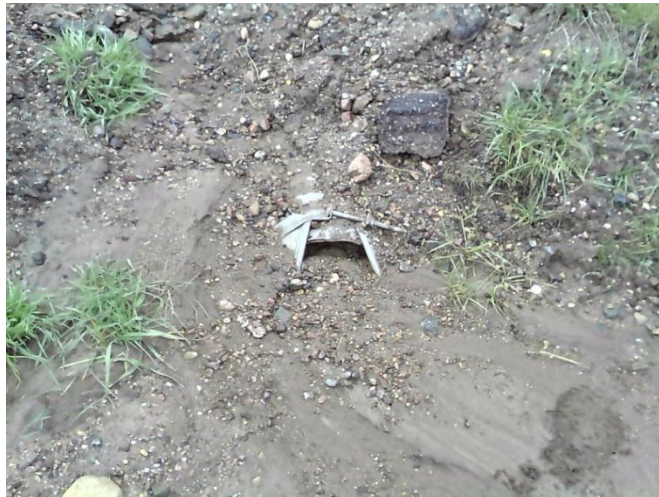
Culvert at Rock Dust Access

- The sump at the rock dust tank along RCR 27 contains non-coal waste (hose, concrete). All non-coal waste will require removal.
- The culvert under the rock dust tank from RCR 27 is blocked at the outlet.

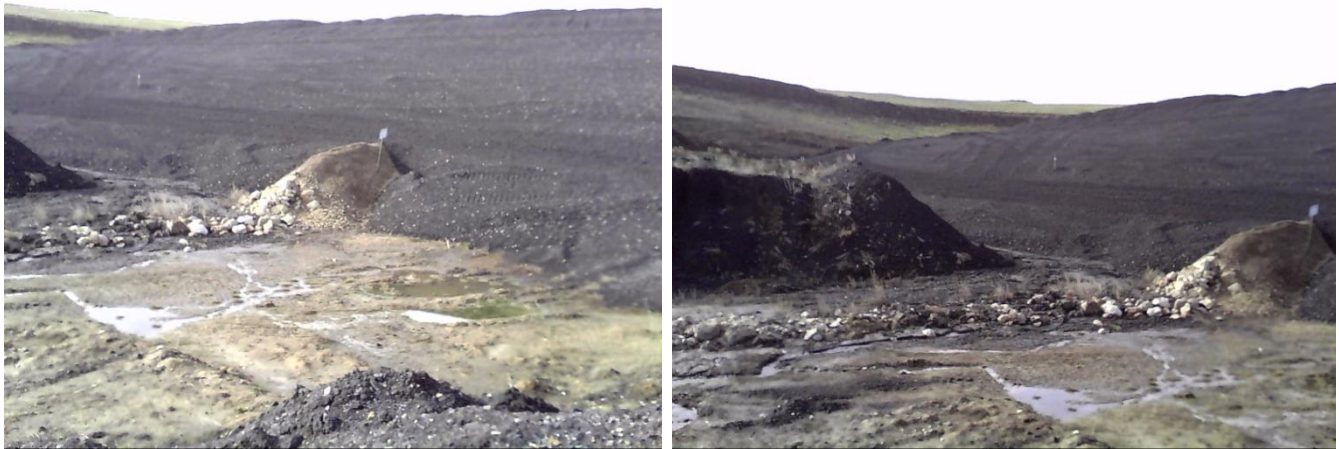
RDA Outslope

Refuse material continues to be placed in the RDA expansion area. Material was in the process of stockpiling at the time of the inspection. The RDA was well compacted and stable at the time of the inspection. The refuse material had not yet reached the head of the under-drain of the RDA. The first lift of the RDA Expansion has been completed. The exposed under-drain was stable and constructed as designed. Phase 1 of the RDA expansion is nearing completion. TR67 was approved with a stipulation that future bonding for each phase of construction will be required prior to the initiation of the next Phase. No problems were noted at the RDA.

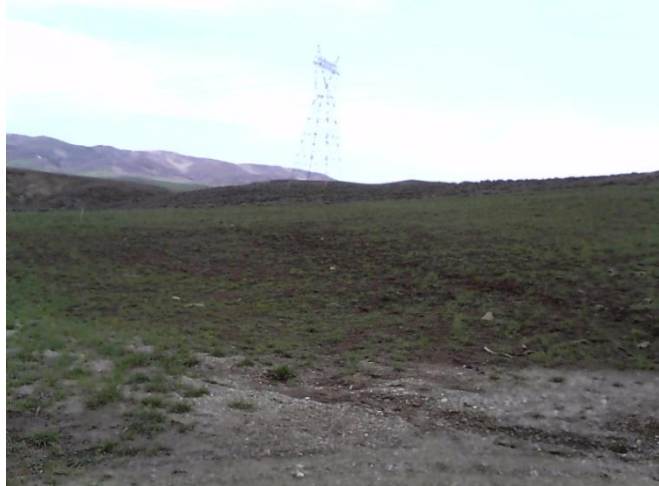
Fish Creek Tipple Pad

The reclaimed Fish Creek Tipple area, 18RT vent shaft area, and the bleeder shaft are stable with no problems noted, with the exception of the ditches at the Fish Creek Tipple identified and noted in the Hydrologic balance section.

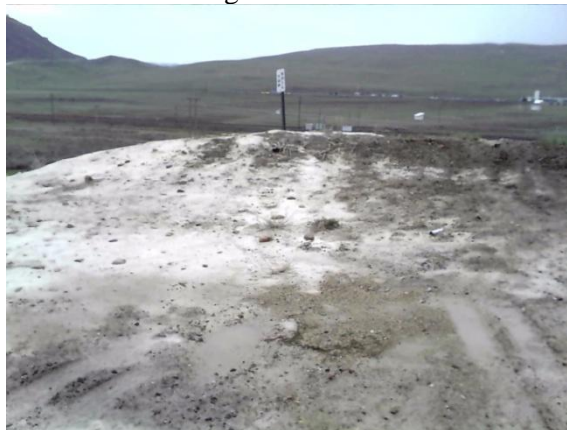
- The topsoil pile at the Rock Dust Tank at RCR 27 displayed little vegetation and a substantial amount of rock dust covering the pile. The pile will need to be revegetated and the rock dust removed.

Rock Dust Tank Topsoil Pile
