## COLORADO DIVISION OF RECLAMATION, MINING AND SAFETY COAL PROGRAM INSPECTION REPORT

<b>Permit Number:</b> C-1996-083 <b>Mine Name:</b> Bowie No. 2 Mine <b>Operator:</b> Bowie Resources, LLC <b>Operator Address:</b> Mr William A Bear P.O. Box 483 Paonia, CO 81428	<b>County:</b> Delta <b>Operation Type:</b> Underground <b>Permit Status:</b> Active <b>Ownership:</b> Federal and Forest
<b>Operator Representative Present:</b>  Bill Bear	
<b>Operator Representative Signature:</b> (Field Issuance Only)

<b>Inspection Start Date:</b> May 9, 2013 <b>Inspection Start Time:</b> 08:30 <b>Inspection End Date:</b> May 9, 2013 <b>Inspection End Time:</b> 11:30	<b>Inspection Type:</b> Coal Partial Inspection <b>Inspection Reason:</b> Normal I&E Program <b>Weather:</b> Cloudy
<b>Joint Inspection Agency:</b>  None	<b>Joint Inspection Contacts:</b>
<b>Post Inspection Agency:</b>  None	<b>Post Inspection Contacts:</b>
<b>Inspector(s):</b>  Susan L. Burgmaier	<b>Inspector's Signature:</b>  <i>Susan Burgmaier</i> <b>Signature Date:</b>  05/16/2013

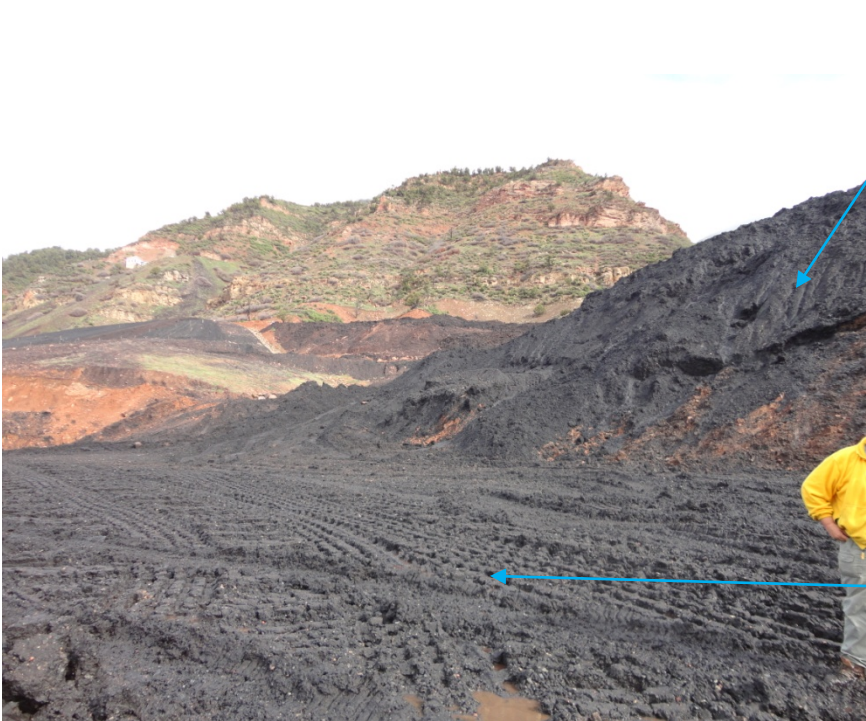
Refuse material was being hauled to Gob Pile 2, and being end dumped in the central area of the pile. At the time of the inspection, end dumped material was located in the northernmost area of the pile, in the newly approved expansion area, and on the western edge. No compaction operations were underway during the inspection, as none of the end dumped material was dry enough for handling. Material on the western edge of Gob Pile 2 had been placed at an approximate 2:1 slope; the approved slope angle is 3:1.

The manner of end dumping material throughout the pile is inconsistent with Rule 4.09.1(1)(c), which requires placement of waste material in a controlled manner to ensure stability of the fill. The pace of compactive effort does not appear to meet the requirements of Rule 4.09.1(7), which requires concurrent compaction of fill material that is placed on the refuse pile.

<p>End dumped material on Gob Pile 2.</p> <p>Compacted area on lower portion of Gob Pile 2.</p> <p>Photo 1</p>

Abatement Description: Place and compact all existing end-dumped material on Gob Pile #2 in accordance with the Rules and approved permit application package.

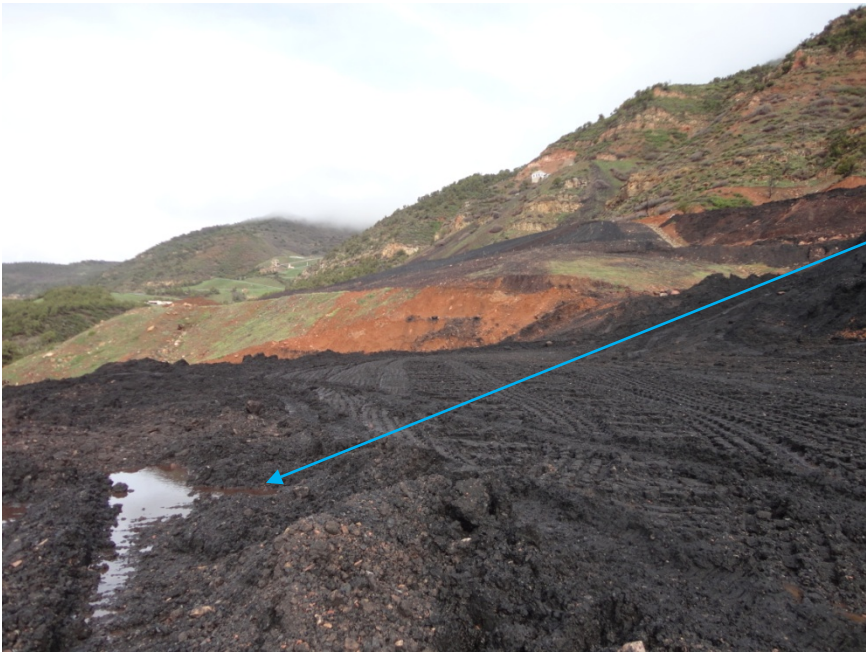
As discussed above, under the "Hydrologic Balance" section of this report, water was pooling in several of the drainage ditches on Gob Piles 2 and 4. Additionally, water was pooling between piles that had been end dumped and also along the haul road on Gob Pile 2.

The combination of pooled water and steepness of the end dumped material on Gob Pile 2 would indicate that the required factor of safety of 1.5, per Rule 4.10.4(2) is not being maintained.

<p>Standing water on Gob Pile 2</p> <p>Photo 2</p>

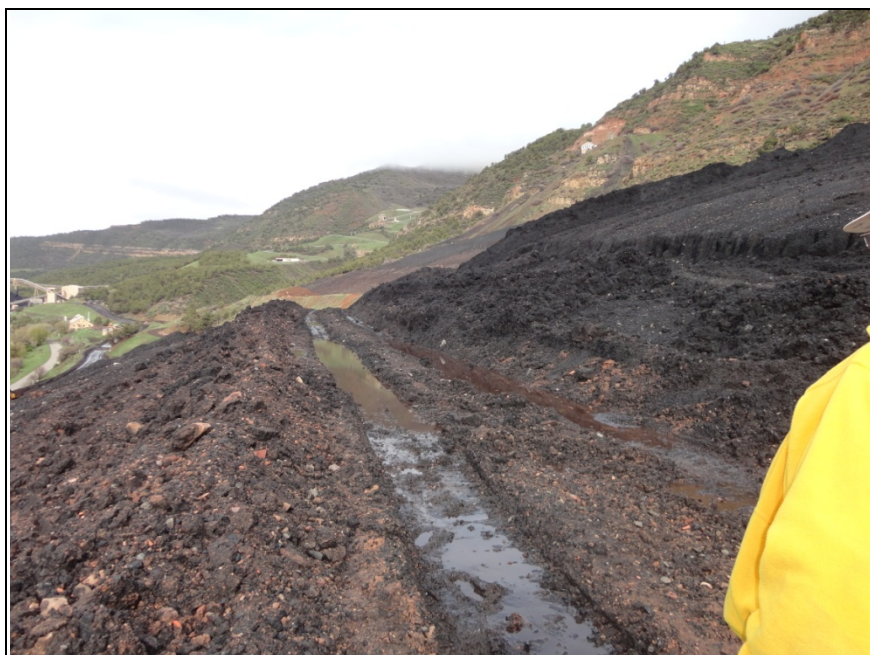
Photo 3

Haulage road up Gob Pile 2, standing water.

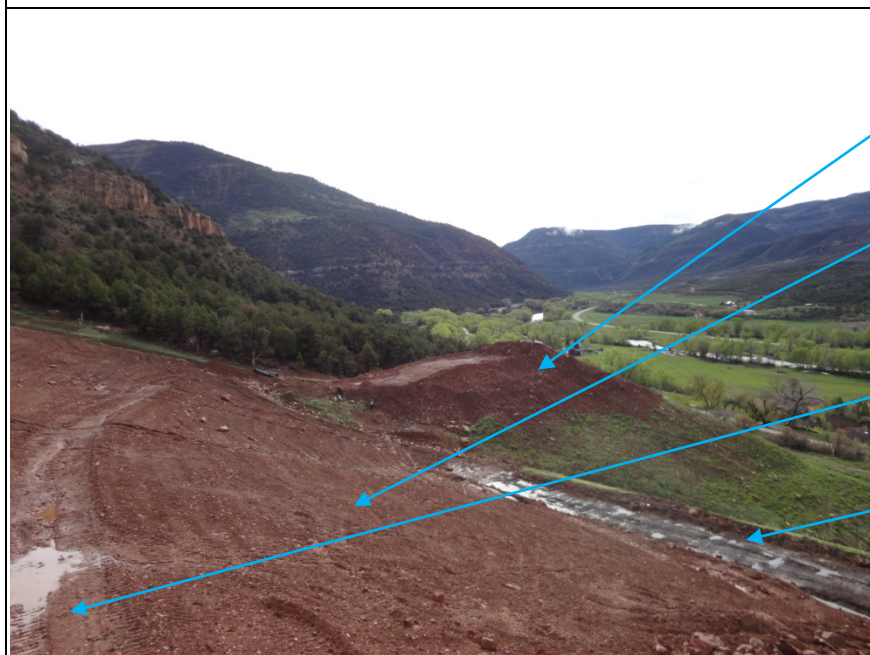
Photo 4

Some of the ditches on Gob Piles 2 and 4 were blocked, causing surface water runoff on the pile to pool and not flow off of the pile as required by Rules 4.10.1(1)(a) and 4.09.2(7). Ditches F1, F3, F12, F16, F17, F18, and F20 were backed up with standing water because end dumped gob material and partially excavated cover material in the central part of the pile prevented flow as depicted on Map 21-3 of the currently approved permit application package. Flow along ditches F5 and F6 was prevented by the temporary cover fill stockpile located on the second bench above Pond F.

Cover fill stockpile on east end of Gob Pile 2

Covered compacted gob

Ditch D-F12

Ditch D-F6

Abatement Description: Remove cover fill material from ditches D-F5 and D-F6 and repair or reconstruct all lateral ditches on Gob Piles 2 and 4 to ensure positive drainage as designed in the approved permit application package.

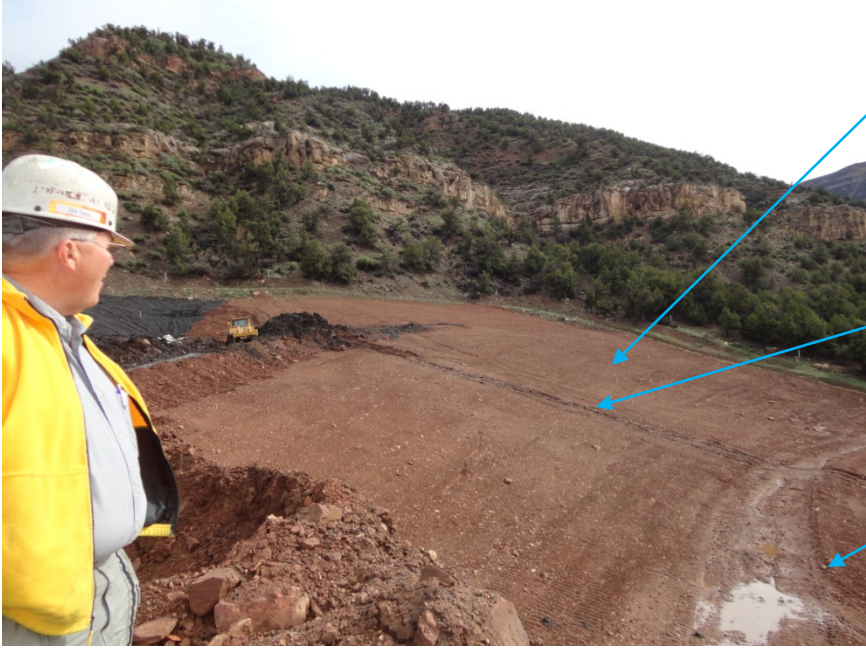
<p>Covered compacted Gob</p> <p>Gully off of Haul Road</p> <p>Ditch D-F-12</p> <p>Photo 5</p>

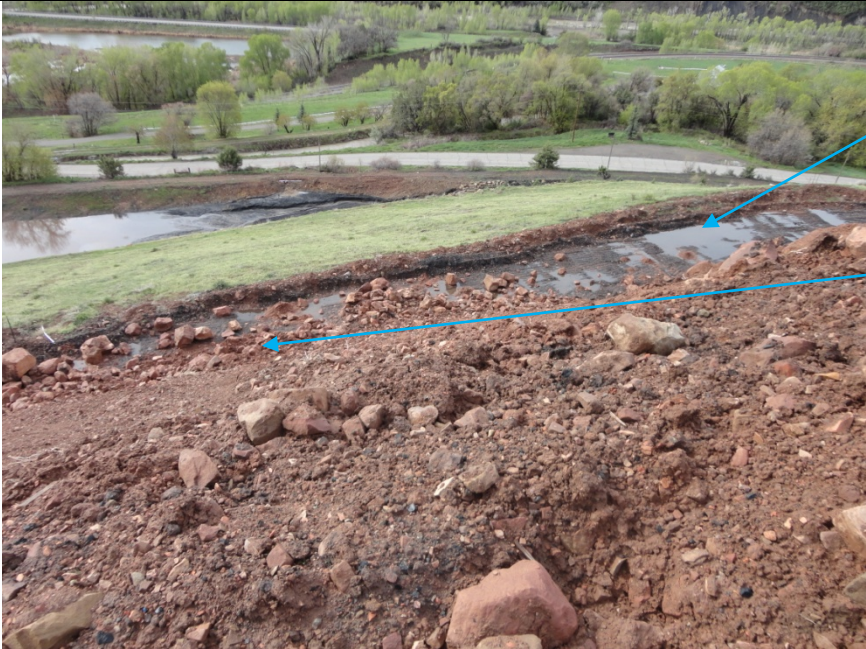
<p>Ditch D-F5</p> <p>Cover fill material blocking ditch</p> <p>Photo 6</p>

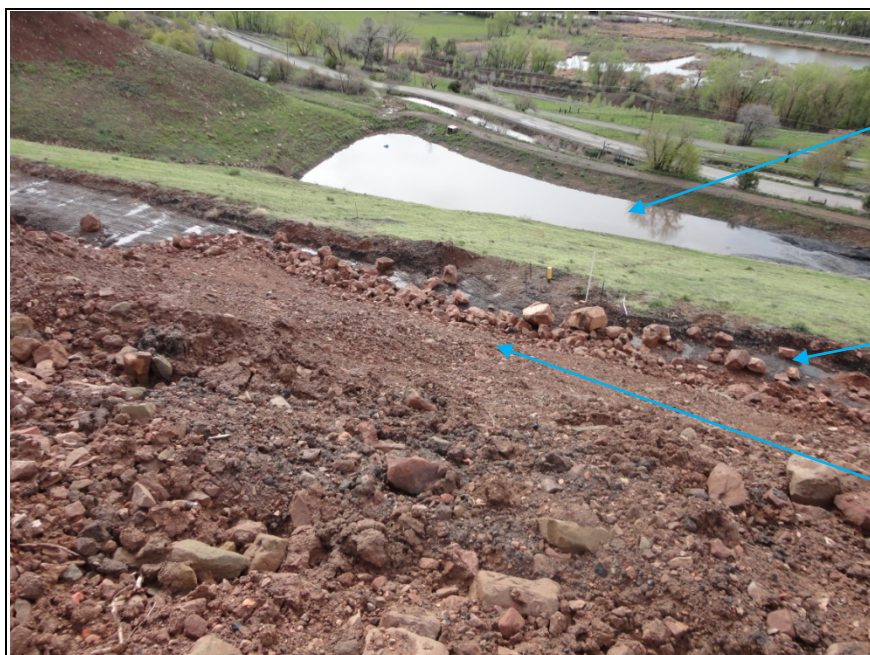
Photo 7

Pond F

Ditch D-F6

Cover fill material  
blocking ditch

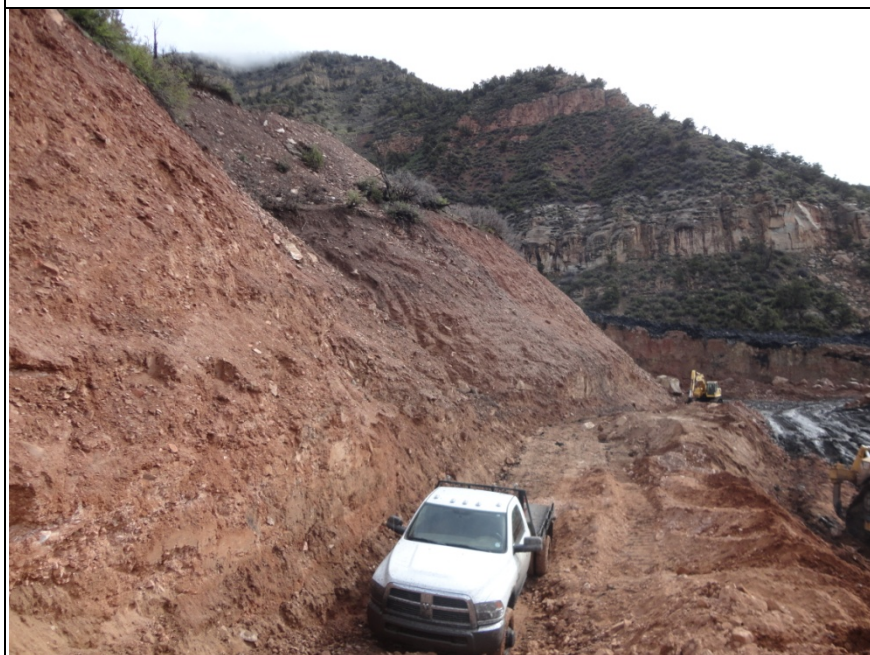
Photo 8

Cover fill material was being excavated in the Gob Pile 2 expansion area. Because it was too wet to access Gob Pile 4 to spread the excavated cover material, it was being temporarily stored on the second bench of Gob Pile 2.

Excavation area at head of  
Gob Pile 2 expansion area

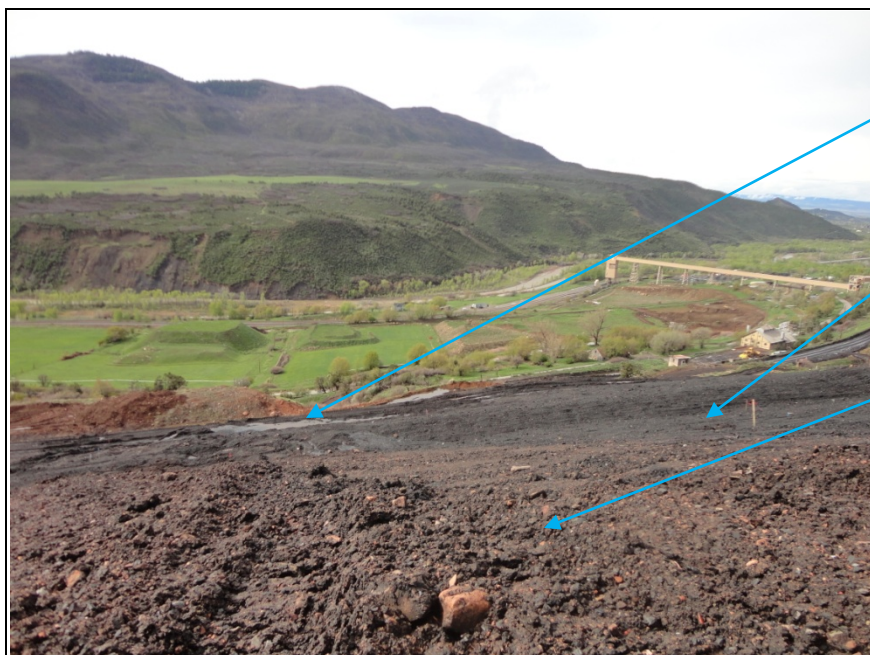
Photo 9

Ditches D-F17

and D-F20

Compacted outslope of  
Gob Pile 4

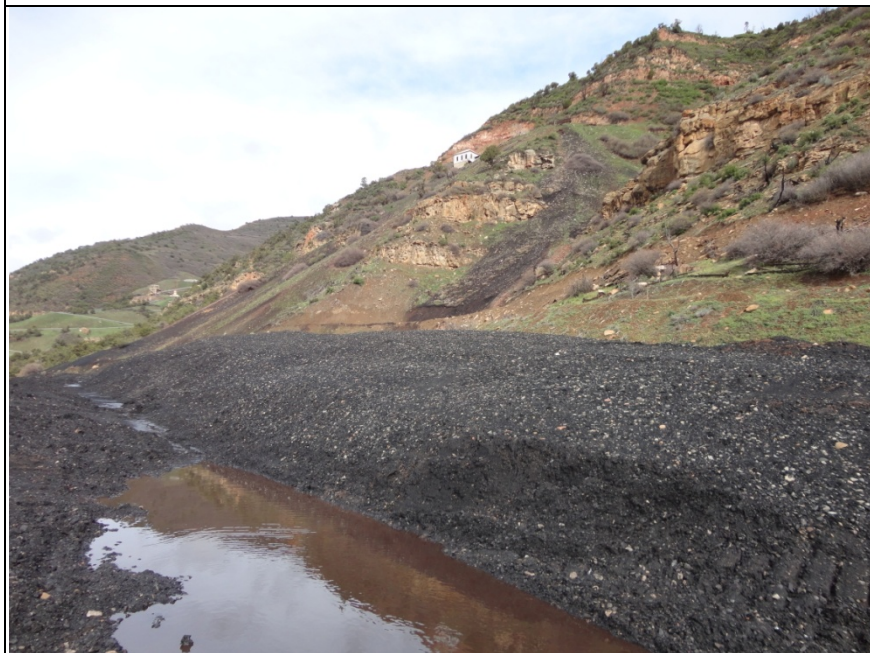
Photo 10

Ditch D-F18

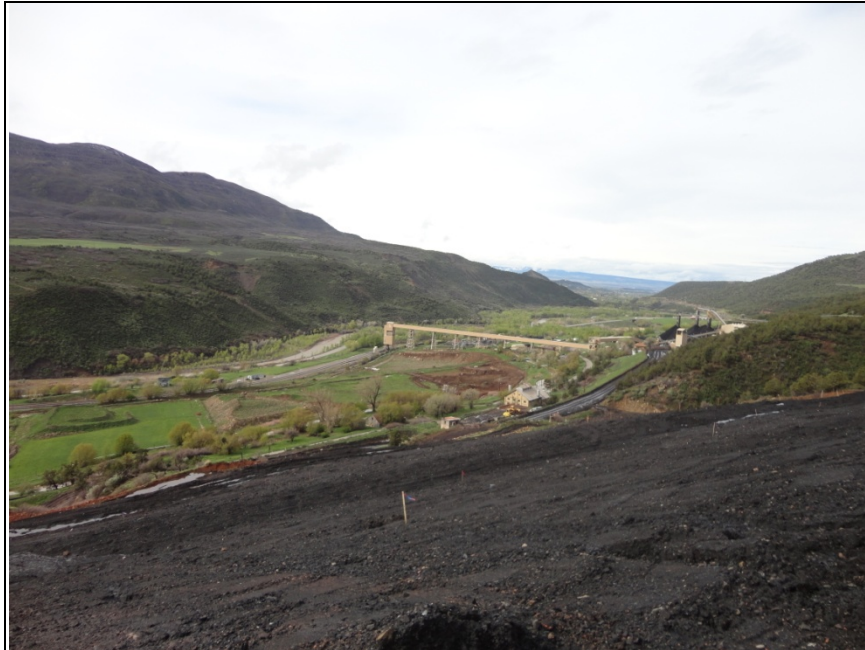
Photo 11

Compacted outslope of  
Gob Pile 4

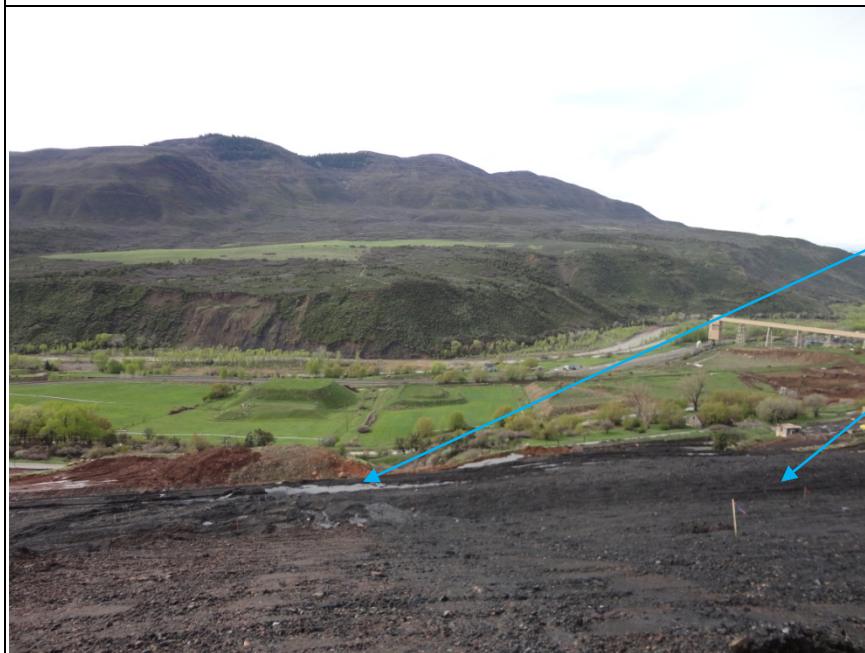
Photo 12

Gob Pile 4

Ditch D-F17

Ditch D-F20

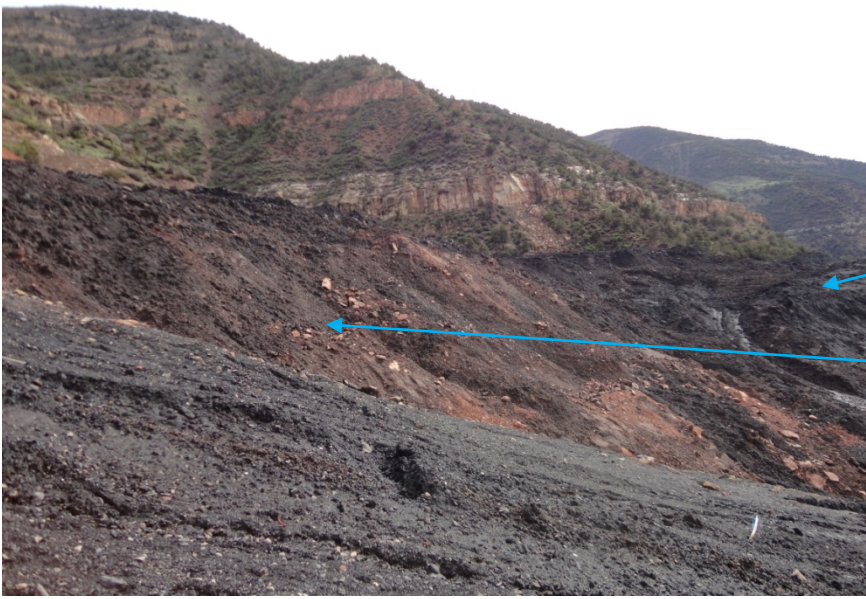
Refuse material had been end dumped in the Gob Pile #2 expansion area, where cover fill material had yet to be excavated. Care should be taken when rehandling the refuse to ensure that cover fill material resources are not contaminated with refuse material.

<p>Gob Pile 2 expansion area</p> <p>End dumped material</p> <p>Area to be excavated</p> <p>Photo 13</p>

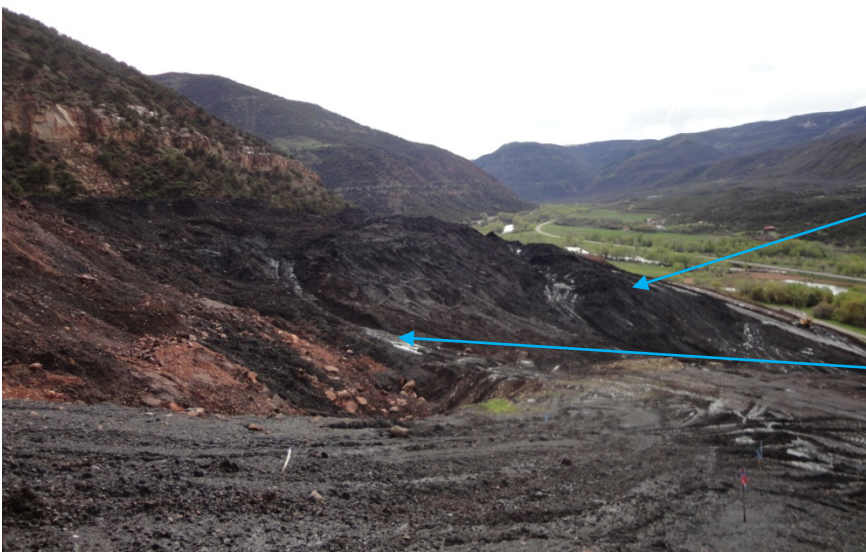
<p>Gob Pile 2</p> <p>End dumped material</p> <p>Water standing on roadway</p> <p>Photo 14</p>

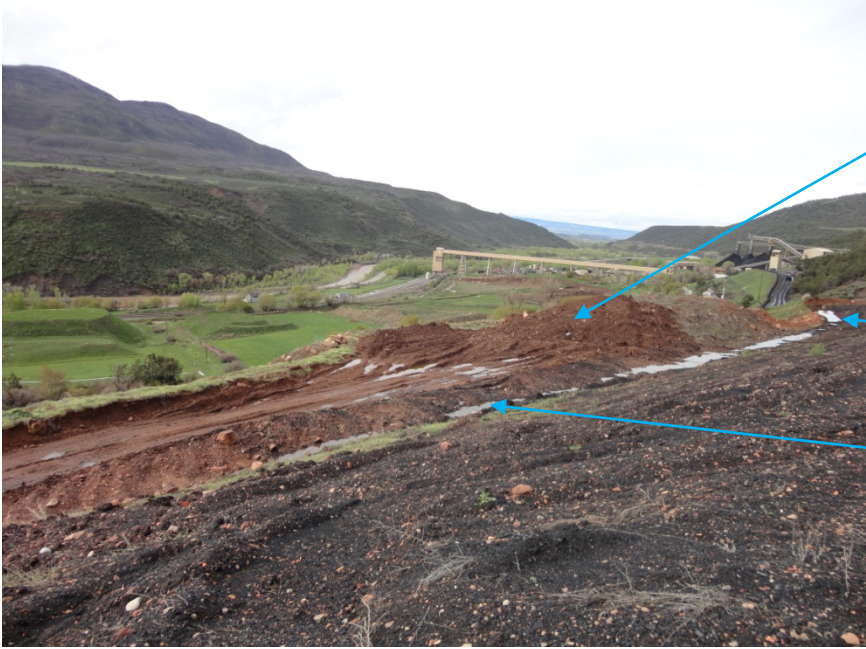
Blocked drainage ditches on Gob Piles 2 and 4 were causing water to pool at the base of the topsoil stockpile between Gob Piles 2 and 4 (bounded by ditches F-9, F-13, F-14, and F-17). The topsoil stockpile should be protected from water erosion, as required by Rule 4.06.3(2). The topsoil stockpile and immediate area should be regraded to ensure protection of the topsoil resource.

<p>Topsoil Stockpile</p> <p>Ditch D-F16</p> <p>Ditch D-F17</p> <p>Photo 15</p>

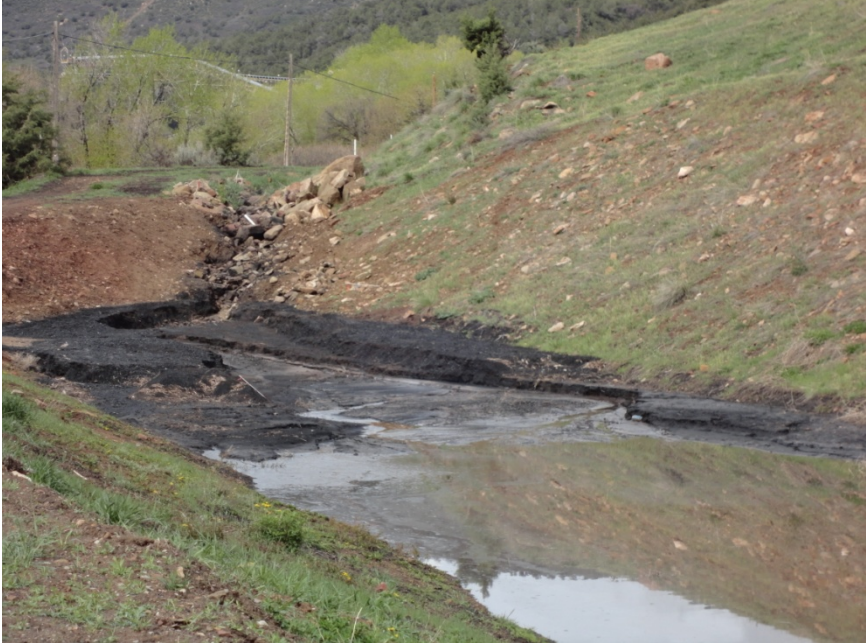
Ponds B, C, D, F, and K all held water; none were discharging or being pumped. Pond J was dry. Pond F had a 2' delta of sediment at the inlet. The aerial extent of the delta was roughly .05-.075 acres, which would equate to roughly 0.10-0.15 acre feet of sediment. This is a very rough estimation, given the irregularity of the deposition of sediment, but does indicate that a significant amount of sediment has collected in the pond inlet. The sediment capacity of this pond is only 0.20 acre feet, so this should be monitored closely to ensure that the available capacity in the pond is adequate to treat runoff from the design event (10 yr - 24 hr). The operator indicated that Ponds B, C, F, and possibly D would be dredged this summer. The operator will also be placing elevation markers in Pond F (required by June 15, 2013) to assist in determining the available capacity of the pond.

<p>Pond F Inlet</p> <p>Photo 16</p>

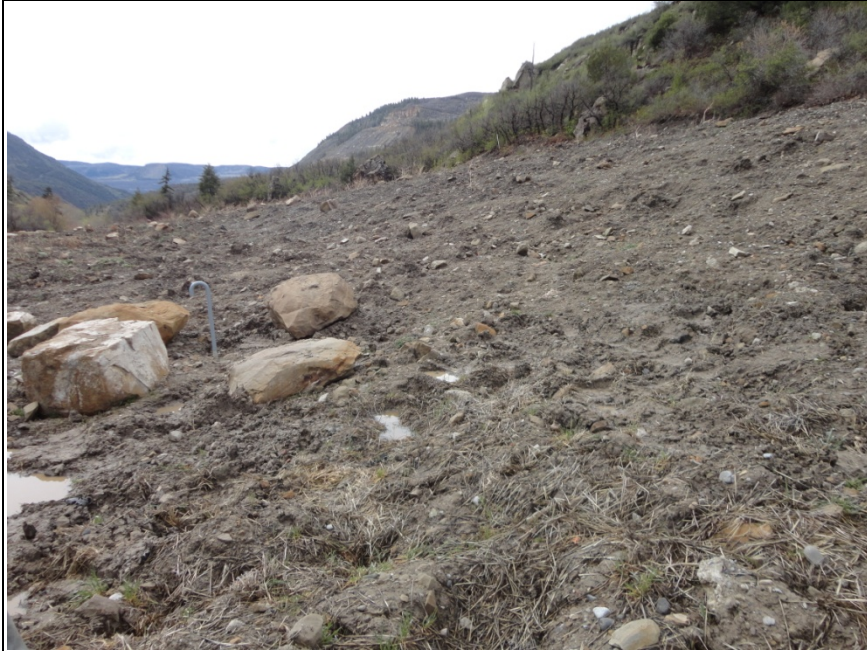
Photo 17

The backfilled Hubbard Creek fan shaft site was inspected. There did not appear to be additional settling or vertical displacement since the last site inspection (March 19, 2013), but it was still apparent that the immediate shaft fill area was lower than its original surface configuration. This area should continue to be visually monitored to ensure that it does not become a public safety hazard, and repairs should be made as necessary. If additional backfill material is required, the topsoil should first be removed, segregated, and properly stored until it is redistributed.

Hubbard Creek Fan Site

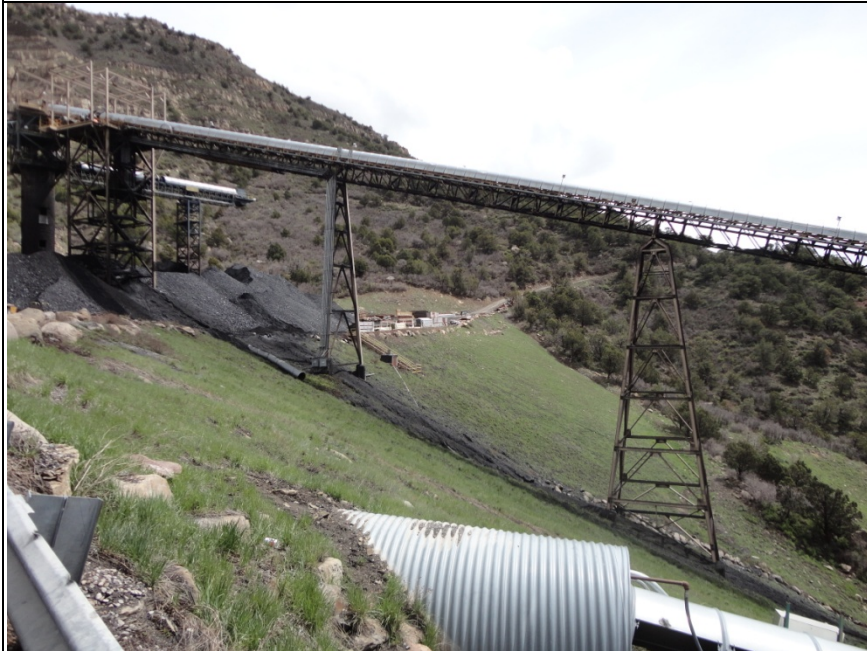
Photo 18

Gullies from recent erosion were observed along ditch D-C6 on the southern outslope of the D Seam bench. It appeared that the culvert (designated '36" Undesigned Culvert' on Map 15-2) that flows to ditch D-C6 had been blocked, causing flow over the road berm and out onto the outslope. At the time of the inspection, the culvert was clear and flow was through ditch D-C6, as designed. There was no off-site damage as a result of the overflow, since all of this area flows to Ponds B or C, and the gully was within the disturbed area boundary.

D Portal Bench Outslope

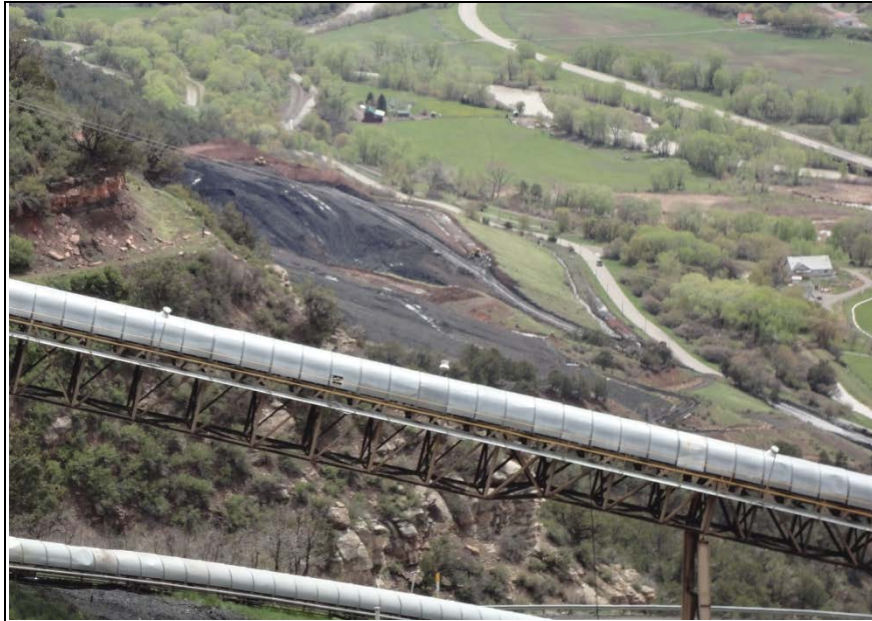
Photo 19

Gob Pile 2 from just east of D Portal Bench
