COLORADO DIVISION OF RECLAMATION, MINING AND SAFETY COAL PROGRAM INSPECTION REPORT

Permit Number: C-1981-014 Mine Name: Southfield Mine Operator: Energy Fuels Coal, Inc. Operator Address: Mr George Patterson P.O. Box 459 Florence, CO 81226	County: Fremont Operation Type: Underground Permit Status: Permanent Cessation Ownership: Private
	Operator Representative Present: None
Operator Representative Signature: (Field Issuance Only)

Inspection Start Date: May 7, 2013 Inspection Start Time: 13:00 Inspection End Date: May 8, 2013 Inspection End Time: 12:30	Inspection Type: Coal Complete Inspection Inspection Reason: Normal I&E Program Weather: Windy	
Joint Inspection Agency: None	Joint Inspection Contacts:	
Post Inspection Agency: None	Post Inspection Contacts:	
Inspector(s): Janet H. Binns	Inspector's Signature:

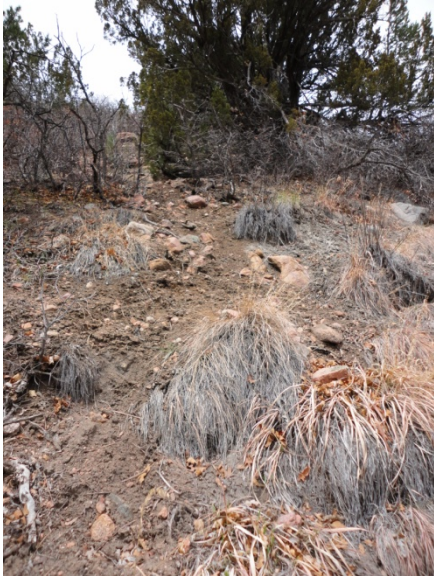
The reclaimed Monarch fan backfilled slope is dominated by bunch grasses. There are considerable openings between the bunch grasses. This slope needs to be monitored by EFCI to assure that weedy species or erosion does not become an concern on this slope.

Photo 1: Reclaimed Monarch fan slope

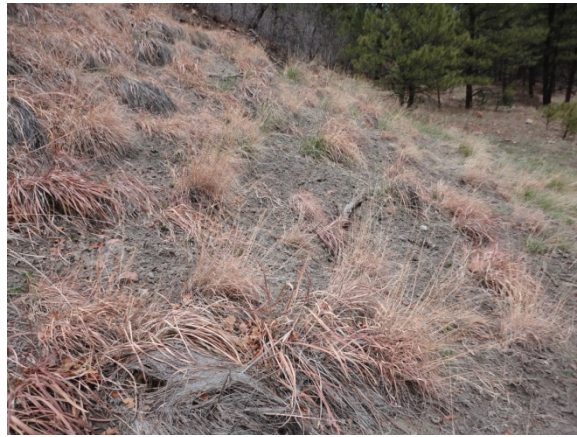
Photo 2: reclaimed Monarch fan slope

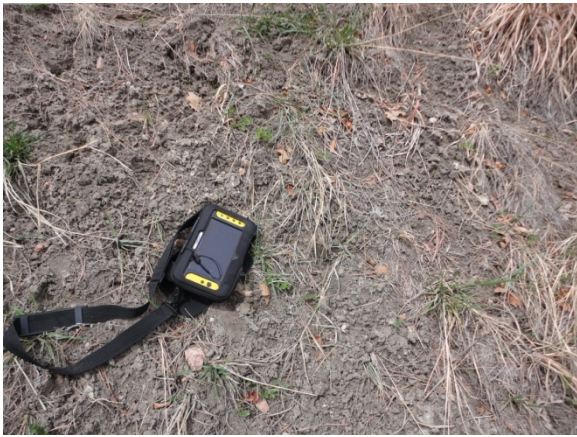
Photo 3: open space between bunch grass on Monarch Fan reclamation (Yuma for scale)

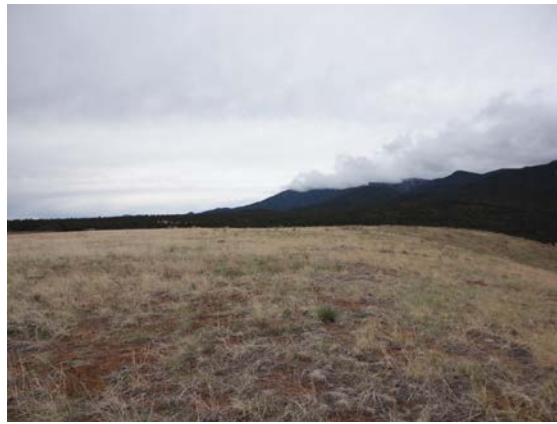
Cover on the RDA remains good. The inspector did not find evidence of noxious weeds, or rilling on the RDA.

Photo 4: top of RDA

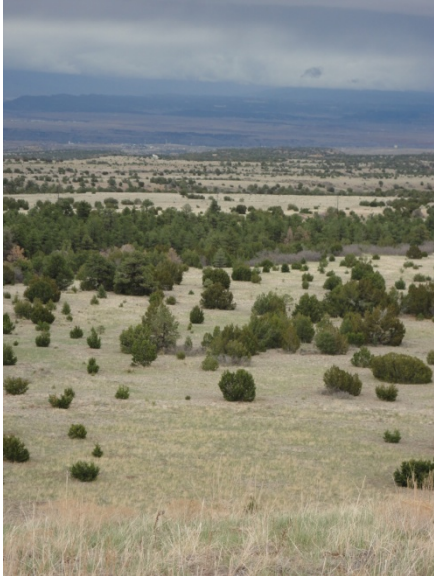
The inspector walked the Grassland reference area. It began raining lightly. The inspector was able to located 2 posts, on East corners. The inspector was unable to locate the other corner posts on the west side of the Grassland reference area. Vegetation is mixed blue grama & wheatgrass, as well as isolated clumps of juniper, Yucca, and oak brush. Some die-off of juniper was noted in the Grassland reference area.

Photo 5: Grassland Reference area

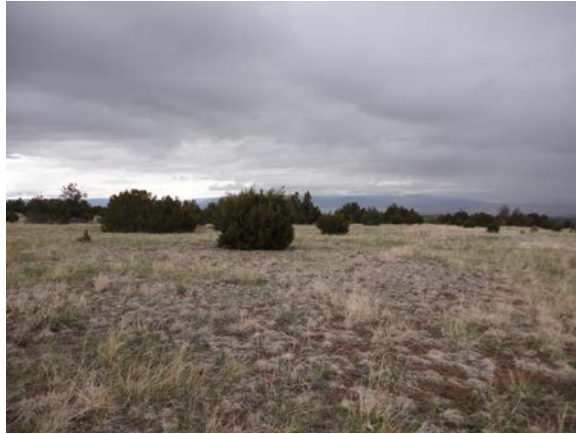
Photo 6: Grassland reference area

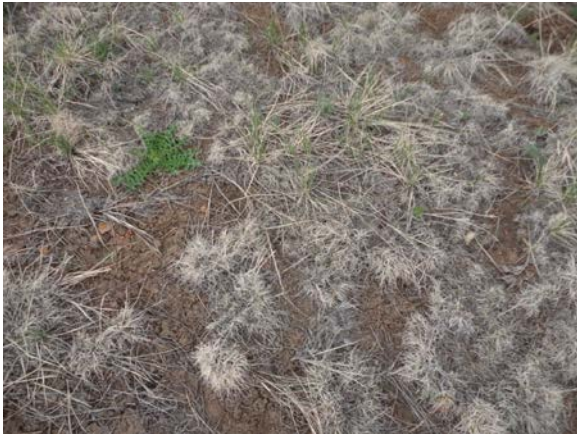
Photo 7: vegetative cover of Grassland reference area

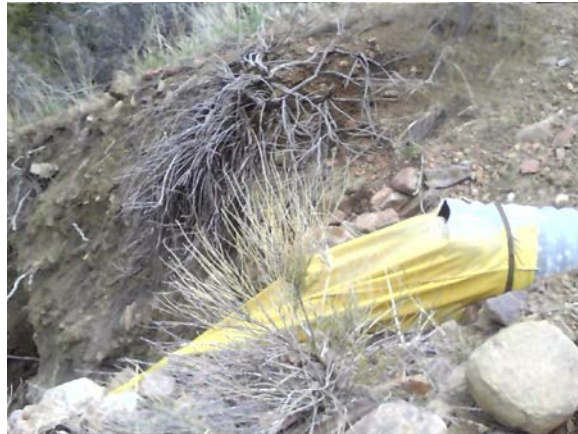
The access road to the Monarch fan was inspected. The Landowner had sent an e-mail to the Division on April 25, 2013 and again on May 7, 2013, with concerns regarding gully formation at the outfall of northernmost culvert on the fan road. This gully has existed for an extended period of time. Previously a fabric “sock” had been attached to the outfall of the culvert (Culvert 1S) in order to reduce the velocity of the outflow from the culvert. Culvert locations are shown on Map 20 for the mine site, and Map 30 for the Monarch Fan access road. The culvert in question is not depicted on either map, nor is there a design found in Exhibit 19. Over time this gully appears to have enlarged. It had been stabilized previously with large boulders. The gully has cut into the bank on the uphill side. Visual estimation size of the gully is 10 feet deep and 30 ft. long. Discussion with George Patterson in the EFCI office regarding this culvert, George said that rock fall had pinched off the outlet “sock” causing flow to back up in the “sock”. George cut the “sock” at the point that it had been pinched off by the rocks. It appears that at the cut location of the “sock” outflow is cutting into the south bank. This undercutting of the bank is allowing for enlargement of the gully. Over time the under cutting could eventually impact the access road.

Only the Northern most culvert (culvert S1-name given by inspector to designate which culvert is being referenced) was showing sign of active erosion at the outfall.

Photo 8: junction of Culvert 1S on Monarch fan road
With "sock"

Culvert 2S on Monarch Fan road indicated no problems or ongoing erosion at the outfall. Culvert 3S has a yellow “sock” attached and exhibited no problems. Culvert 4S has green tubing attached. No problems with this location. Culvert 4S is the only culvert along the Monarch fan road shown on Map 30 and in Exhibit 19. It appears that before the “sock” was pinched off by rockfall, and subsequently cut to alleviate the blockage of flow, the gully did not show signs of actively enlarging. Since the blockage and relief of the “sock” it would appear that this location is showing active erosion. Some method of flow reduction is needed to reduce the ongoing erosion.

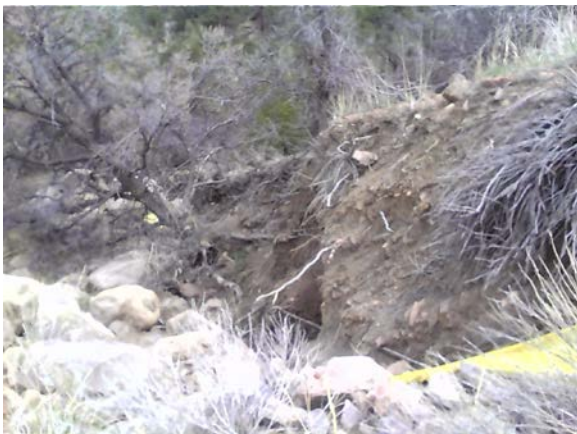
Photo 9: bank cutting on south side of Culvert 1S outfall

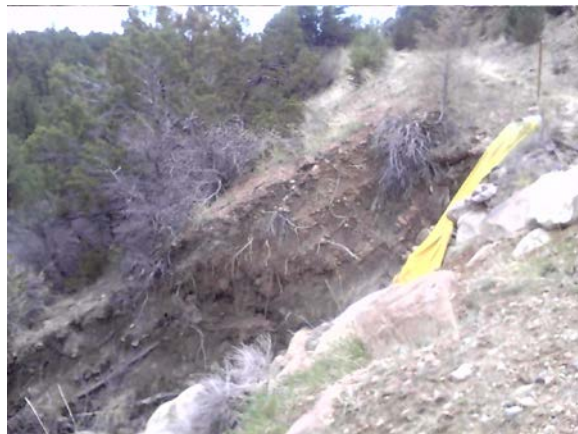
Photo 10: bank cutting at culvert 1S

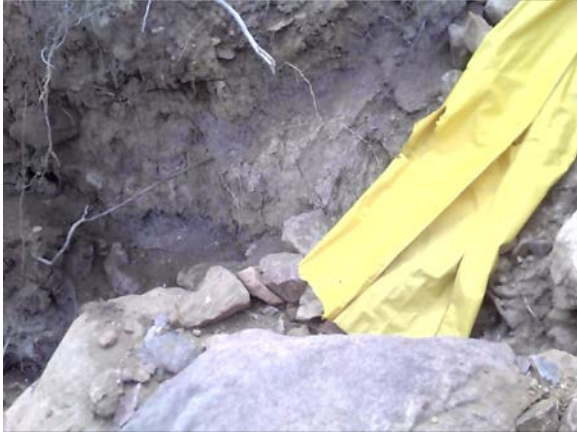
Photo 11: bottom of sock where water is cutting into South bank below culvert 1S Monarch fan road.

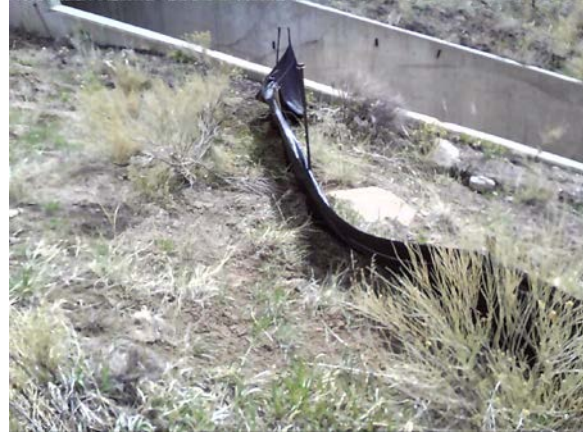
Vegetation on the portal area appears in good condition with good cover. Numerous small trees are easily observed in the SW area of the reclaimed portal. The wattles on the slope west of the gravel pad are holding well. The silt fence on the northwest side of the truck tunnel is holding up and appears to effectively be stabilizing this slope.

Photo 12: Silt fence at Truck tunnel holding well.

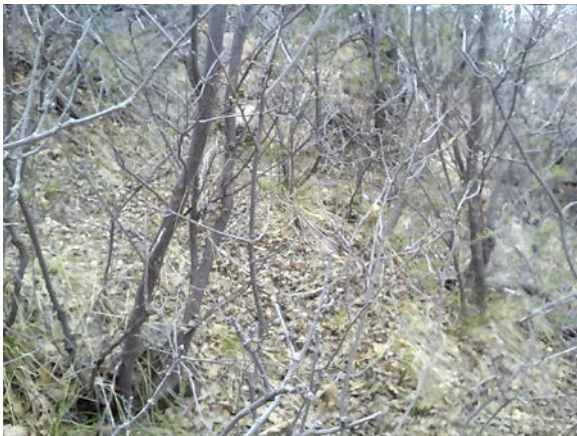
The inspector tried to walk the perimeter of the proposed Pinyon Juniper reference area. Portions of this area are extremely dense with oakbrush, and juniper. The proposed boundary was located to avoid areas that had been previously disturbed by mining activities. There is drainage toward the west extent that appears to be a natural drainage. The previously disturbed waterline is further to the west and outside of the proposed area.

Photo 13: Proposed PJ reference area

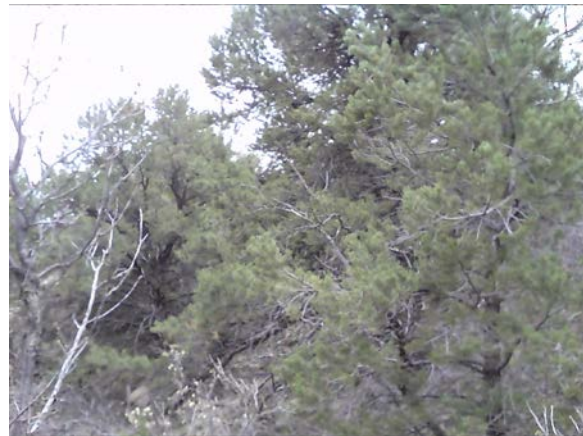
Photo 14: Proposed PJ reference area
