COLORADO DIVISION OF RECLAMATION, MINING AND SAFETY COAL PROGRAM INSPECTION REPORT

Permit Number: C-1996-084 Mine Name: Lorencito Canyon Mine Operator: New Elk Coal Company, LLC Operator Address: Mr Ron Thompson 12250 Highway 12 Weston, CO 81091	County: Las Animas Operation Type: Surface Permit Status: Permanent Cessation Ownership: Private
Operator Representative Present: RonThompson	
Operator Representative Signature: (Field Issuance Only)

Inspection Start Date: April 29, 2013 Inspection Start Time: 13:00 Inspection End Date: April 30, 2013 Inspection End Time: 17:00	Inspection Type: Coal Complete Inspection Inspection Reason: Normal I&E Program Weather: Clear	
Joint Inspection Agency: None	Joint Inspection Contacts:	
Post Inspection Agency: None	Post Inspection Contacts:	
Inspector(s): Leigh D. Simmons Daniel I. Hernandez	Inspector's Signature:

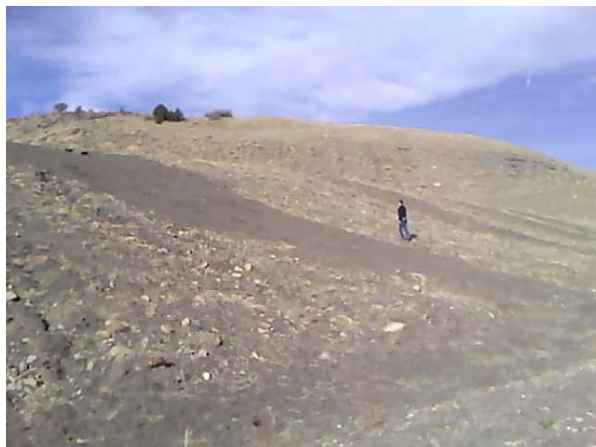
A large gully on a north facing slope in the area between pond 8 and pond 9b, near the top of the drainage had been repaired, and is due to be hydromulched soon.

Photo 1: Repaired gully between ponds 8 and 9/9b, to be hydromulched

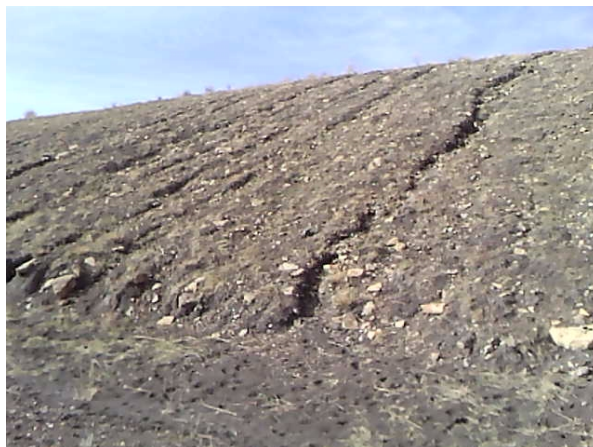
Some rills on fill 9 were inspected. There was some vegetation growing in them, so unless erosion develops further attempts to repair them at present may cause more harm than good.

Photo 2: Vegetated rills on fill 9 to be monitored

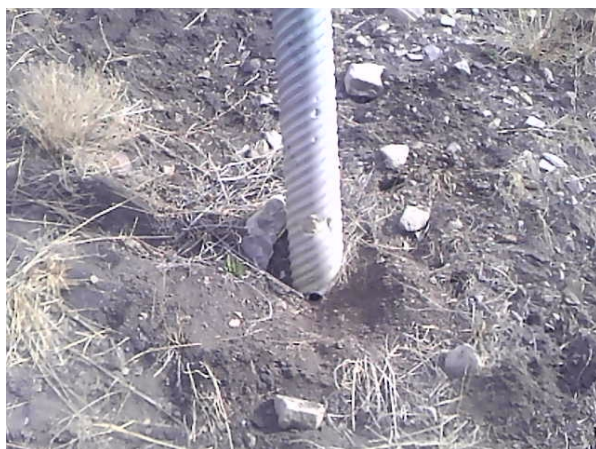
Culverts under the road to pond 9 were clear. Pond 9 was dry. The embankments and emergency spillway appeared stable. The primary spillway was intact, but sediment has accumulated to a point in excess of the design specification. Figure Ex 15-14 from the permit provides a summary of the sedimentation pond designs. It specifies that there should be a minimum of 1.1' between the elevation of the sediment and the lowest weepholes. **Sediment should be cleared from around the primary spillway riser; the riser should then be checked against the design specifications in Figure Ex 15-14.**

Photo 3: Primary spillway riser, pond 9/9b

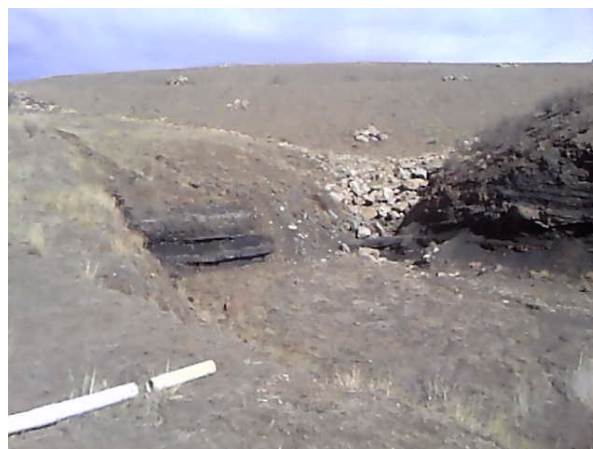
Pond 7 was dry. No problems were observed with the embankments or spillways. **Some non-coal waste should be cleared from the site.** The weepholes in the primary spillway riser were in accordance with the design in Figure Ex 15-14, with some minor modifications - these field modifications were PE certified elsewhere in Exhibit 15. A gully on the east side of fill 7 has been stable since ~2006 according to Mr Thompson. It is currently ~6' wide and ~3' deep. If further erosion is observed it will be necessary to repair the gully, despite the difficult access. Across the road from fill 7 one of the ditches is stable, but the other has eroded and washed out some bales. **The bales should be replaced with rock dams.**

Photo 4: Non-coal waste at pond 7

Non-coal waste around the site, in particular near fill 9 and around pond 7, should be cleared.

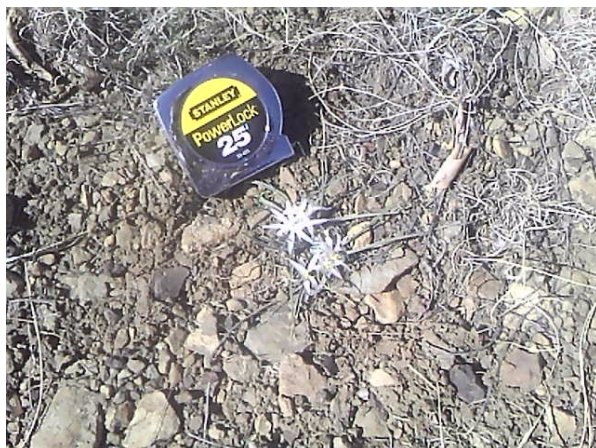
Leucocrinum montanum, or sand lily, was observed near pond 7.

Photo 5: *Leucocrinum montanum*

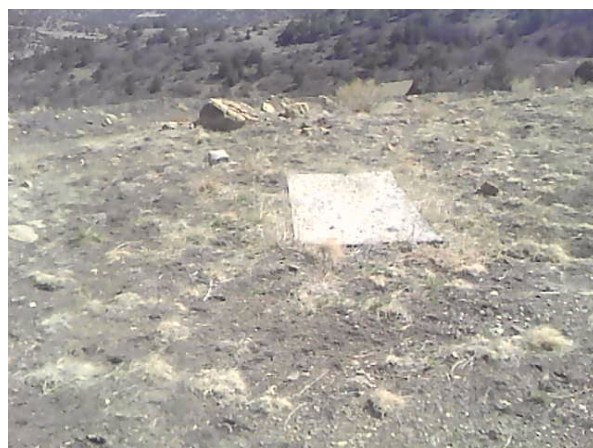
Photo 6: Non-coal waste

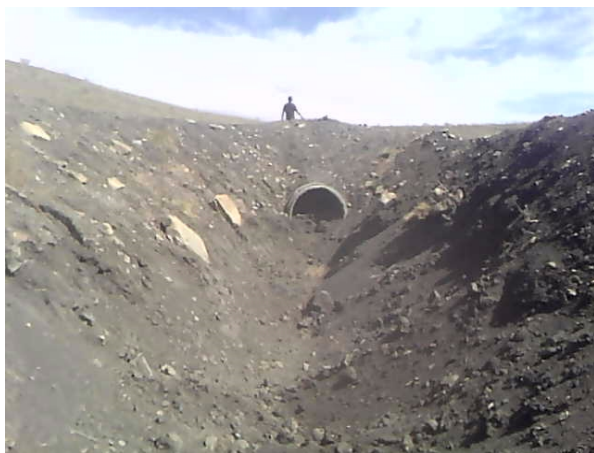
The culverts under the haul roads were all clear, with the exception of the 48" concrete culvert. It was partially blocked with tightly compacted sediment. The culvert should be cleaned out.

Photo 7: Concrete culvert

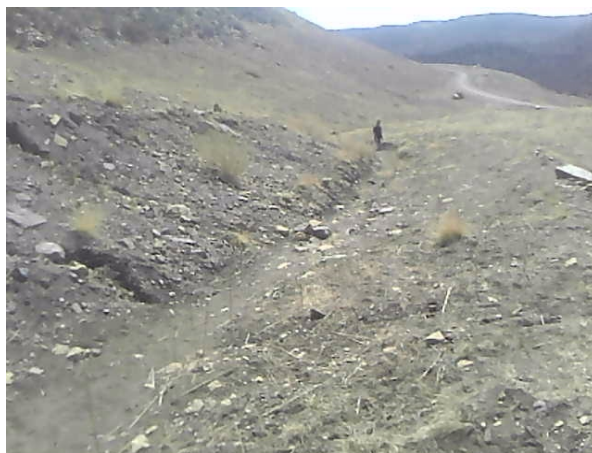
Photo 8: Ditch near fill 7 needing flow control

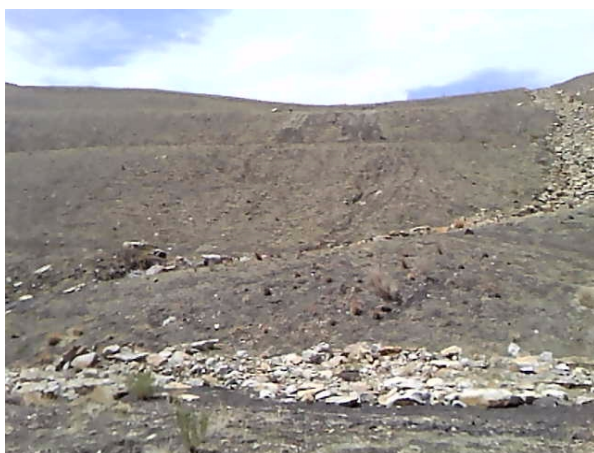
Photo 9: Gully and rills on fill 9 needing repair

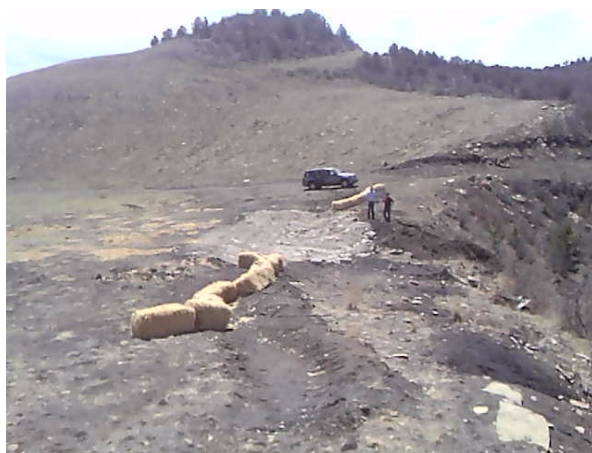
New rock armoring at the top of the drainage above pond 5 looked excellent. Bales had been added to prevent gullying around the sides. Before the area can be permitted as an SAE it will be necessary to demonstrate that runoff will meet effluent limits, or add some additional control structure. All the culverts on the road to pond 5 were clear. Pond 5 was dry. The embankments and spillways were in good condition. The primary spillway was in accordance with the design specification.

Photo 10: Improvements made to drainage above pond 5

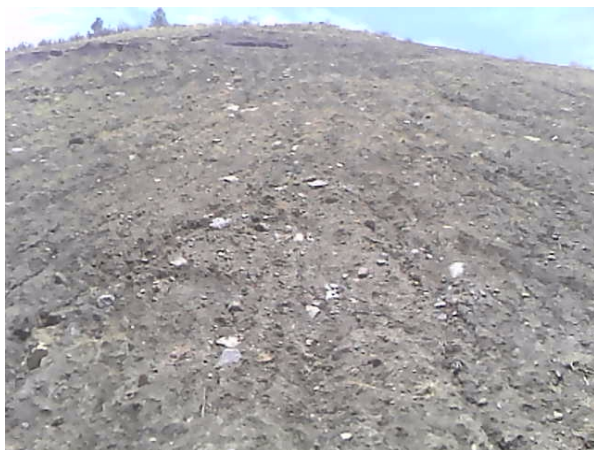
Rills of the north side of the "nob" are a constant concern however no problems requiring immediate attention were identified.

Photo 11: The "nob"
