## COLORADO DIVISION OF RECLAMATION, MINING AND SAFETY COAL PROGRAM INSPECTION REPORT

<b>Permit Number:</b> C-1981-012 <b>Mine Name:</b> New Elk Mine <b>Operator:</b> New Elk Coal Company, LLC <b>Operator Address:</b> Mr Ron Thompson 12250 Highway 12 Weston, CO 81091	<b>County:</b> Las Animas <b>Operation Type:</b> Underground <b>Permit Status:</b> Temporary Cessation <b>Ownership:</b> Private
	<b>Operator Representative Present:</b>  Ron Thompson
<b>Operator Representative Signature:</b> (Field Issuance Only)

<b>Inspection Start Date:</b> April 29, 2013 <b>Inspection Start Time:</b> 13:00 <b>Inspection End Date:</b> May 16, 2013 <b>Inspection End Time:</b> 11:00	<b>Inspection Type:</b> Coal Complete Inspection <b>Inspection Reason:</b> Normal I&E Program <b>Weather:</b> Cloudy	
<b>Joint Inspection Agency:</b>  None	<b>Joint Inspection Contacts:</b>	
<b>Post Inspection Agency:</b>  None	<b>Post Inspection Contacts:</b>	
<b>Inspector(s):</b>  Leigh D. Simmons  Daniel I. Hernandez	<b>Inspector's Signature:</b>

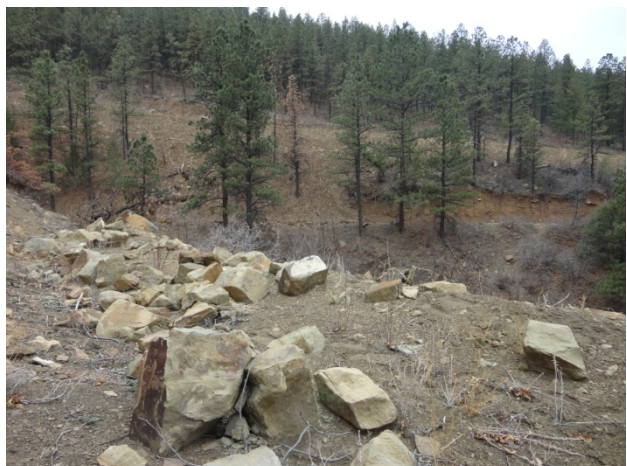
- Clean water diversion ditch D26 does not exist as shown on map 13, and may be impossible to construct without compromising the road above. The short leg of the ditch west of the natural drainage has a very small watershed and may not be necessary. **East of the drainage, the ditch needs to be cleaned of rocks, non-coal waste and vegetation, and should be shaped and graded to ensure it functions as designed. The old section of ditch, running south east from the lower water tank pad, should be reclaimed.**

Photo 1: D26

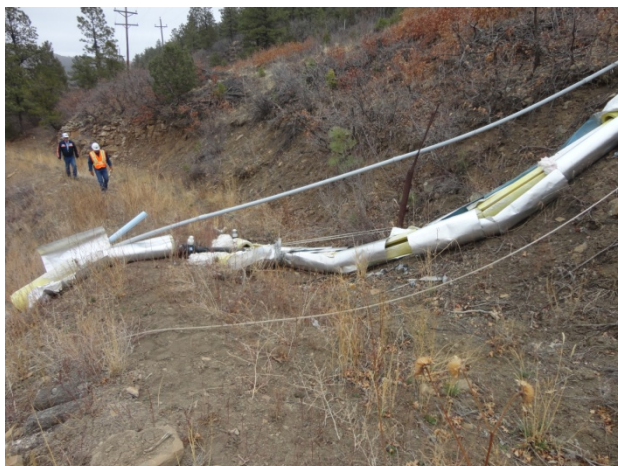
- A defunct water pipe and an old electrical cable were compromising ditch D26. **These items should be removed.**
- Ditch D39aa does not exist on the ground, and the highwall behind the substation has not been constructed as shown on map 13. In the same area, the parking lot has not yet been added to map 13. **An unmarked**

Photo 2: Water lines compromising D26

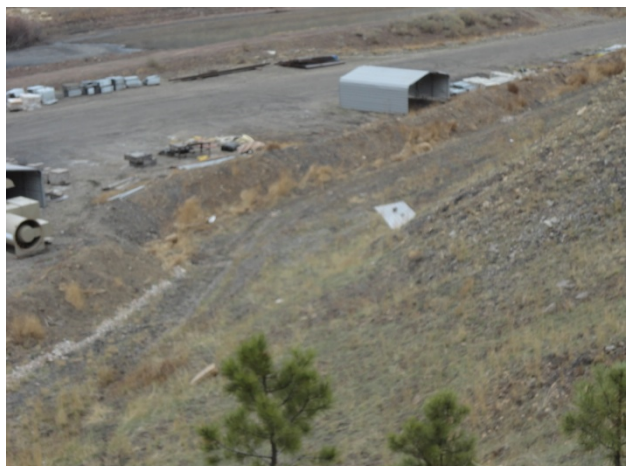
Photo 3: Non-coal waste outside disturbance boundary

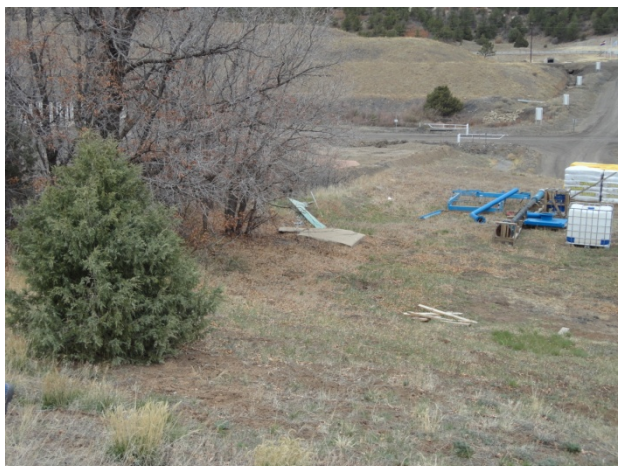
Photo 4: Non-coal waste

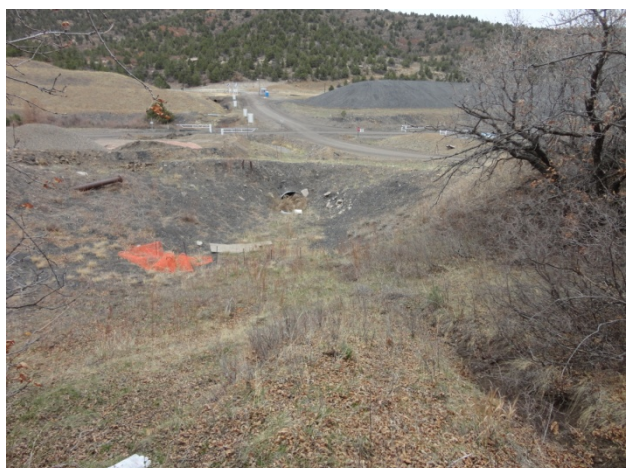
Photo 5: Non-coal waste

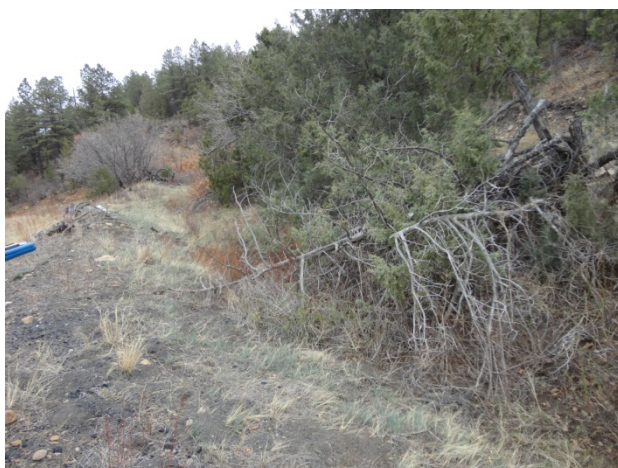
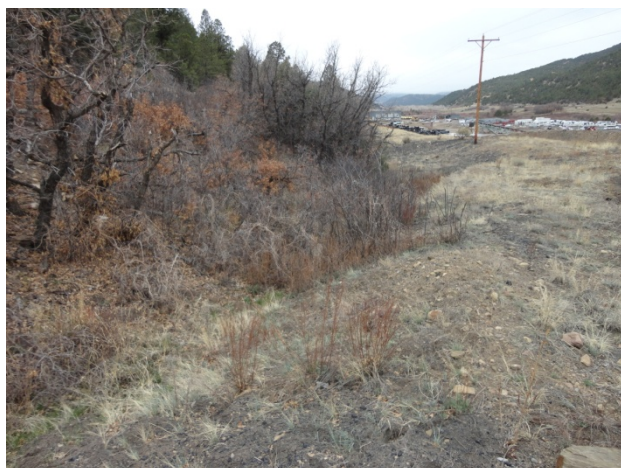
Photo 6: Vegetation to be cleared from D7

Photo 7: Vegetation to be cleared from D7 (2)

- Culvert C4 had been removed. **The cut where it used to be should be deepened to prevent the ditch acting as an impoundment. Timber and vegetation should be cleared from ditch D7.** The first section of culvert C3 had been replaced, replacement of the second section is pending the delivery of new culverts. The ditch from C3 to the river had been cleaned and was in excellent shape.

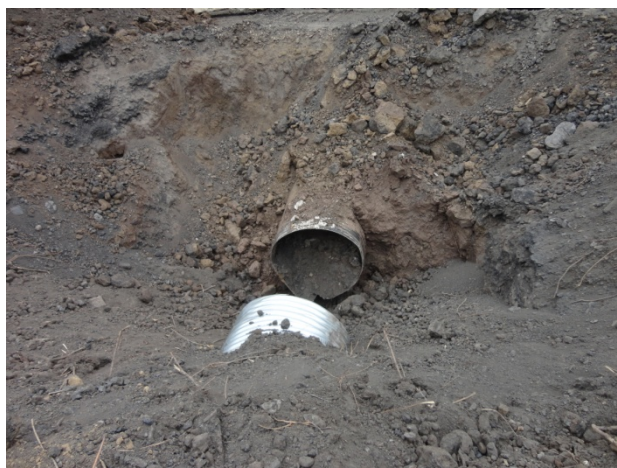
Photo 8: C3 work in progress

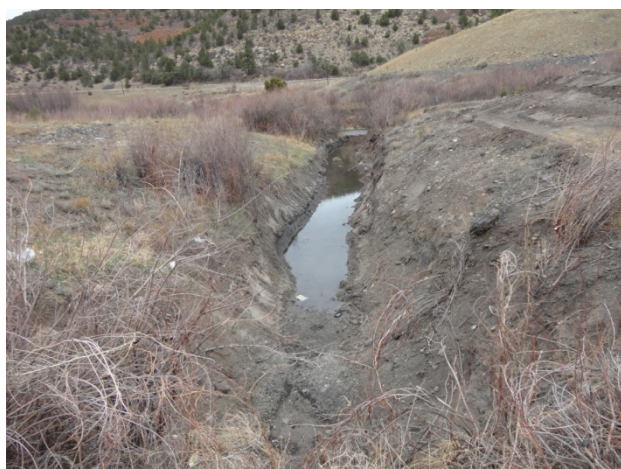
Photo 9: C4 removed, ditch currently acting as impoundment

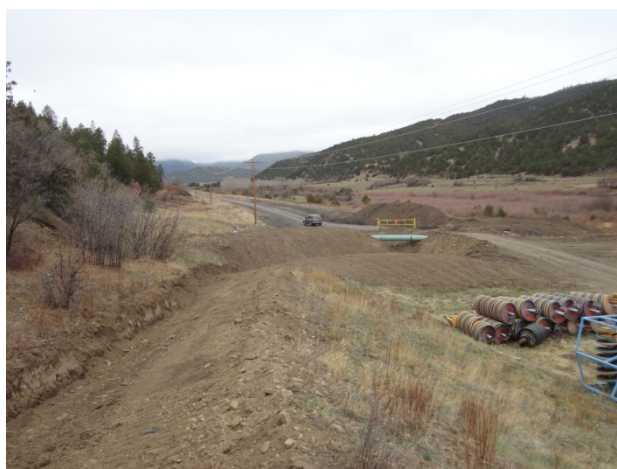
Photo 10: Completed work at C2

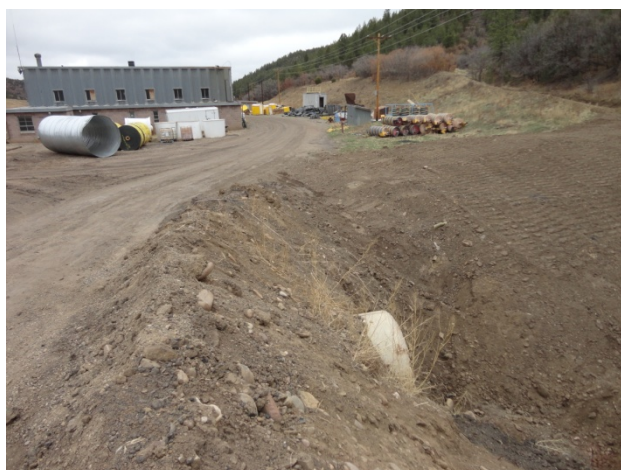
- Redundant sections of culvert C2 had been excavated, leaving just a single concrete culvert. The downstream section of the ditch, on the north side, runs into a wetland. **Some scrap aluminium should be removed and the berm should be re-shaped.** On the south side of C2, **a berm should be established to prevent shop area runoff from entering the clean water system.**

Photo 11: Berm needed to protect C2 inlet

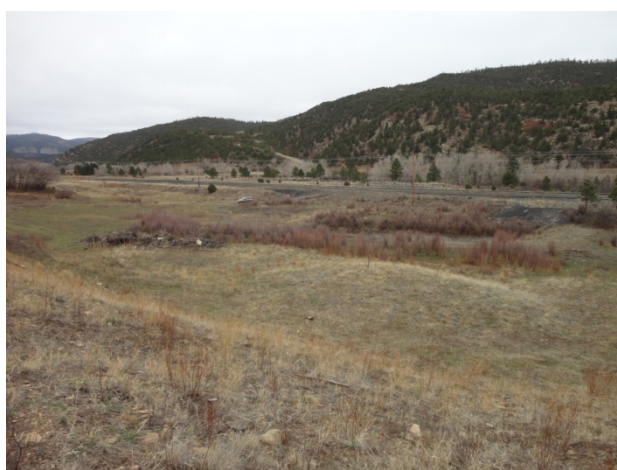
- No recent disturbance was observed at the core lab SAE. This area could potentially be phase 1 bond released, and the natural drainage from the south re-established.

Photo 12: Containments and core lab SAE area

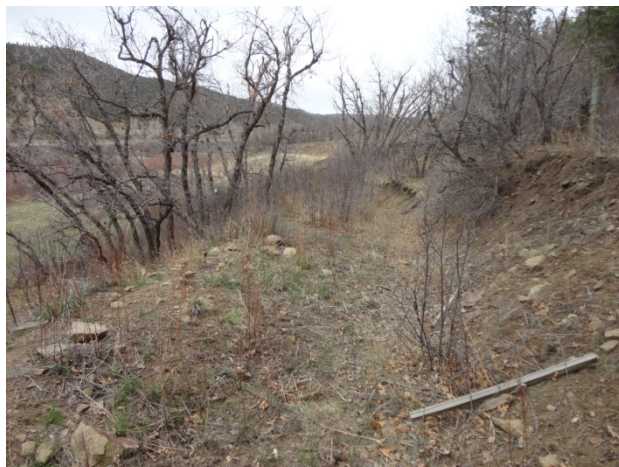
- Clean water ditch D29 exists but becomes indistinct towards the flat area. D29b is ~50' uphill, draining to the west. The scheme works, but is not as drawn on either version of map 14. **Both ditches need to be cleared. D29 currently ends in the containment; the ditch should be extended to the east, into the clean water system.**

Photo 13: D29

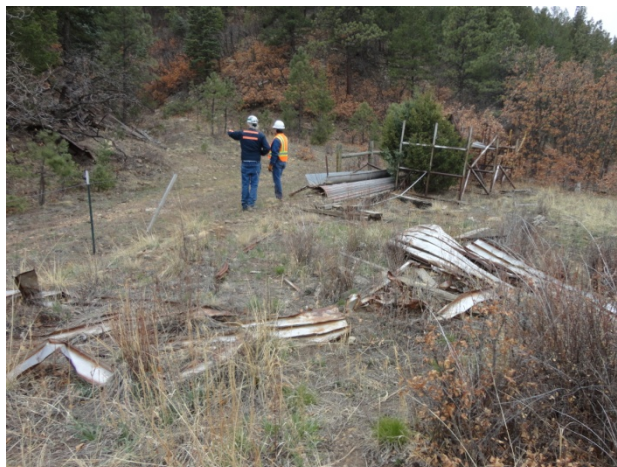
Photo 14: Pre-law non-coal waste

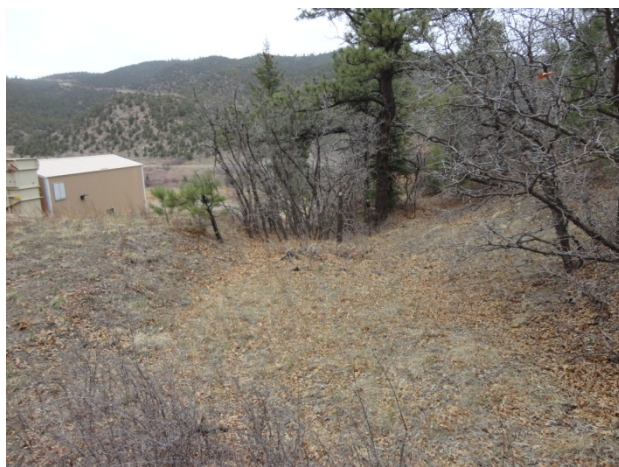
- The upstream section of armored ditch D28 exists in the natural drainage beside the west fan, as drawn on map 14 dated 7/24/2012, although many of the features shown on this map don't exist on the ground. An earlier version of the map, dated 3/12/2012, more closely reflects the physical reality on the ground in many cases, but neither version is comprehensive.

Photo 15: Signs of D28 near west fan

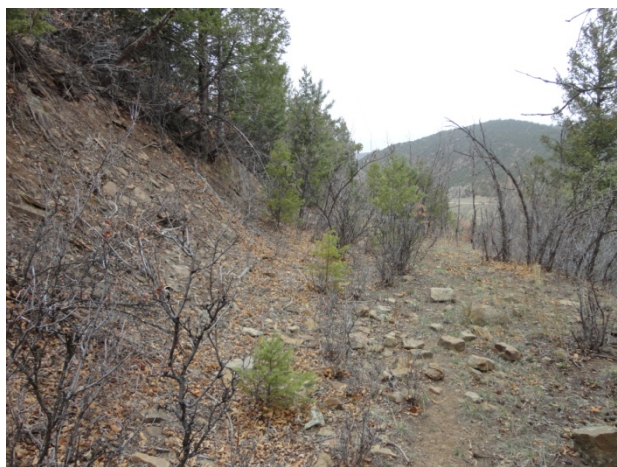
Photo 16: Indistinct diversion ditch near west fan

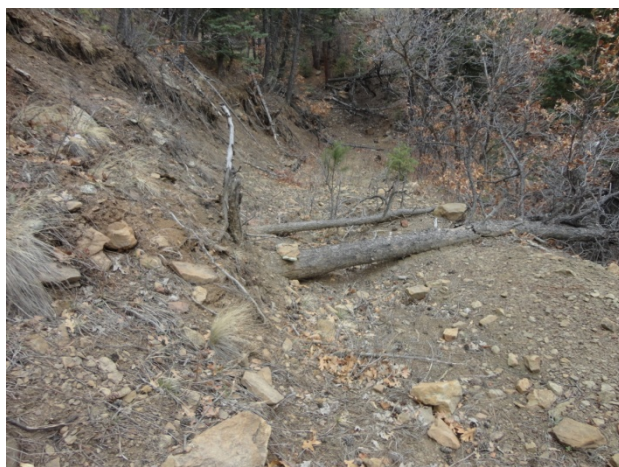
Photo 17: Diversion ditch near west fan to be cleared

- The clean water diversion ditch above the west fan exists uphill of the position shown on the 3/12/2012 map, but **needs to be cleared of vegetation and reshaped in places.**

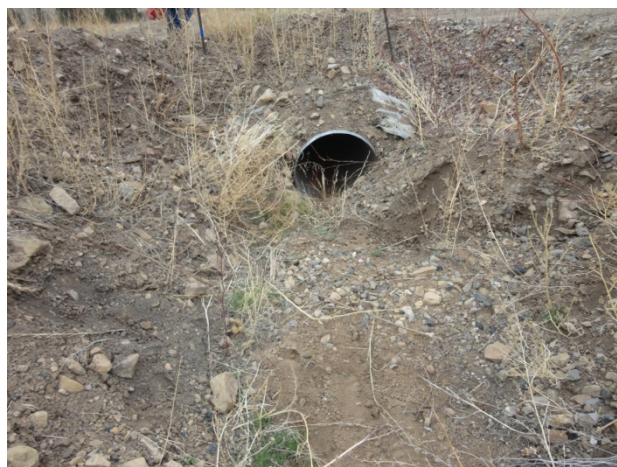
Photo 18: C23 to be cleared

- Culvert C23a does not exist. Culvert C23 was partially blocked, but has about 2' free at the top. Table 21 specifies that C23 has a minimum diameter of 30", which would give a cross sectional area of 94 square inches. Although C23 is oversized, even a 4' diameter culvert blocked to 2' does not have the cross sectional area to meet the design specification. **C23 should be cleared.**

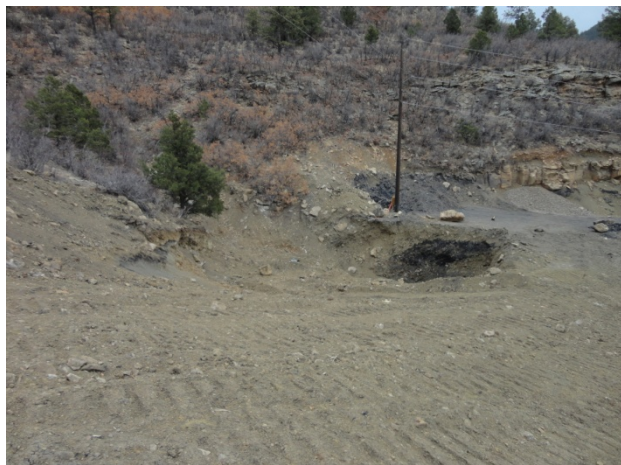
Photo 19: C41 project to be completed

- The damaged section of the culvert under the conveyor, C41, had been replaced and the area around it filled and restored. Delivery of a final 30' section of culvert is holding up the completion of this project. **The final section should be placed and the surrounding area backfilled around it.**

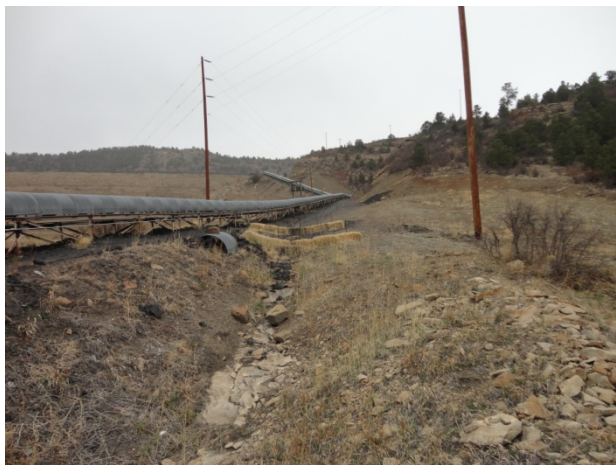
Photo 20: New bales beside the refuse conveyor

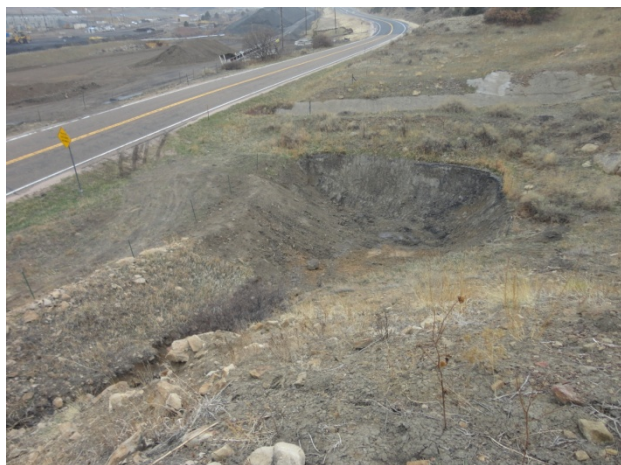
Photo 21: Containment 5

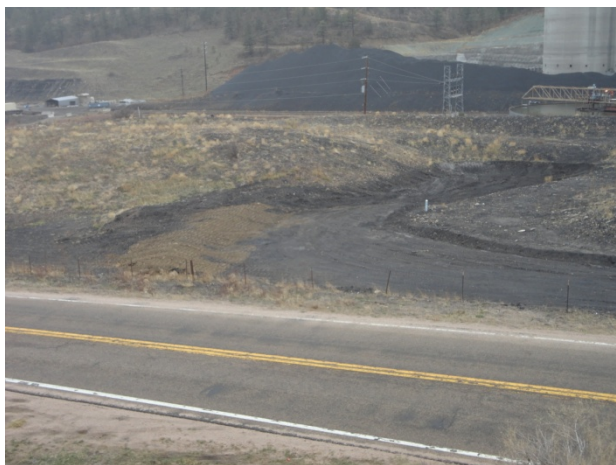
Photo 22: Berm at edge of disturbed area north of containment 3

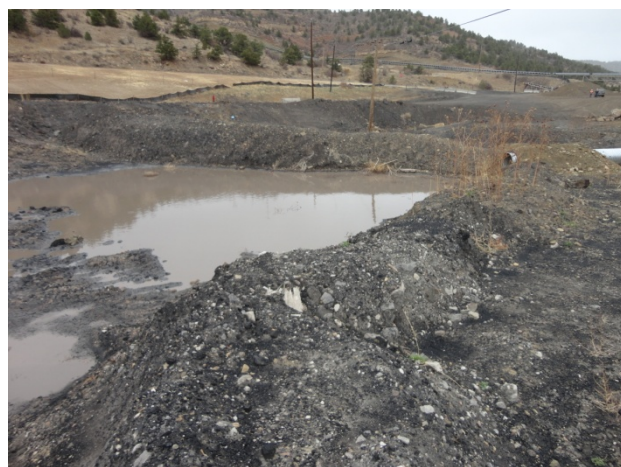
Photo 23: Inlet to C13

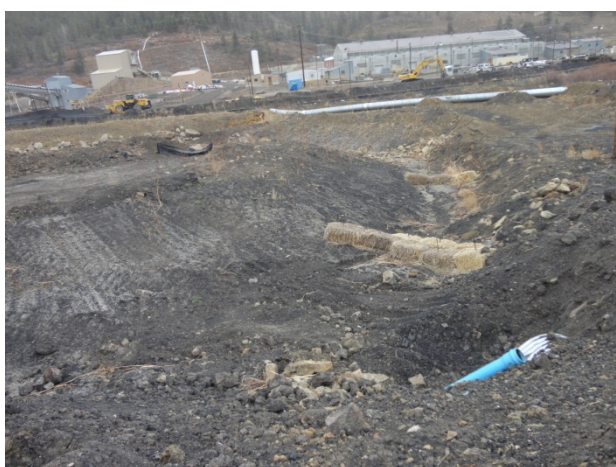
- Culvert C26 had been removed and an open channel to the river restored. The clean water system comprising ditches D11 and D19, and culverts C14, C14a and C30 had been re-routed. Neither of the recent versions of Map 13 reflects the reality on the ground exactly, but the system appears effective.

Photo 24: Open channel replacing C26

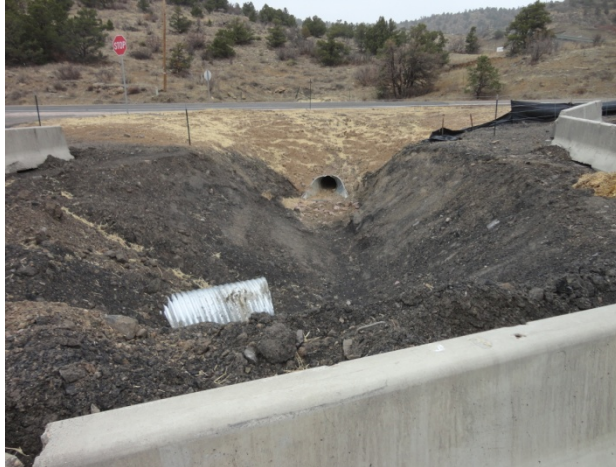
Photo 25: C14 repositioned

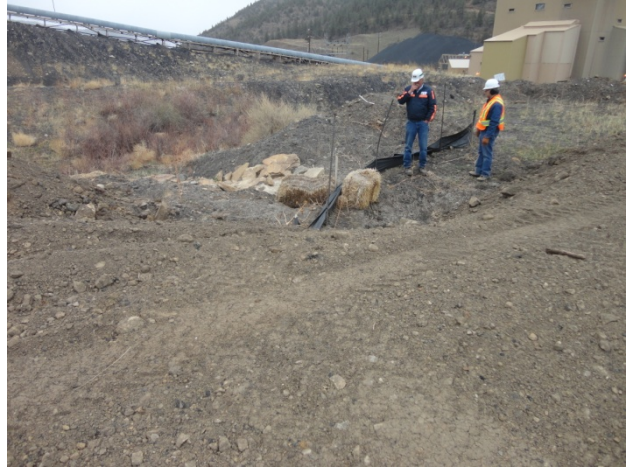
Photo 26: East end of topsoil stockpile SAE needs to be built up

- The topsoil stockpile SAE was good at the western end, but **needs to be built up at the eastern end, and a silt fence should be installed.**
- Culverts C70 and C71 had been removed and an open channel restored from the double culverts from the pond 8 emergency spillway to the river. **This area is to be hydromulched.**

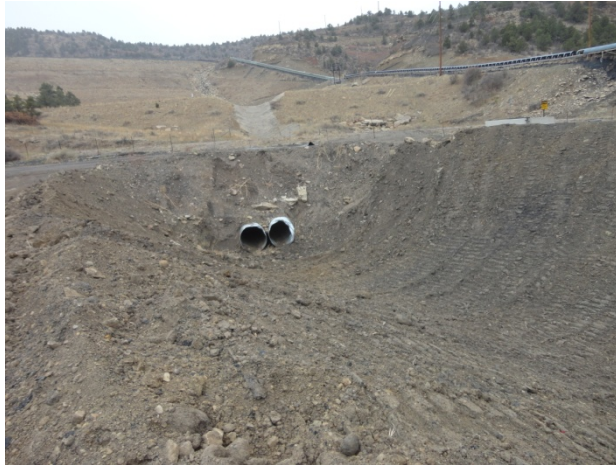
Photo 27: Open channel in place of C70

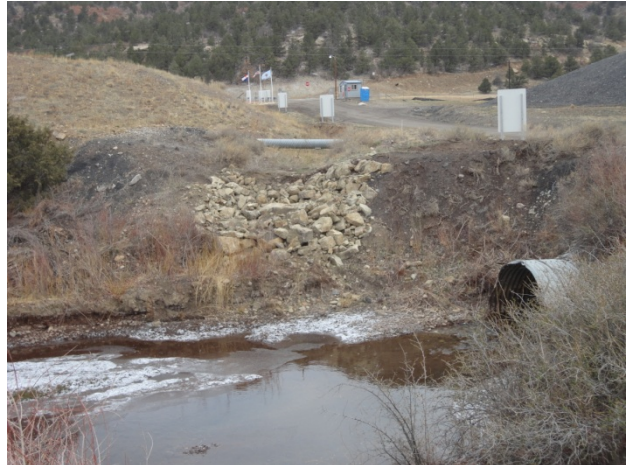
- No problems were noted around the soil storage area.
- Culverts C9 and C9a were clear.
- The gabion at the outlet of ditch D10 had been replaced with rock armoring. The new work looked excellent.

Photo 28: Armoring to replace gabion at D10 outlet

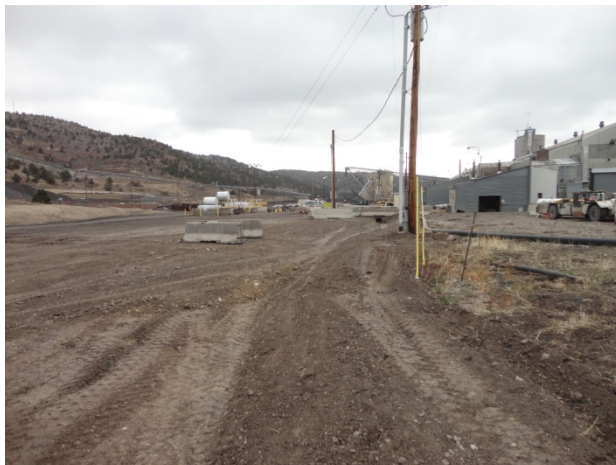
Photo 29: Re-routed D16

- **The upstream leg of ditch D16 needs to be re-shaped**, but the downstream leg has been successfully re-routed past the power pole.
- **The C16 system of culverts is ineffective. The culverts are due to be replaced.**

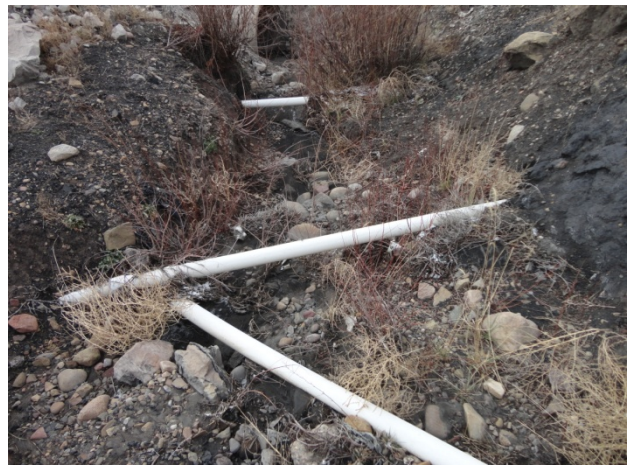
Photo 30: PVC to be removed from D32b

- Culvert C72 was clear at both ends, but **C73 needs to be cleaned at the outlet**. Some work at the pumphouse was still to be completed. **The berms in the area should then be completely restored, the stream buffer zone protected and clearly indicated and the ground hydromulched.** Culvert C74 had been pulled; the decision had not yet been made whether to replace it to allow access to the cistern. **Below C74 ditch D15 should be re-shaped.** The remainder of the system (D32, C64, D32a, C65, D32b) were all clear, although **PVC pipes in D32b should be removed.**

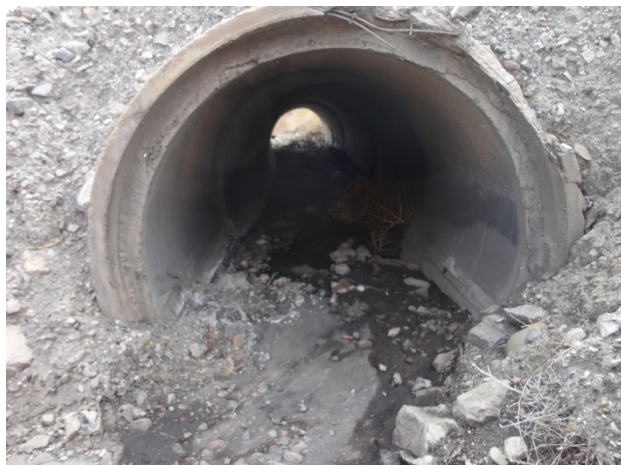
Photo 31: C19 to be cleaned

- **Culverts C19 and C22 both need to be cleaned.** D22 and C32 were good.
- No problems were observed with Pond 6. Mr. Thompson expected to solicit bids for lining the pond in June.

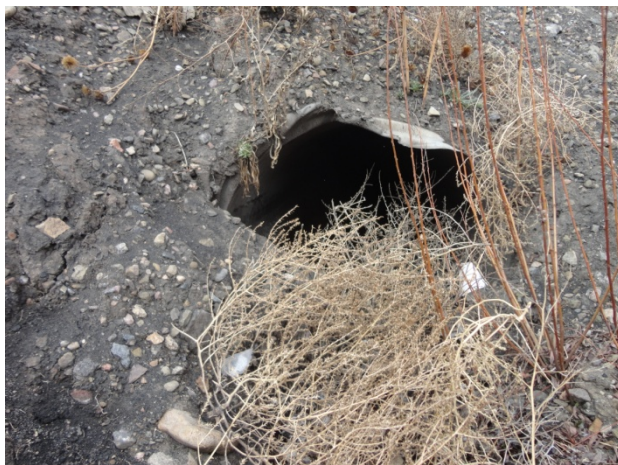
Photo 32: C22 to be cleaned

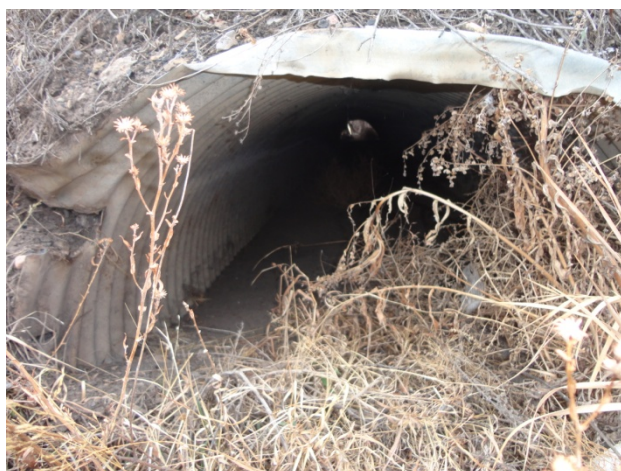
Photo 33: "Railroad culvert", needs to be cleaned

- The two “railroad culverts” at the eastern end of the disturbance boundary both need to be cleaned
- The berm at the eastern end of the SAE south of pond 7 had been restored. The boundary of this SAE does not match that shown on map 13. **The position of the unlabelled clean water diversion ditch should also be verified and the ditch re-established on the ground.** No bales are needed in the ditch.

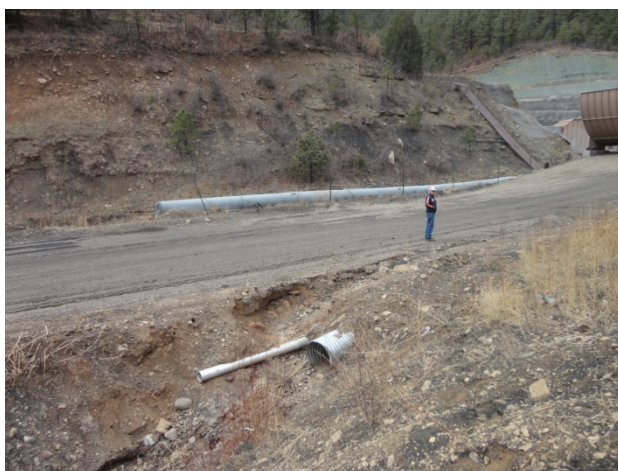
Photo 34: C48 in the background, unidentified culvert conveying disturbed area runoff in front

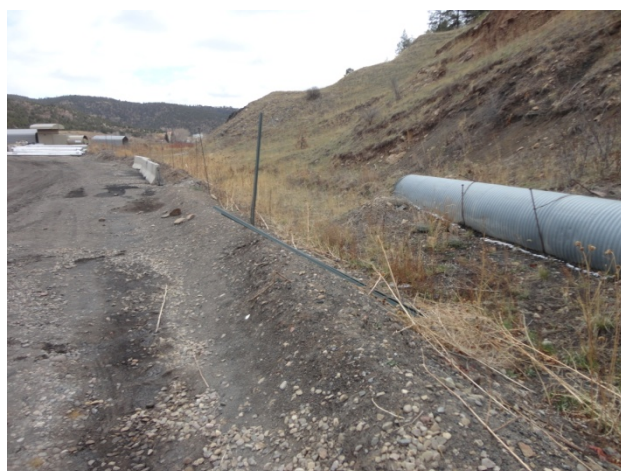
Photo 35: Looking east down clean water diversion south of pond 7

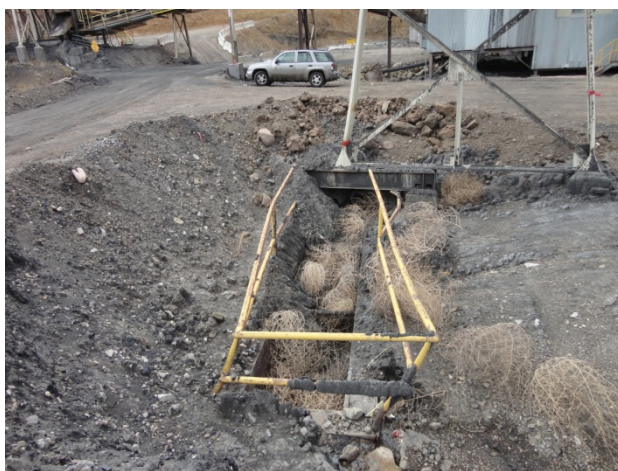
Photo 36: Drop inlet 3 to be cleaned

- **Drop inlets 2 and 3 both need to be cleaned.**
- **The culvert running into drop inlet 3 needs to be identified and cleaned.** (In this area, the conveyor is incorrectly drawn on map 13, leading to confusion with identification of features on the ground)

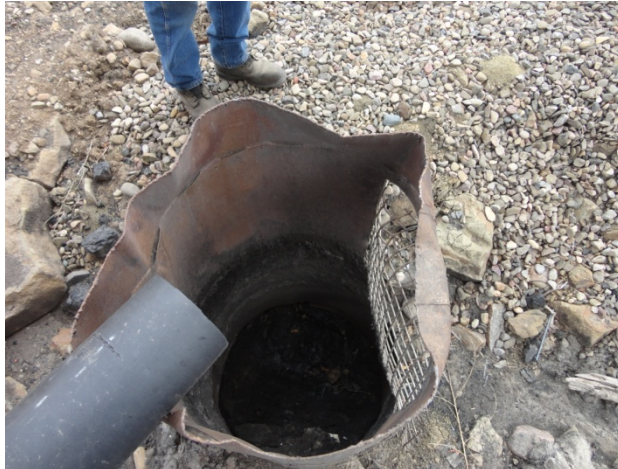
Photo 37: Drop inlet 2 to be cleaned

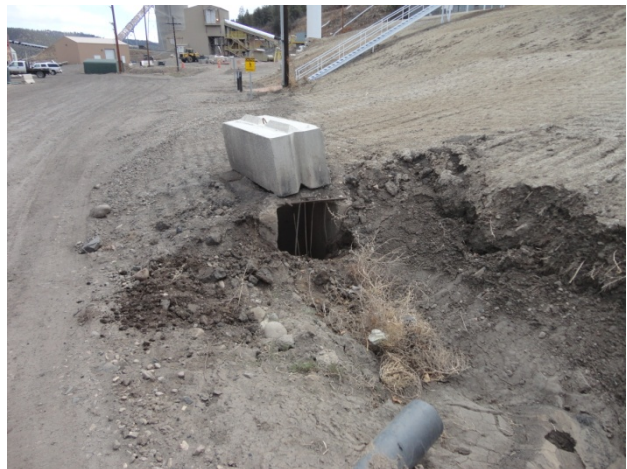
Photo 38: Inlet to C12

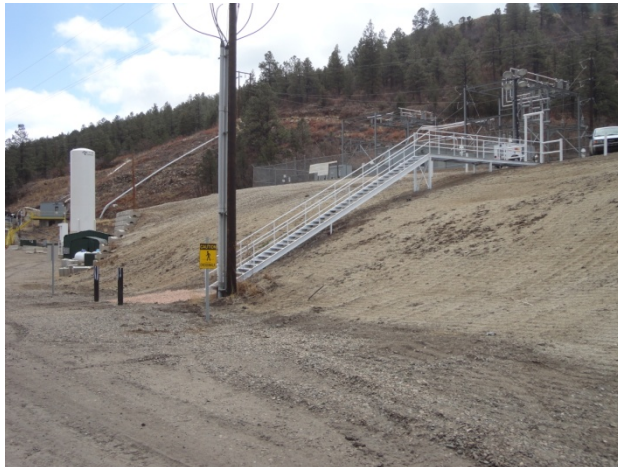
MR119, dealing with the construction of a parking lot and walkway, was recently approved.

Photo 39: New parking lot and walkway

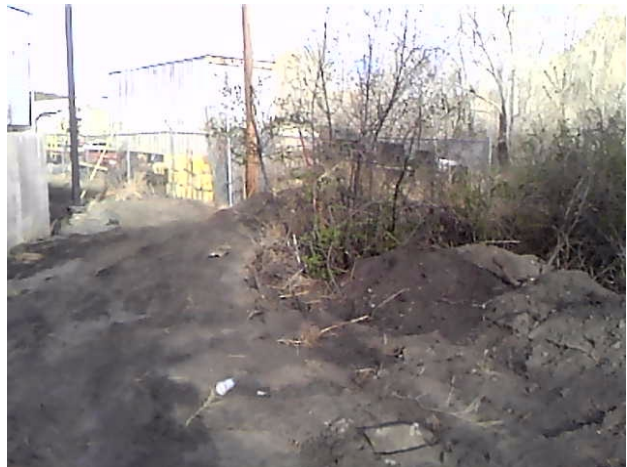
The Jansen Load-out was inspected on Tuesday 30th. Weeds and non-coal waste had been cleared from the site. The berm had been restored. Boundary markers were in place. Both sumps were clear.

Photo 40: improved berm at Jansen Loadout

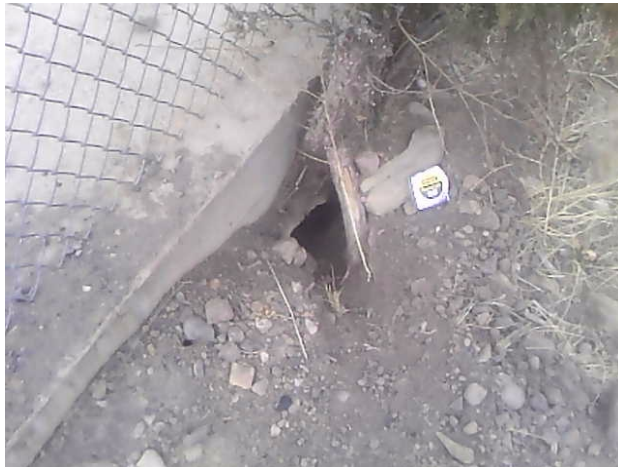
The Apache Canyon airshafts were inspected on Tuesday 30th. **The phone number on the mine ID sign at the second airshaft needs to be updated.** Some repairs had been made at the second airshaft, but a new hole had opened up around the base of the concrete pad, near a small tree. **The hole must be filled.**

Photo 41: Slumping at airshaft pad to be filled

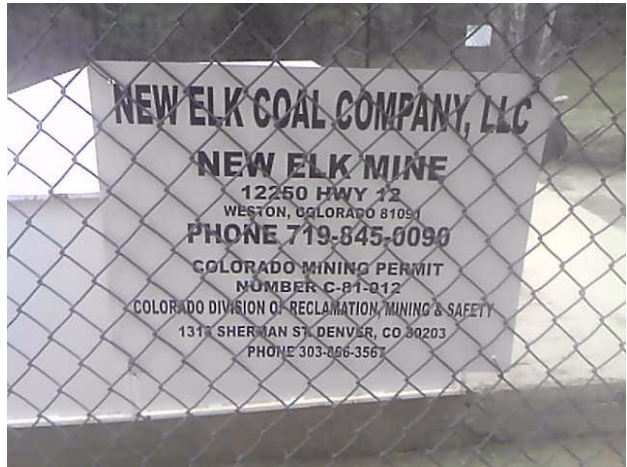
Photo 42: Sign at second Apache Canyon airshaft
