## COLORADO DIVISION OF RECLAMATION, MINING AND SAFETY COAL PROGRAM INSPECTION REPORT

<b>Permit Number:</b> C-1981-019 <b>Mine Name:</b> Colowyo Coal Mine <b>Operator:</b> Colowyo Coal Company L.P. <b>Operator Address:</b> Mr. Tony Tennyson 5731 State Highway 13 Meeker, CO 81641	<b>County:</b> Moffat, Rio Blanco <b>Operation Type:</b> Surface <b>Permit Status:</b> Active <b>Ownership:</b> Federal
	<b>Operator Representative Present:</b>  None
<b>Operator Representative Signature: (Field Issuance Only)</b>

<b>Inspection Start Date:</b> May 16, 2013 <b>Inspection Start Time:</b> 10:23 <b>Inspection End Date:</b> <b>Inspection End Time:</b>	<b>Inspection Type:</b> Aerial Inspection <b>Inspection Reason:</b> Normal I&E Program <b>Weather:</b> Clear
<b>Joint Inspection Agency:</b>  None	<b>Joint Inspection Contacts:</b>  
<b>Post Inspection Agency:</b>  None	<b>Post Inspection Contacts:</b>  
<b>Inspector(s):</b>  Robert D. Zuber, P.E.	<b>Inspector's Signature:</b>  <i>Robert D. Zuber</i> <b>Signature Date:</b>  5/20/2013

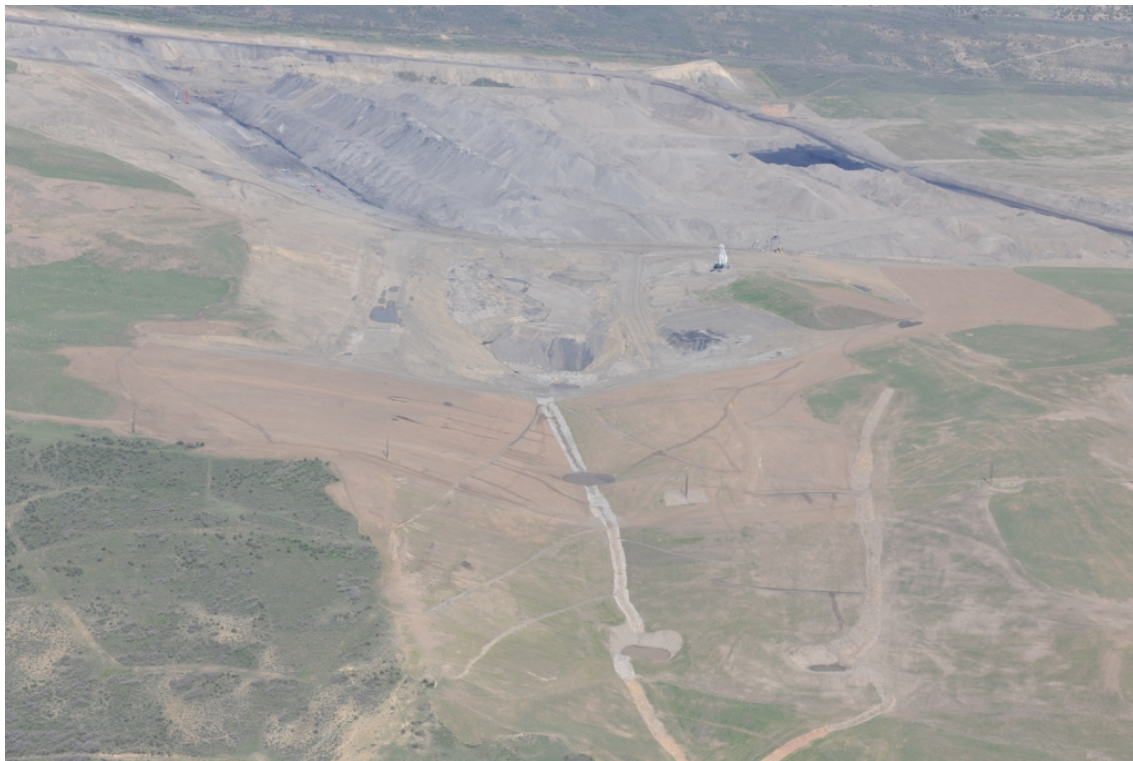
Some contour ditches appeared to have blowouts. These were seen above NTEP1 Pond, near EP2 Pond, and above East Taylor Pond. These will be inspected on the ground in the next three business days.

**SL-07 Area (EP-057) in middle of photo. Some contour ditches may have blown out.**

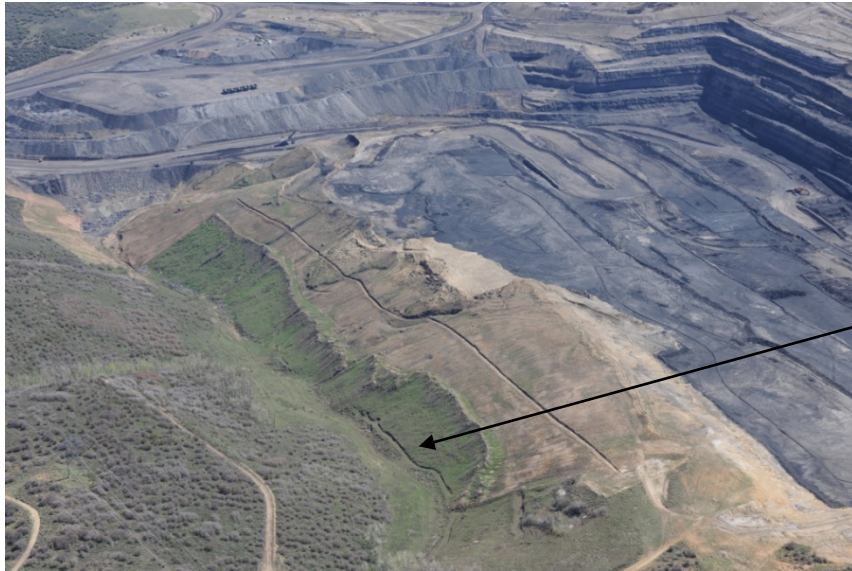
**Topsoil Stockpile 16I**

Topsoil Stockpile 16I was inspected. There is a feature below the topsoil stockpile that looks like a scarp. This will be investigated on the ground in the next three business days.

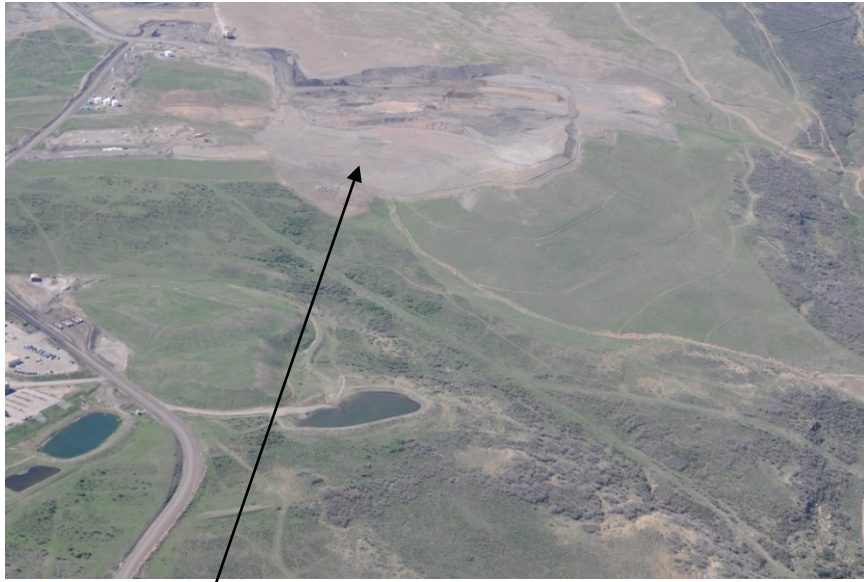
**SL-07 Area (WP018)**

The SL-07 bond release application contains four reclamation blocks, and three of these can be viewed in the photographs of this inspection: WP018, WP019, and EP057. ST002 (the fourth block) was not photographed. No problems were identified in the photographs of the three blocks other than the issue mentioned in the hydrology section.
