COLORADO DIVISION OF RECLAMATION, MINING AND SAFETY COAL PROGRAM INSPECTION REPORT

Permit Number: C-1996-083 Mine Name: Bowie No. 2 Mine Operator: Bowie Resources, LLC Operator Address: Mr William A Bear P.O. Box 483 Paonia, CO 81428	County: Delta Operation Type: Underground Permit Status: Active Ownership: Federal and Forest
	Operator Representative Present: None Present - Aerial Inspection
Operator Representative Signature: (Field Issuance Only)

Inspection Start Date: May 16, 2013 Inspection Start Time: 11:11 Inspection End Date: May 16, 2013 Inspection End Time: 11:12	Inspection Type: Aerial Inspection Inspection Reason: Normal I&E Program Weather: Clear
Joint Inspection Agency: None	Joint Inspection Contacts:
Post Inspection Agency: None	Post Inspection Contacts:
Inspector(s): Sandra L. Brown Harry B. Ranney	Inspector's Signature:

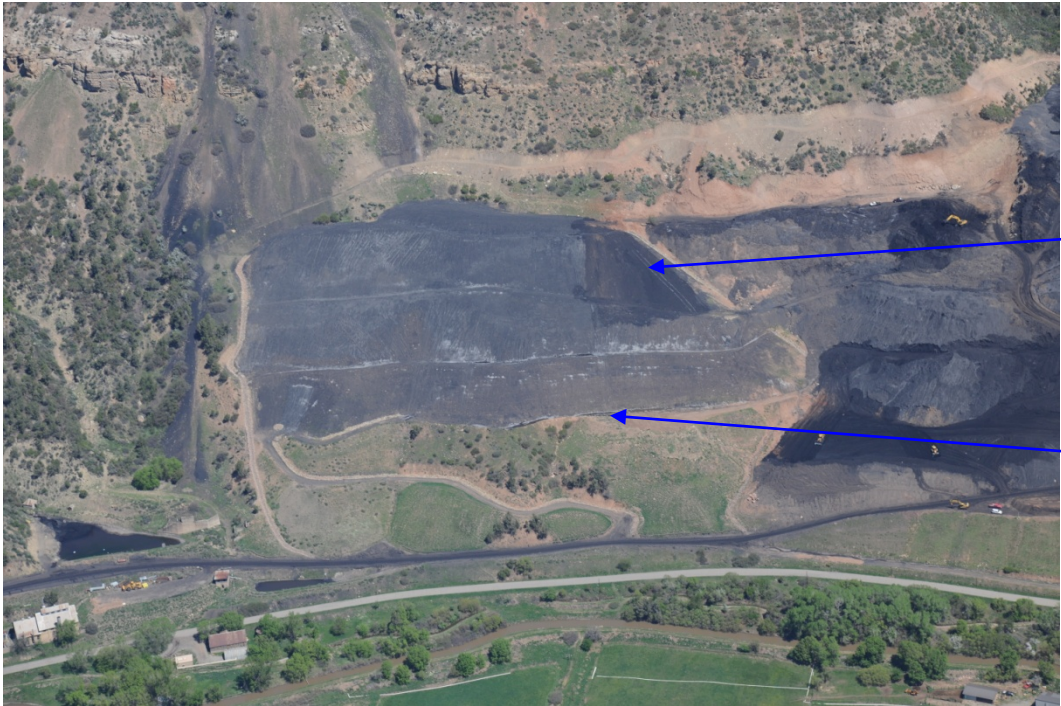
Compaction activities were underway on the west end of the second bench of Gob Pile #2, where the cover fill material pile was formerly located. It appeared that the material being compacted was coming from the end dumped material just north of/above the second bench. An excavator was moving material in the northern portion of the Gob Pile #2 expansion area. Recent grading activities were apparent on the east end of the upper bench of Gob Pile #4.

<p>Gob Pile #4</p> <p>Recently graded</p> <p>Standing Water</p>

Abatement Description: Remove cover fill material from ditches D-F5 and D-F6 and repair or reconstruct all lateral ditches on Gob Piles 2 and 4 to ensure positive drainage as designed in the approved permit application package.

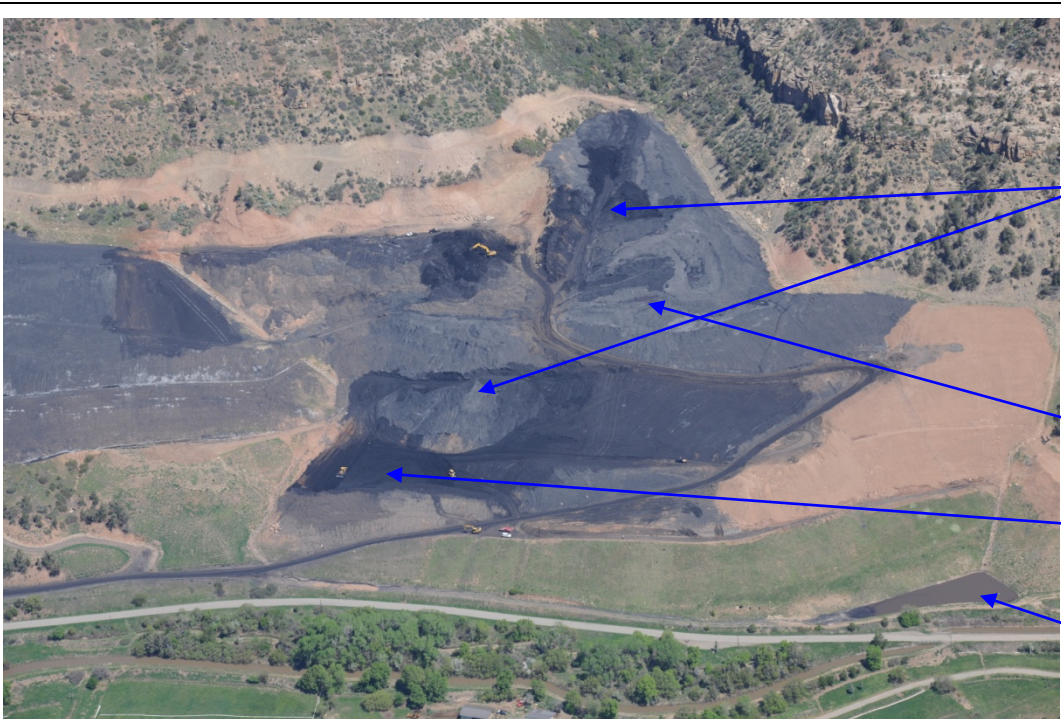
Standing water was observed on the upper bench of Gob Pile #2, in the area where material had been end dumped and was awaiting spreading and compaction.

<p>Gob Pile #2</p> <p>End Dumped Material</p> <p>Standing Water</p> <p>Compaction Effort</p> <p>Pond F</p>

Abatement Description: Place and compact all existing end-dumped material on Gob Pile #2 in accordance with the Rules and approved permit application package.

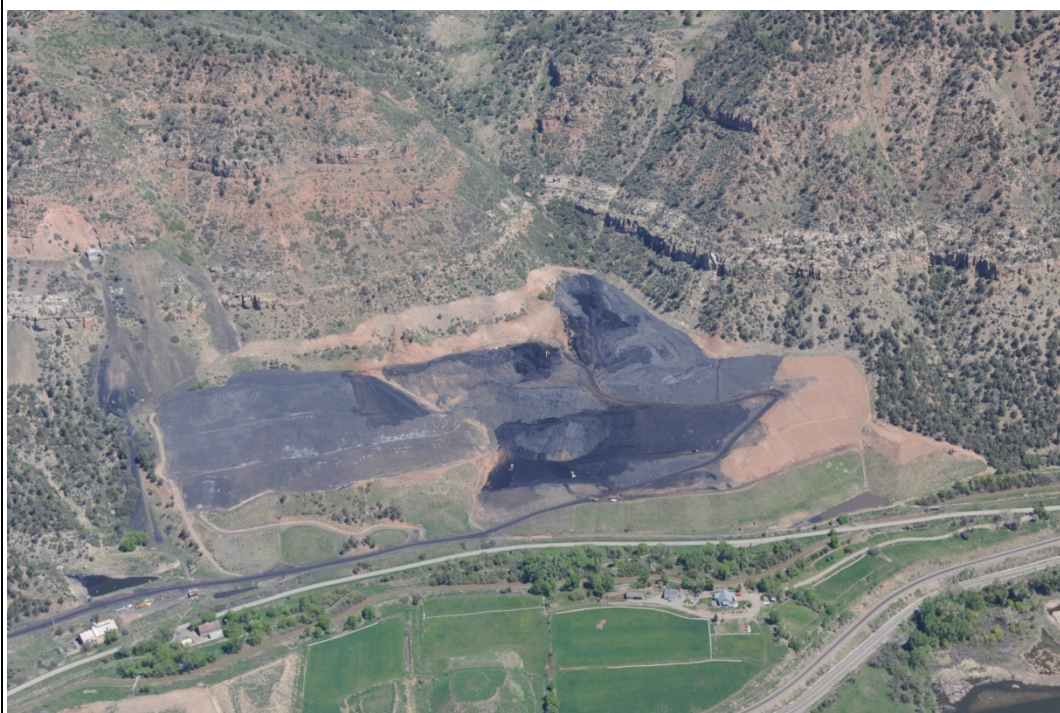
Gob Piles

#4 at left, #2 at right, #3 bottom center
