**COLORADO DIVISION OF RECLAMATION, MINING AND SAFETY
COAL PROGRAM INSPECTION REPORT**

Permit Number: C-1992-081 Mine Name: Hayden Gulch Loadout Operator: Hayden Gulch Terminal, LLC Operator Address: Mr. Roy Karo 37796 Routt County Road 53 P.O. Box 670 Hayden, CO 81639	County: Routt Operation Type: Loadout Permit Status: Permanent Cessation Ownership: Private
	Operator Representative Present: Dennis Jones
Operator Representative Signature: (Field Issuance Only)

Inspection Start Date: May 13, 2013 Inspection Start Time: 12:30 Inspection End Date: May 13, 2013 Inspection End Time: 14:30	Inspection Type: Coal Partial Inspection Inspection Reason: Normal I&E Program Weather: Clear
Joint Inspection Agency: None	Joint Inspection Contacts:
Post Inspection Agency: None	Post Inspection Contacts:
Inspector(s): Jared L. Ebert	Inspector's Signature:

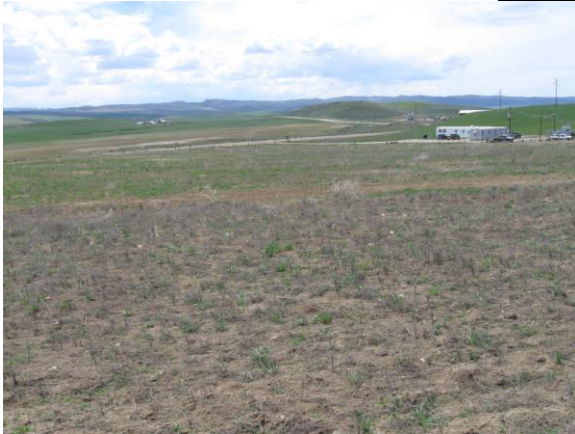
The former facilities area was walked, this area appears stable. Some minor rills were observed on several slopes.

The former facilities area has sparse vegetation establishing throughout the parcel. The primary vegetation observed was annual forbs. Some desirable vegetation such as perennial grasses has begun to germinate.

Former facilities area from the northwest end looking south east.

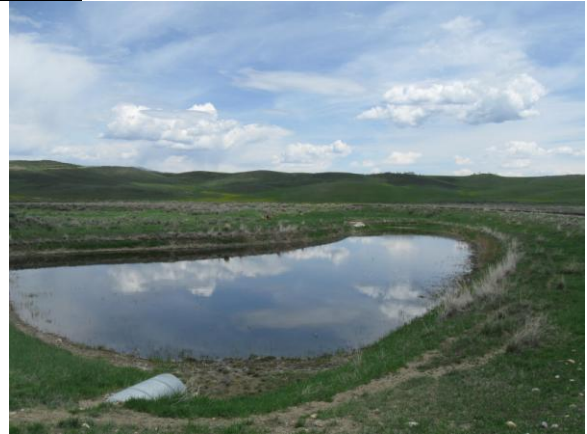
Rail loop pond.

Several deer were observed near the water's edge at the rail loop pond.

The rail loop pond was holding water but was not discharging. The inlet was clear and functional and the pond embankment was stable and vegetated. The spillway was also clear and functional. The soil embankment holding the discharge pipe in place will need to be repaired as some of it has eroded away.

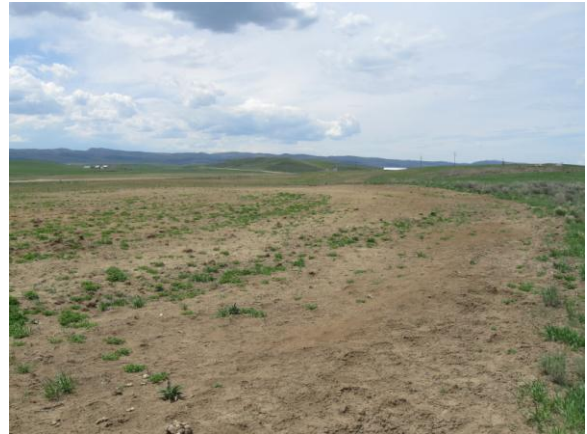
Topsoil stockpile No. 2 was stable and some vegetation has begun to re-establish on the pile. Several rills were observed on the access corridor used to transport the topsoil to the reclaimed area.

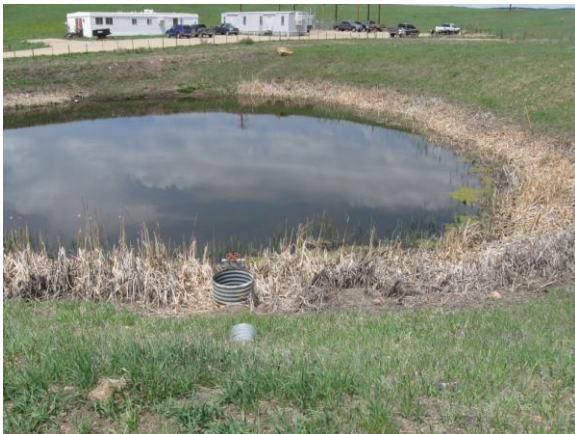
Truck loop pond.

The truck loop pond was holding water but was not discharging. The pond embankment appeared stable and vegetated. The primary and emergency spillway was clear and functional.

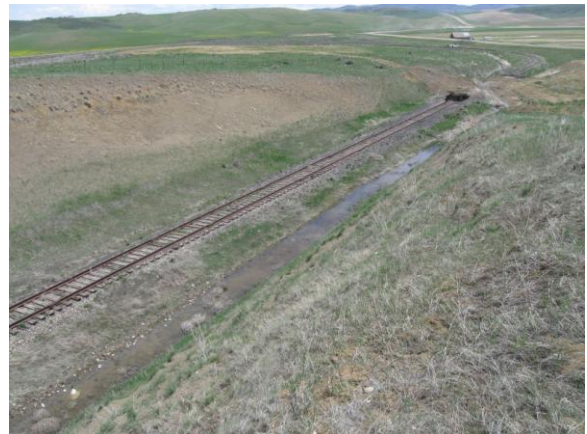
Ditch No. 8 was holding standing water near where the rail road has been partially removed. This ditch will need to be repaired to restore positive drainage.

Ditch No. 8. Standing water.
