**COLORADO DIVISION OF RECLAMATION, MINING AND SAFETY**  
**MINERALS PROGRAM INSPECTION REPORT**  
**PHONE: (303) 866-3567**

<b>MINE NAME:</b> High Mesa Gravel Pit	<b>MINE/PROSPECTING ID#:</b> M-2000-067	<b>MINERAL:</b> Sand and gravel	<b>COUNTY:</b> Delta
<b>INSPECTION TYPE:</b> Monitoring	<b>INSPECTOR(S):</b> Dustin Czapla	<b>INSP. DATE:</b> May 1, 2013	<b>INSP. TIME:</b> 12:15
<b>OPERATOR:</b> Beavers Construction Co./High Mesa Gravel	<b>OPERATOR REPRESENTATIVE:</b> None	<b>TYPE OF OPERATION:</b> 112c - Construction Regular Operation

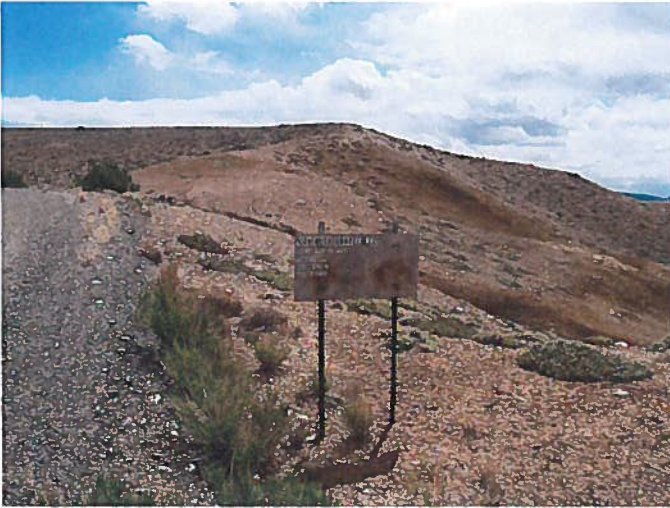
Adequate mine identification signage was noted at the entrance to the site.

Figure 1: Mine identification sign located near the entrance to the site.

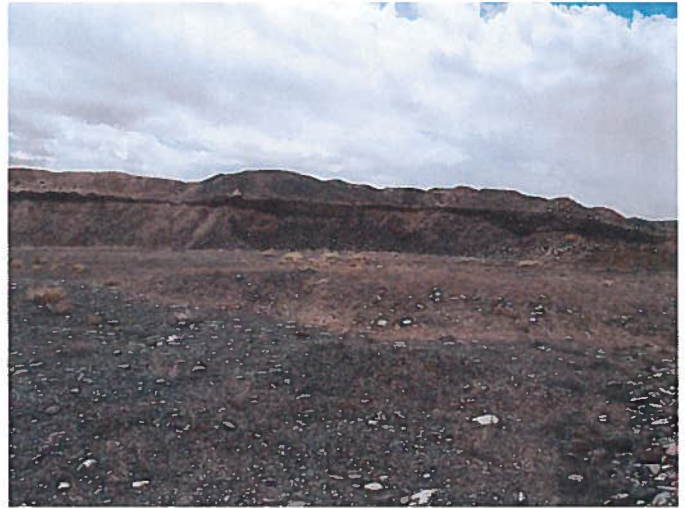
According to the approved mining plan for this site, the highwall is to be excavated and maintained at 3H:1V. Nearly 1,600 linear feet of highwall, approximately 20 feet high, was observed with slopes approximately 0.75H:1V. Additionally, the financial warranty held for this site is based on a 10 ac. disturbance. According to the operator's most recent annual report, there is one acre disturbed at the site. Based on this inspection it is estimated that at least 18 acres are disturbed at the site.

Figure 2: Facing south, toward the highwall located in the south side of the Phase 1 area, on the east side of the access road.

**CORRECTIVE ACTIONS:** The operator shall submit a Technical Revision, with the required \$216 revision fee, to update and clarify the current approved mine plan to reflect existing and proposed activities by the corrective action date.

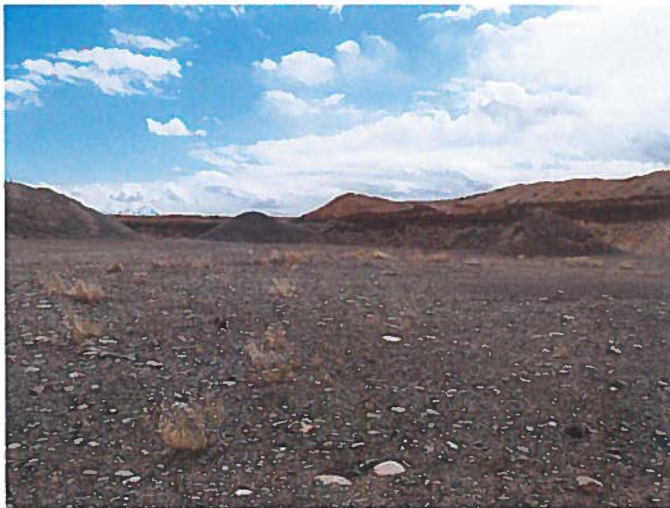
Figure 3: Facing southeast toward the highwall in the southeast part of the Phase 1 area.

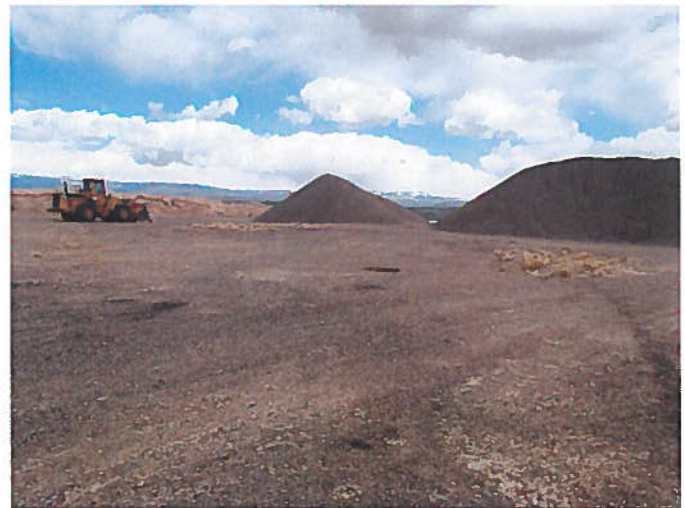
Evidence of recent mining activity at the site was not apparent. Stockpiles of crushed material still exist on site. According to annual reports, excavation has not occurred at the site in recent years and the only documented mining activity appears to be infrequent stockpile removal.

Figure 4: View of stockpiles located in the Phase 4 area.

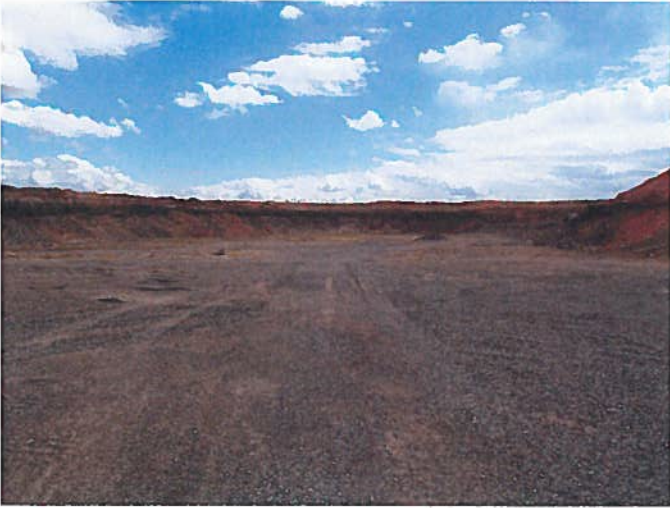
Figure 5: Facing east, toward the highwall located in the east side of the Phase 3 area.

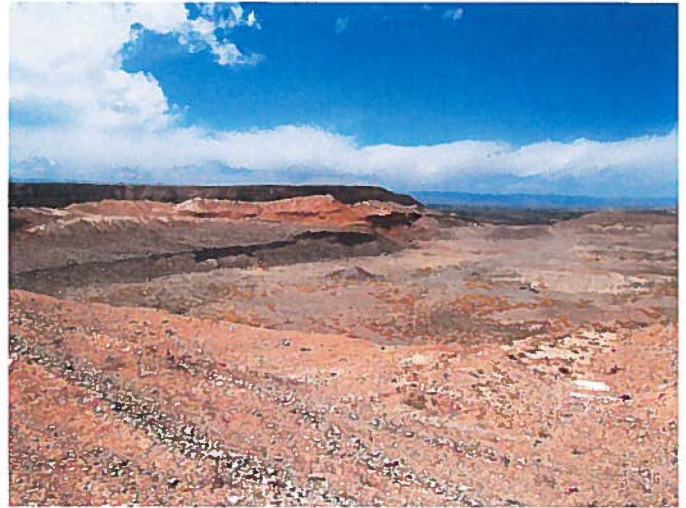
Figure 6: View from on top of the east highwall in the Phase 3 area, facing west.

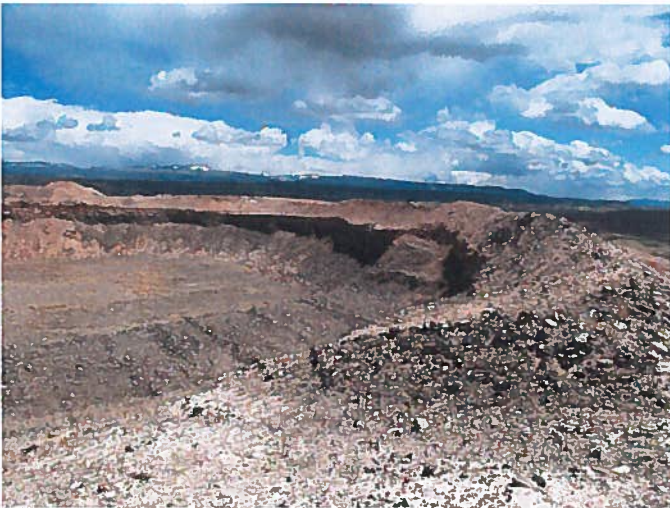
Figure 7: View from on top of the south highwall in the Phase 1 area, facing northeast.

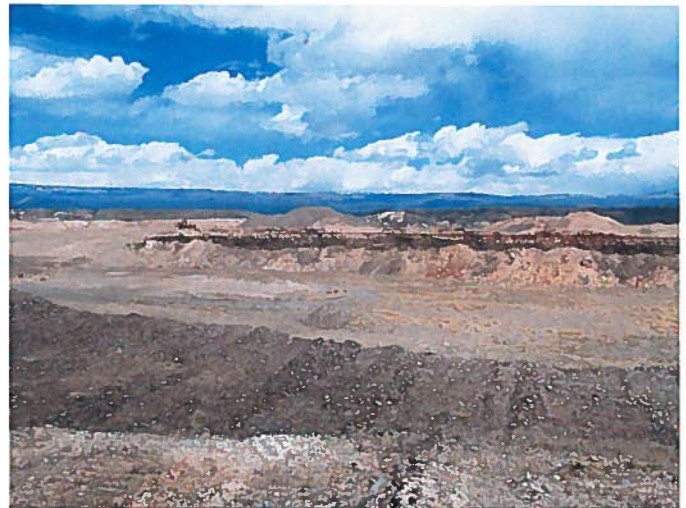
Figure 8: View from on top of the south highwall in the Phase 1 area, facing northeast.
