COLORADO DIVISION OF RECLAMATION, MINING AND SAFETY
MINERALS PROGRAM INSPECTION REPORT
PHONE: (303) 866-3567

MINE NAME: SR-13A Mine	MINE/PROSPECTING ID#: M-1977-311	MINERAL: Uranium and vanadium	COUNTY: San Miguel
INSPECTION TYPE: Monitoring	INSPECTOR(S): Dustin M. Czaplá	INSP. DATE: May 16, 2013	INSP. TIME: 11:00
OPERATOR: Cotter Corporation	OPERATOR REPRESENTATIVE: Glen Williams	TYPE OF OPERATION: 110d - Designated Limited Impact

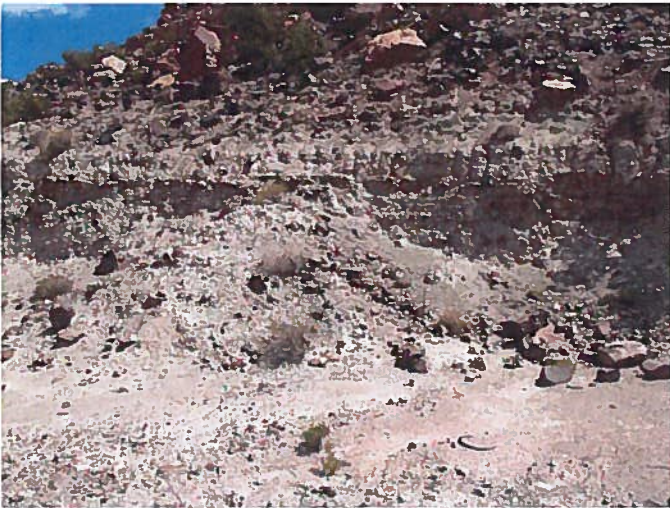
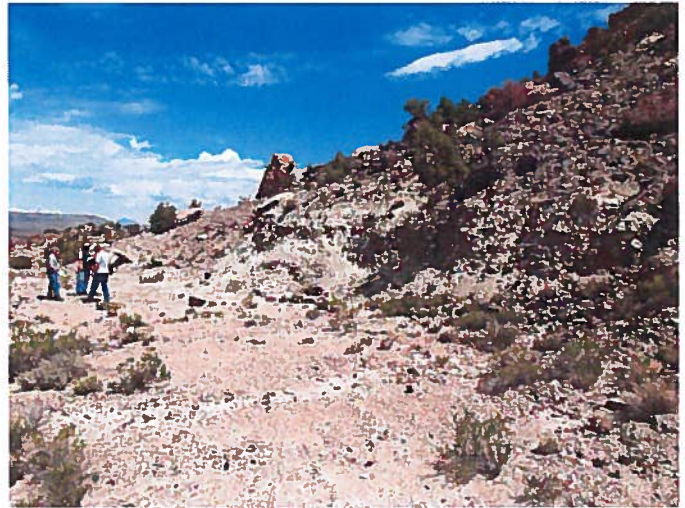
- (1) Venthole 1 has been sealed and backfilled. No signs of settling or subsidence were noted. The access road to the vent hole appeared to be stable with no significant erosion observed.
- (2) The reclaimed waste area appeared stable. The waste pile has been graded (pocked) and some vegetation is becoming established. No signs of significant erosion or slope failure were noted.
- (3) The road to the transmitter will be left in place. The road appeared stable and no signs of problematic erosion were noted.

Figure 1: Venthole 1

Figure 2: Venthole 1

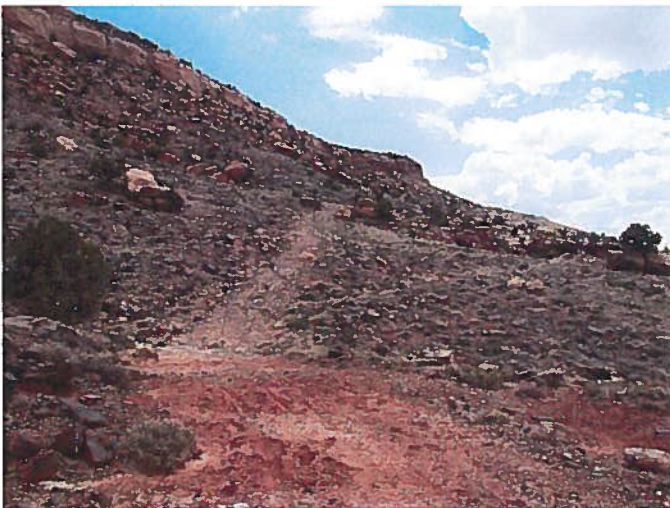
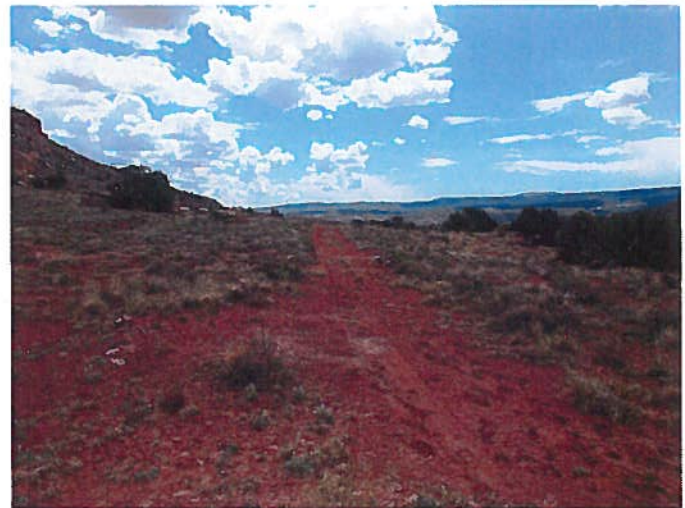
Figure 3: Access road to Venthole 1

Figure 4: Access road to Venthole 1

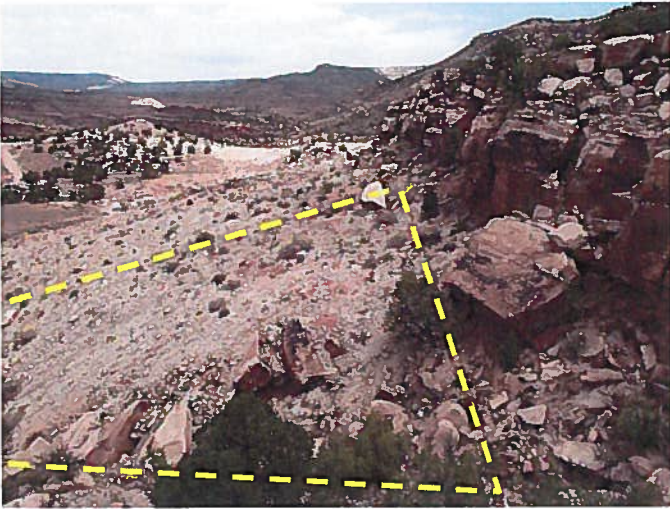
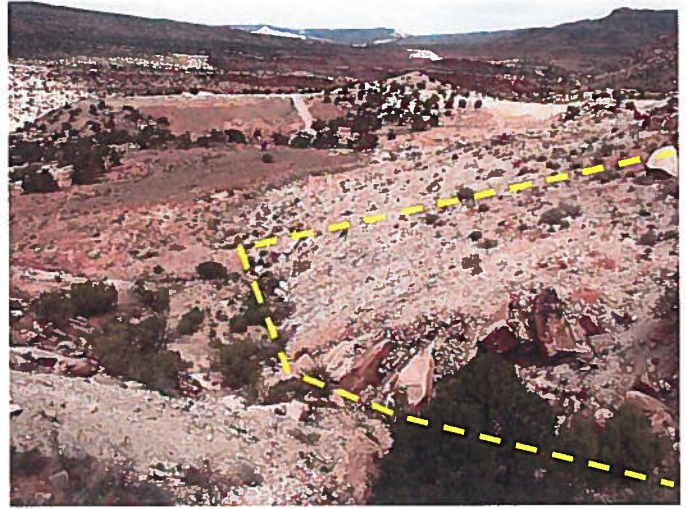
Figure 5: Reclaimed waste area to be released outlined by yellow polygon.

Figure 6: Reclaimed waste area to be released outlined by yellow polygon.

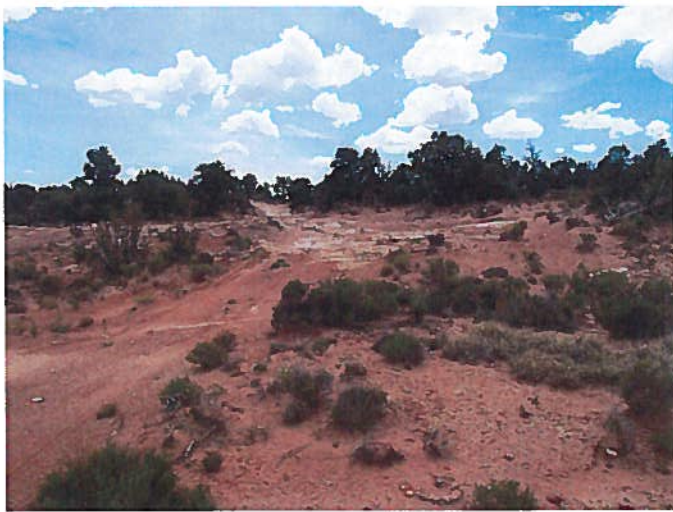
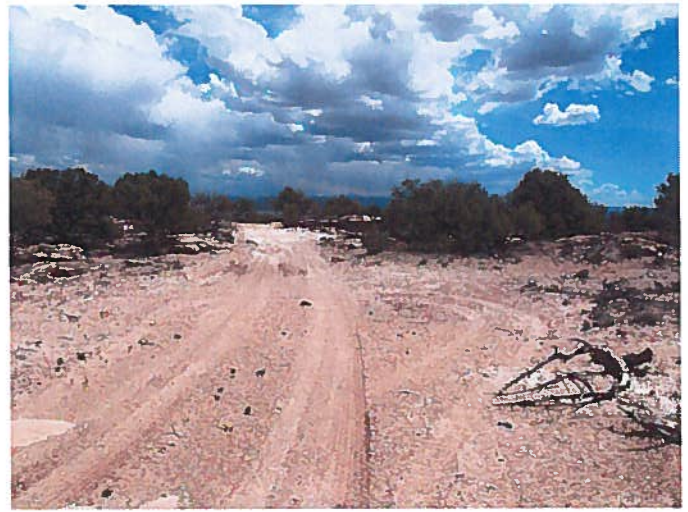
Figure 7: Access road to transmitter.

Figure 8: Access road to transmitter.
