**COLORADO DIVISION OF RECLAMATION, MINING AND SAFETY
COAL PROGRAM INSPECTION REPORT**

Permit Number: C-1994-082 Mine Name: Yoast Mine Operator: Seneca Coal Company, LLC Operator Address: Mr. Roy Karo 37796 Routt County Road 53 P.O. Box 670 Hayden, CO 81639	County: Routt Operation Type: Surface Permit Status: Permanent Cessation Ownership: Federal
	Operator Representative Present: Dennis Jones
Operator Representative Signature: (Field Issuance Only)

Inspection Start Date: May 14, 2013 Inspection Start Time: 10:43 Inspection End Date: May 15, 2013 Inspection End Time: 09:00	Inspection Type: Coal Complete Inspection Inspection Reason: Normal I&E Program Weather: Clear
Joint Inspection Agency: None	Joint Inspection Contacts:
Post Inspection Agency: None	Post Inspection Contacts:
Inspector(s): Jared L. Ebert	Inspector's Signature:

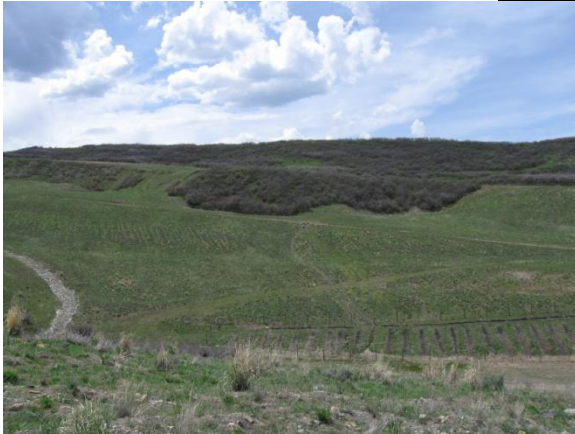
YPM-16 is rip-rapped and stable.

YPM-22 and 16 from north pit area looking southwest.

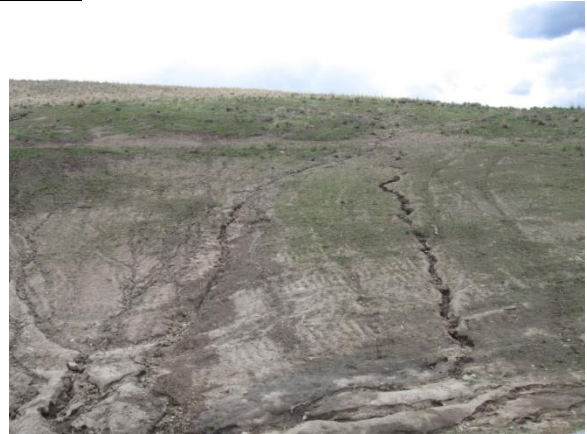
Several surge tanks have been constructed in the YPM-13 drainage. Several rills were observed above the uppermost surge tank. The lower surge tank along this drainage needs to be repaired. Large rills have formed above the tank and the embankment where the discharge pipes and spillway is located has been blown through.

Rills above upper surge tank in YPM-13.

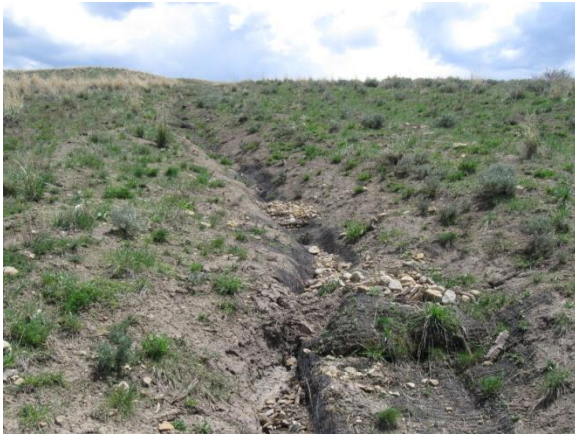
In the north areas, YPM drainage 21 and 21B were walked. Several gullies are forming on the outside of the Turf Re-Inforced Matting (TRM) in YPM-21B.

YPM-21B, rills outside of the TRM

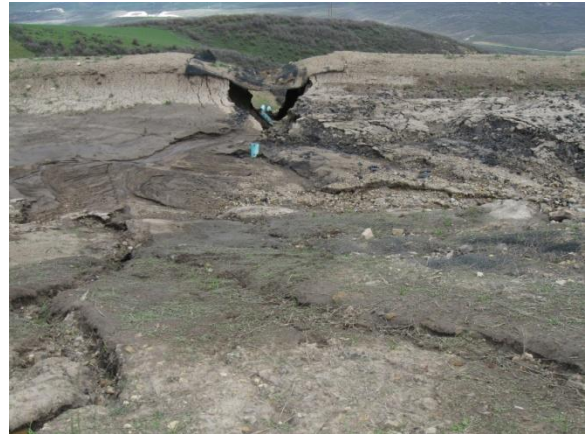
Lower surge tank in YPM-13 drainage.
Damaged and need repair.

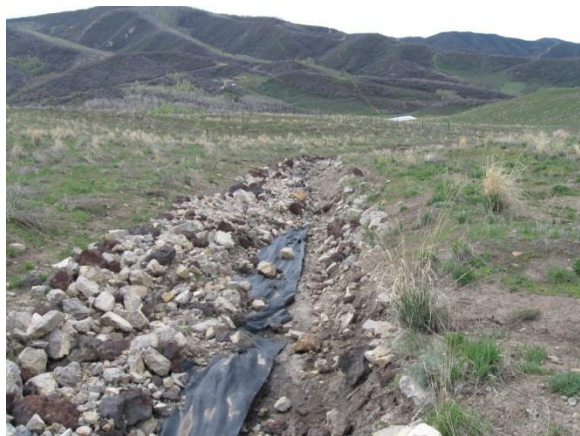
The rip-rap in YPM-3-2 has washed off the TRM in places and the channel is side cutting.

Some of the rip-rap from YPM-3-2 drainage has sloughed off and piled up at the end of the channel and as a result some side cutting of the channel has occurred around the pile of rip-rap.

YPM 3-2. Damage

Repairs will need to be conducted on the damaged drainages. As stated above, it appears the operator has begun repairs on several of the drainages.

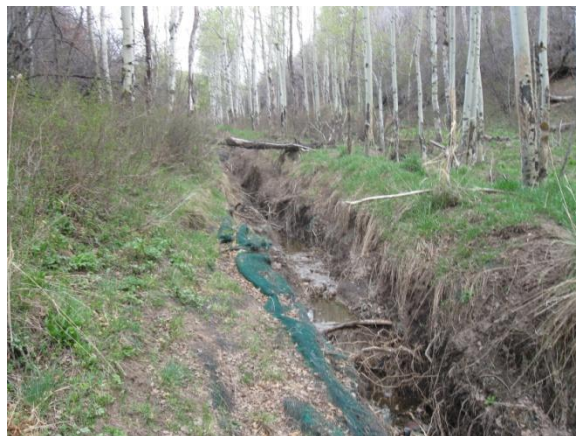
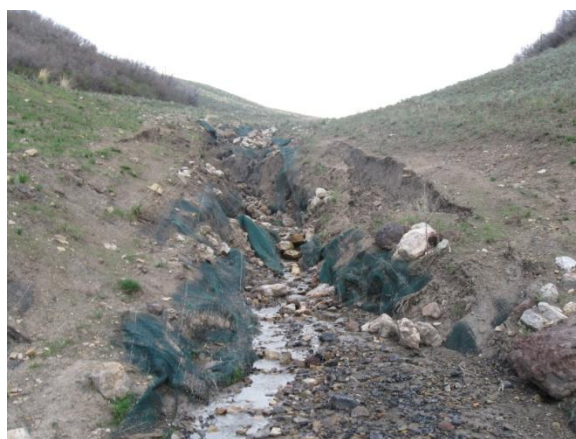
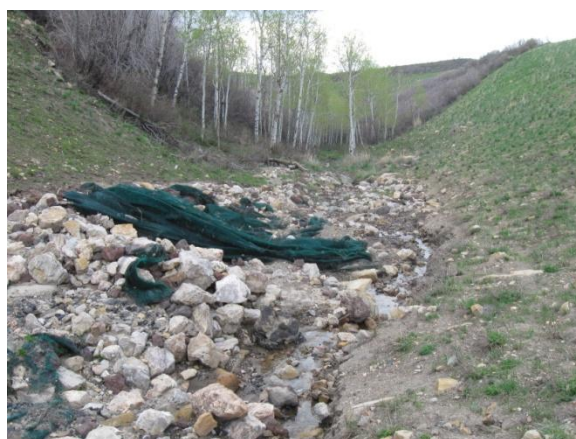
The YPM-7 drainage is damaged, a six to seven foot side cut has formed on the side of the channel just above the intersection of YPM-6-2. Sediment has collected at the top of the YPM-6-2 channel. Also, a large gully has formed in the YPM 6-1 channel. Rock and equipment has been staged in this drainage area and it appears the operator is actively making repairs to these channels.

YPM-6-1. Damage

YPM-6-1 Damage

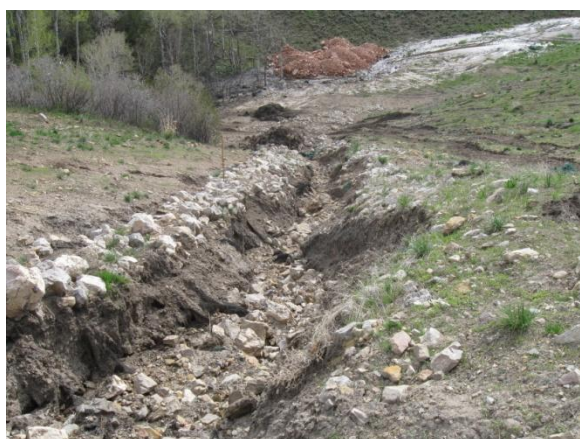
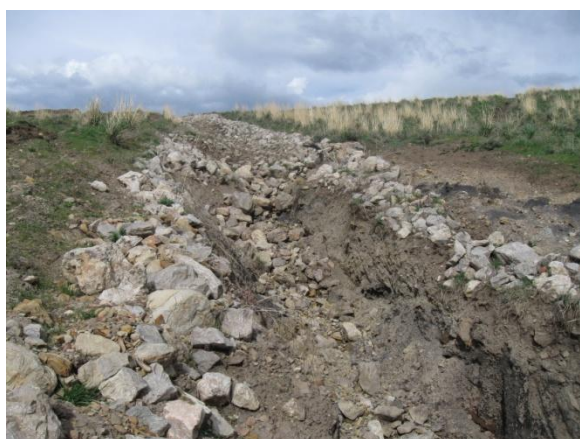
YPM-7 draining into YPM-6-2

YPM-7.

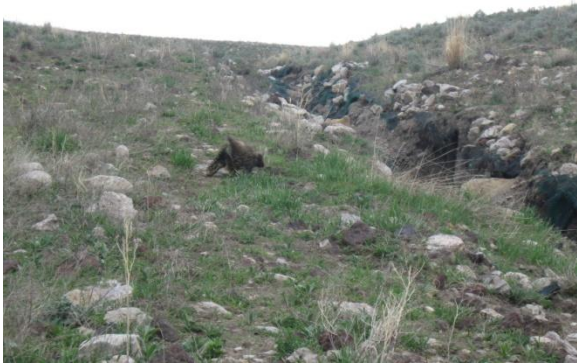
Two porcupines was observed along the YPM-6-1 and 6-2 drainage.

Porcupine

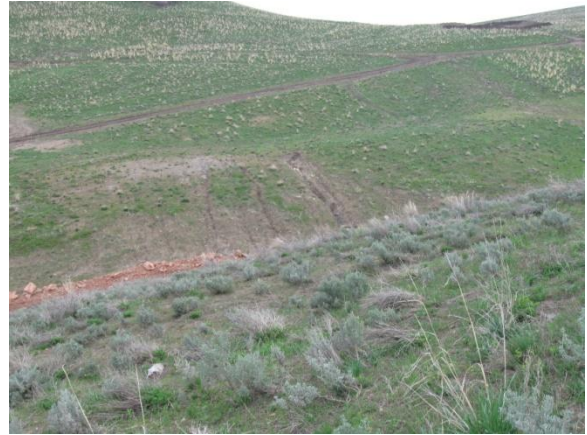
Rills above YPM-6-2.

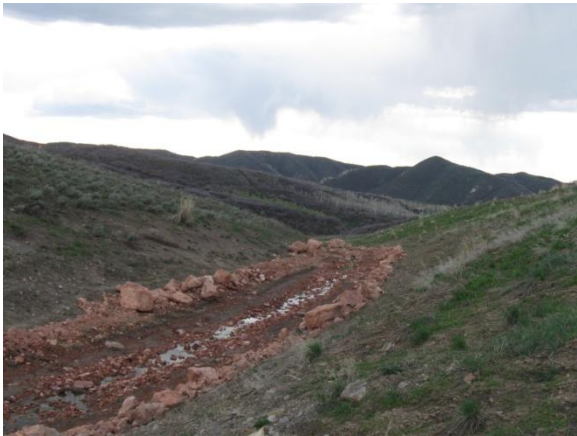
The lower section of YPM 6-2 has been re-shaped and rip rapped.

YPM-6-2 Repair

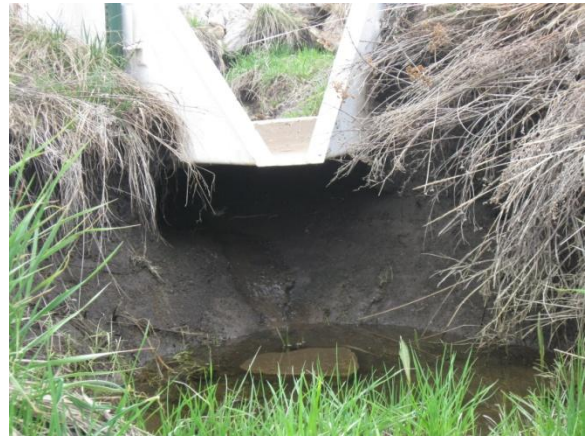
Pond 014 is holding water and discharging. The primary and emergency spillway is clear and functional. The emergency spillway is stable. It appears water is undercutting under the flume and thus the discharge rate cannot be accurately measured. The Operator will need to repair the flume.

Small drainage undercutting the flume at Pond 014. Need repair.

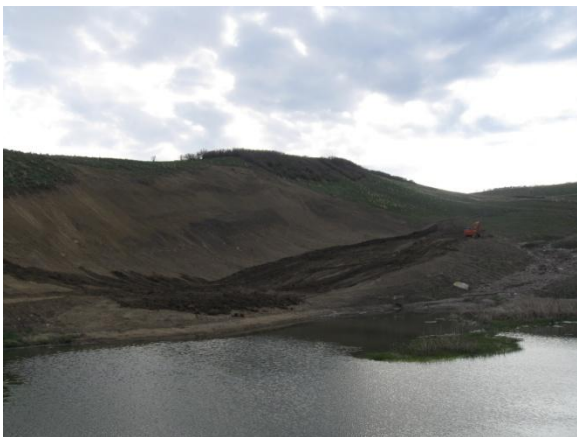
It appears the Operator is pulling topsoil out of stockpile “L” and placing it in the graded area above Pond 012.

Topsoiling above Pond 012.
