## COLORADO DIVISION OF RECLAMATION, MINING AND SAFETY COAL PROGRAM INSPECTION REPORT

<b>Permit Number:</b> X-2004-153-13 <b>Mine Name:</b> CAM Stove Canyon Expl Project <b>Operator:</b> Central Appalachia Mining, LLC <b>Operator Address:</b> Mr. Corey Heaps CAM-Colorado LLC 743 Horizon Ct, Suite 201 Grand Junction, CO 81506	<b>County:</b> Garfield <b>Operation Type:</b> Coal exploration <b>Permit Status:</b> Inactive <b>Ownership:</b> Federal
<b>Operator Representative Present:</b>  Jim Stover	
<b>Operator Representative Signature:</b> (Field Issuance Only)

<b>Inspection Start Date:</b> May 14, 2013 <b>Inspection Start Time:</b> 07:00 <b>Inspection End Date:</b> May 14, 2013 <b>Inspection End Time:</b> 16:00		<b>Inspection Type:</b> Coal Exploration Inspection <b>Inspection Reason:</b> Surety Release Requested <b>Weather:</b> Clear	
<b>Joint Inspection Agency:</b>  None		<b>Joint Inspection Contacts:</b>	
<b>Post Inspection Agency:</b>  None		<b>Post Inspection Contacts:</b>	
<b>Inspector(s):</b>  Elliott R. Russell	<b>Inspector's Signature:</b>

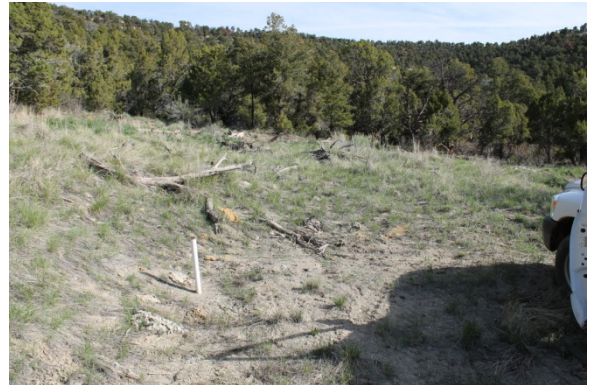
Monitoring well remains at site 7-34-7

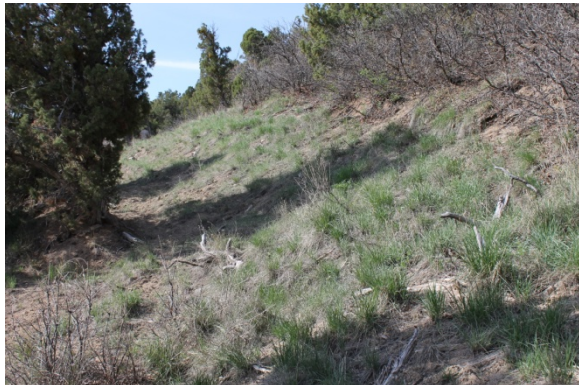
Segment of reclaimed access road to 8-2-9

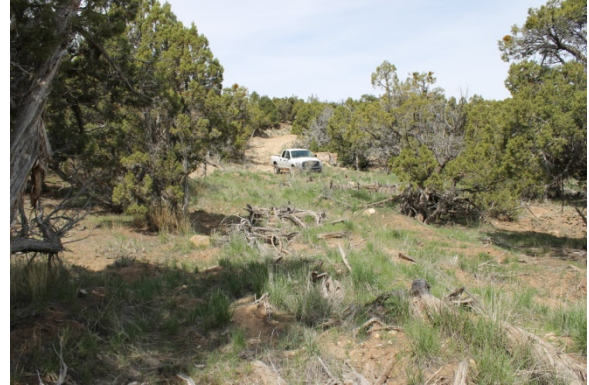
Segment of reclaimed access road to 8-2-7;  
Truck is on unreclaimed access road to 8-2-8

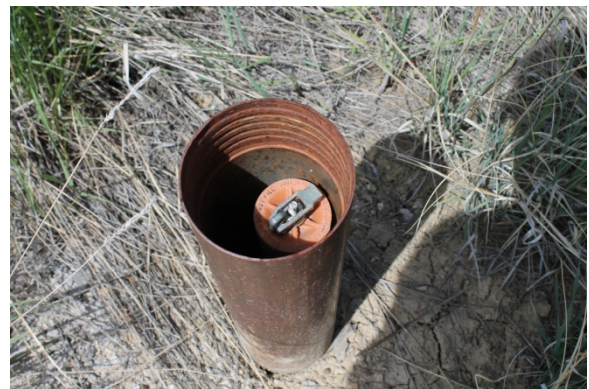
Monitoring well remains at site 8-2-8

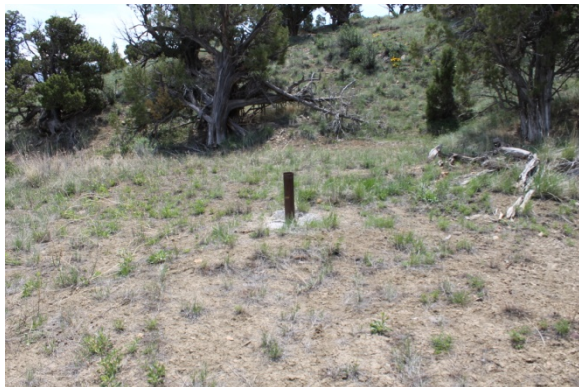
Monitoring well remains at site 8-3-10
