# COLORADO DIVISION OF RECLAMATION, MINING AND SAFETY COAL PROGRAM INSPECTION REPORT

<b>Permit Number:</b> X-2006-217-11 <b>Mine Name:</b> Bowie Terror Creek 2D Seismic Survey <b>Operator:</b> Bowie Resources, LLC <b>Operator Address:</b> Bill Bear P.O. Box 483 Paonia, CO 81428	<b>County:</b> Delta <b>Operation Type:</b> Coal exploration <b>Permit Status:</b> Inactive <b>Ownership:</b> Federal
	<b>Operator Representative Present:</b>  Bill Bear
<b>Operator Representative Signature:</b> (Field Issuance Only)

<b>Inspection Start Date:</b> May 13, 2013 <b>Inspection Start Time:</b> 12:00 <b>Inspection End Date:</b> May 13, 2013 <b>Inspection End Time:</b> 16:30		<b>Inspection Type:</b> Coal Exploration Inspection <b>Inspection Reason:</b> Surety Release Requested <b>Weather:</b> Clear	
<b>Joint Inspection Agency:</b>  None		<b>Joint Inspection Contacts:</b>	
<b>Post Inspection Agency:</b>  None		<b>Post Inspection Contacts:</b>	
<b>Inspector(s):</b>  Elliott R. Russell	<b>Inspector's Signature:</b>

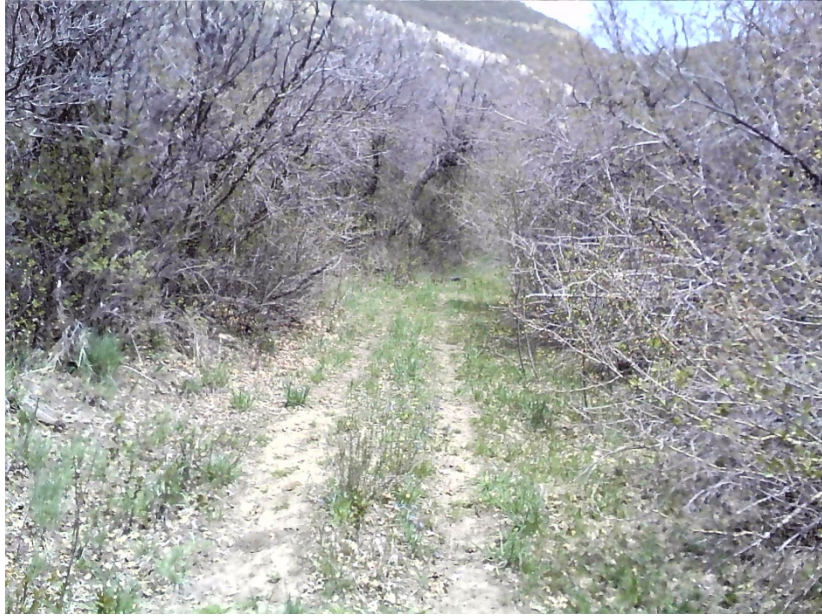
Seismic Line 3 located on a historical existing road. Some brush cutting occurred on this line.

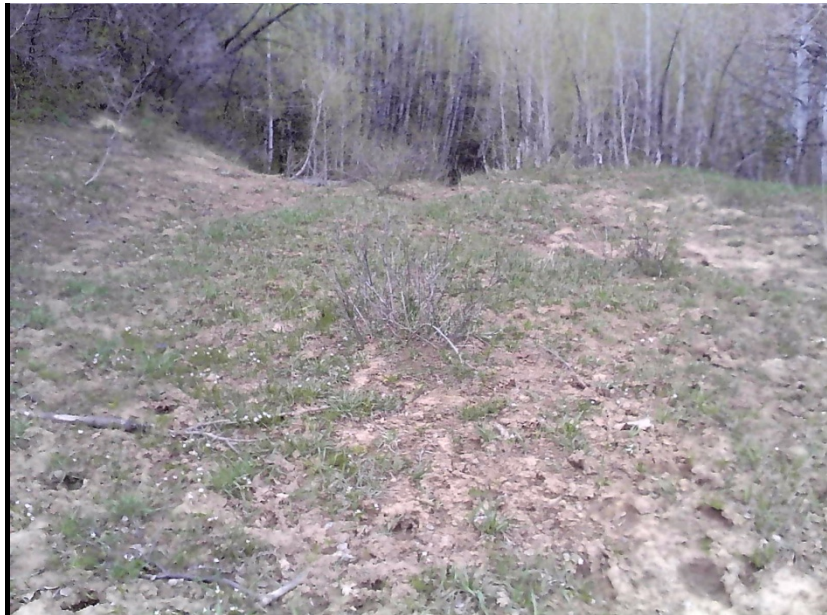
Start of Seismic Line 4 utilizing an existing reclaimed road associated with a high voltage power line.

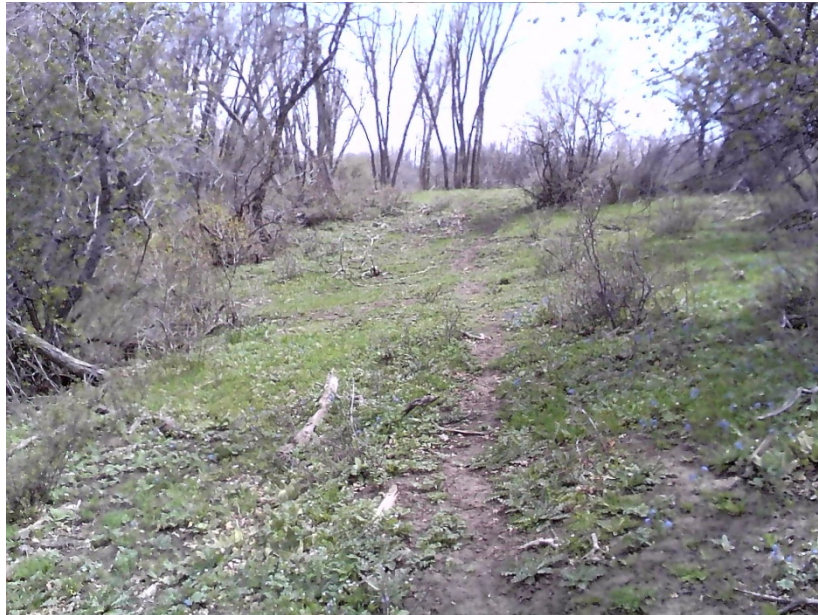
Area of new disturbance connecting two existing roads on Seismic Line 5.
