COLORADO DIVISION OF RECLAMATION, MINING AND SAFETY COAL PROGRAM INSPECTION REPORT

Permit Number: X-1998-219-03 Mine Name: Cottonwood Alluvial GW Monitoring Program Operator: Cottonwood Land Company Operator Address: Mr. Scott Cowman PO Box 250, 36600 Routt County Road 27 Hayden, CO 81639	County: Routt Operation Type: Coal exploration Permit Status: Active Ownership: Private
	Operator Representative Present: None
Operator Representative Signature: (Field Issuance Only)

Inspection Start Date: May 15, 2013 Inspection Start Time: 11:00 Inspection End Date: May 15, 2013 Inspection End Time: 11:45		Inspection Type: Coal Exploration Inspection Inspection Reason: Surety Release Requested Weather: Cloudy	
Joint Inspection Agency: None		Joint Inspection Contacts:	
Post Inspection Agency: None		Post Inspection Contacts:	
Inspector(s): Elliott R. Russell	Inspector's Signature:

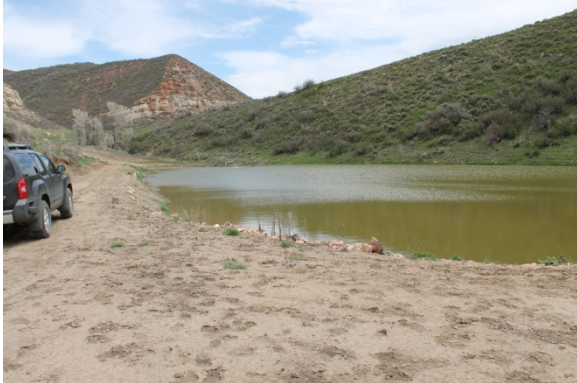
The stock pond was located approximately 2 miles up Berry Gulch near Pagoda, Colorado. The pond was full of water. Three t-posts were found which could possibly be indicators for where the wells use to be. Two were in the water on the south side and one was located on the north side next to the access road. There entire area was redisturbed by constructing the stock pond. The area east of the pond appeared to have been used for the dam embankment's material.

Stock Pond

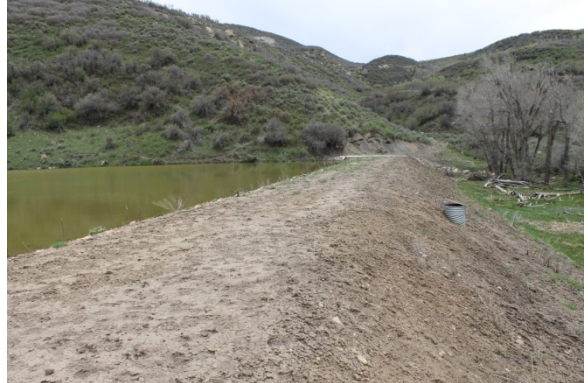
Dam embankment. Looking south

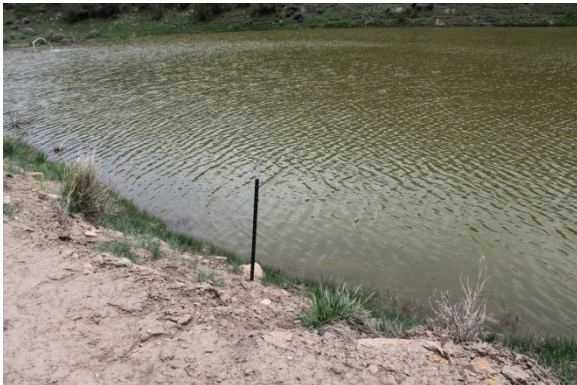
T-post on north side

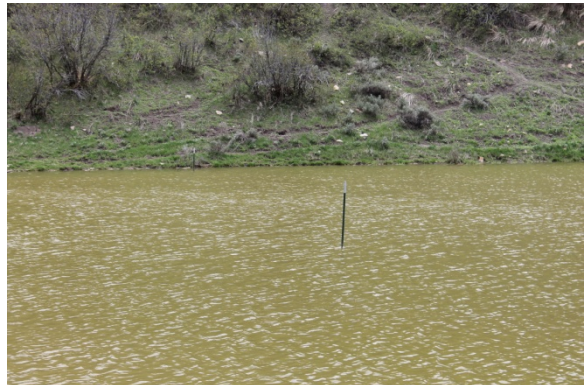
T-posts on south side

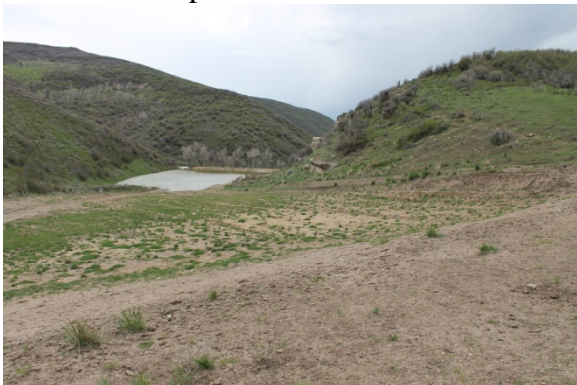
Disturbed area east of pond. Looking west
